Loss of Control Due to Flight Crew Loss of Airplane State Awareness: Analysis and Safety Enhancements

Presented at RASG-AFI LOC-I symposium, Nairobi 22 June 2015
by
Chamsou Andjorin – The Boeing Company

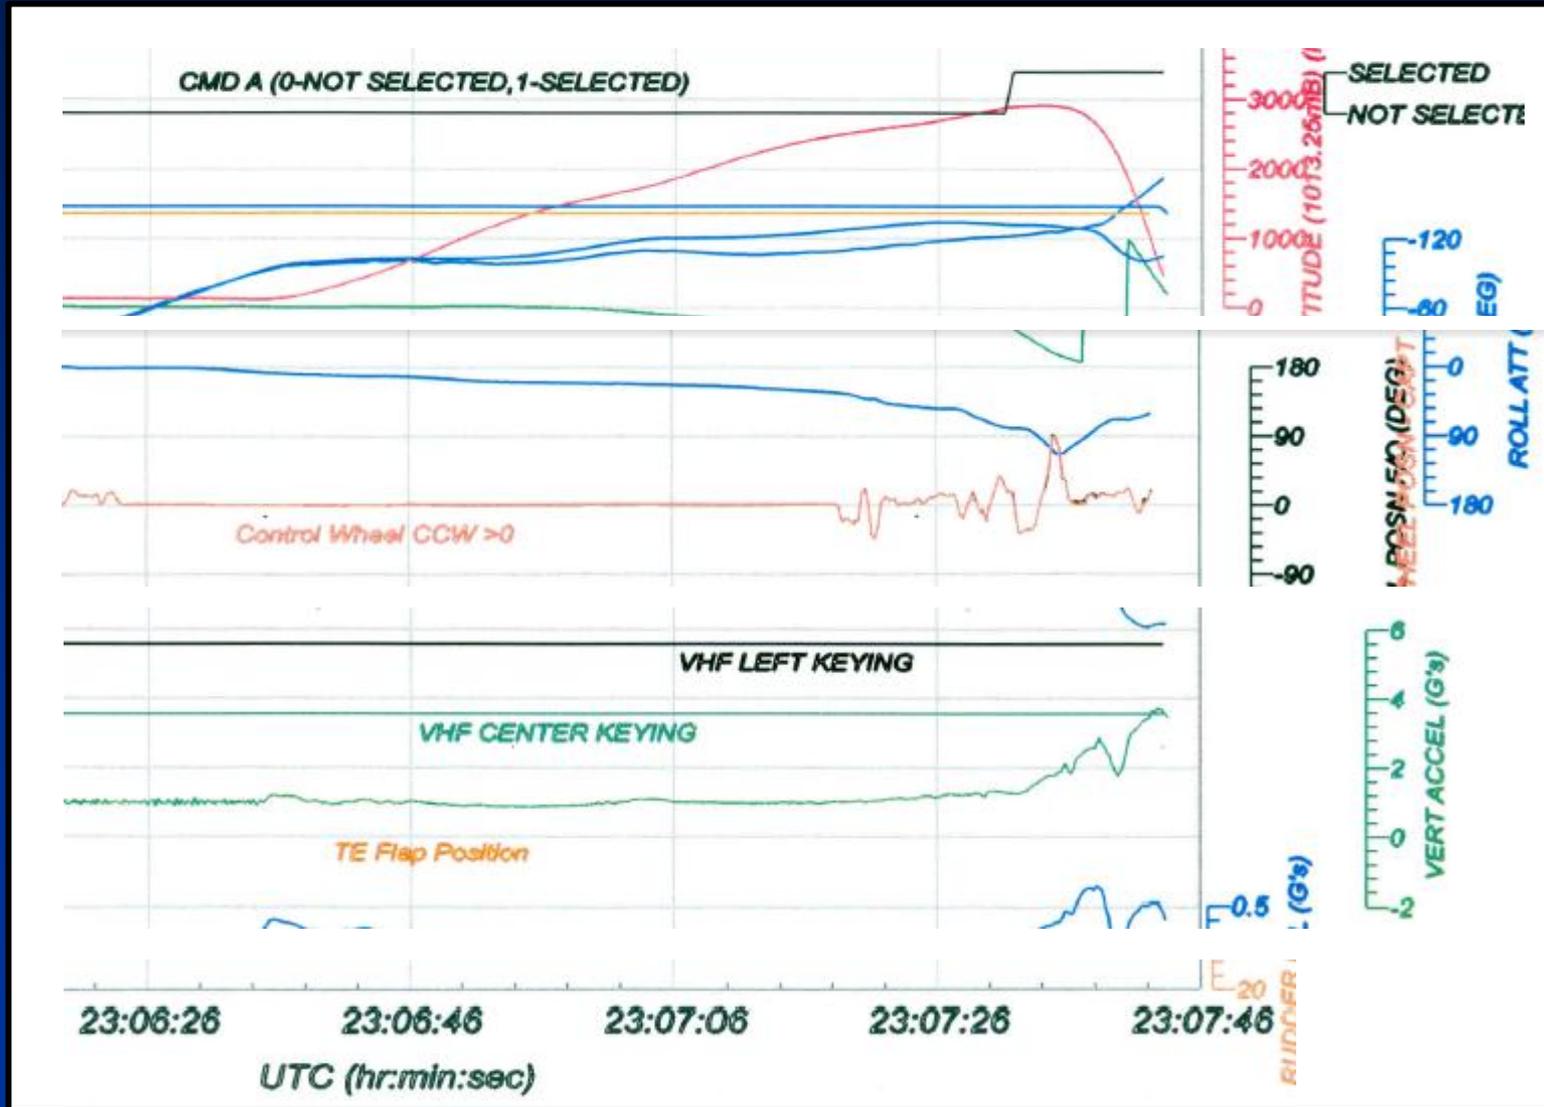
Example of Overbank from ASA Event Set

Kenya Airways 507 - Douala, Cameroon

Boeing 737-800 - May 5, 2007 - 114 fatalities

- During initial climb at 1000 ft AGL with autopilot disconnected
- Bank angle increases from 20° to 35° over roughly thirty seconds at normal g
- No initial input from the PF (from CVR, crew likely believes autopilot engaged): loss of attitude awareness
- At 35° bank, PF control wheel: right, left, right (mostly right) over 20 sec
- Bank angle increases past 90° and vertical speed goes from positive to negative

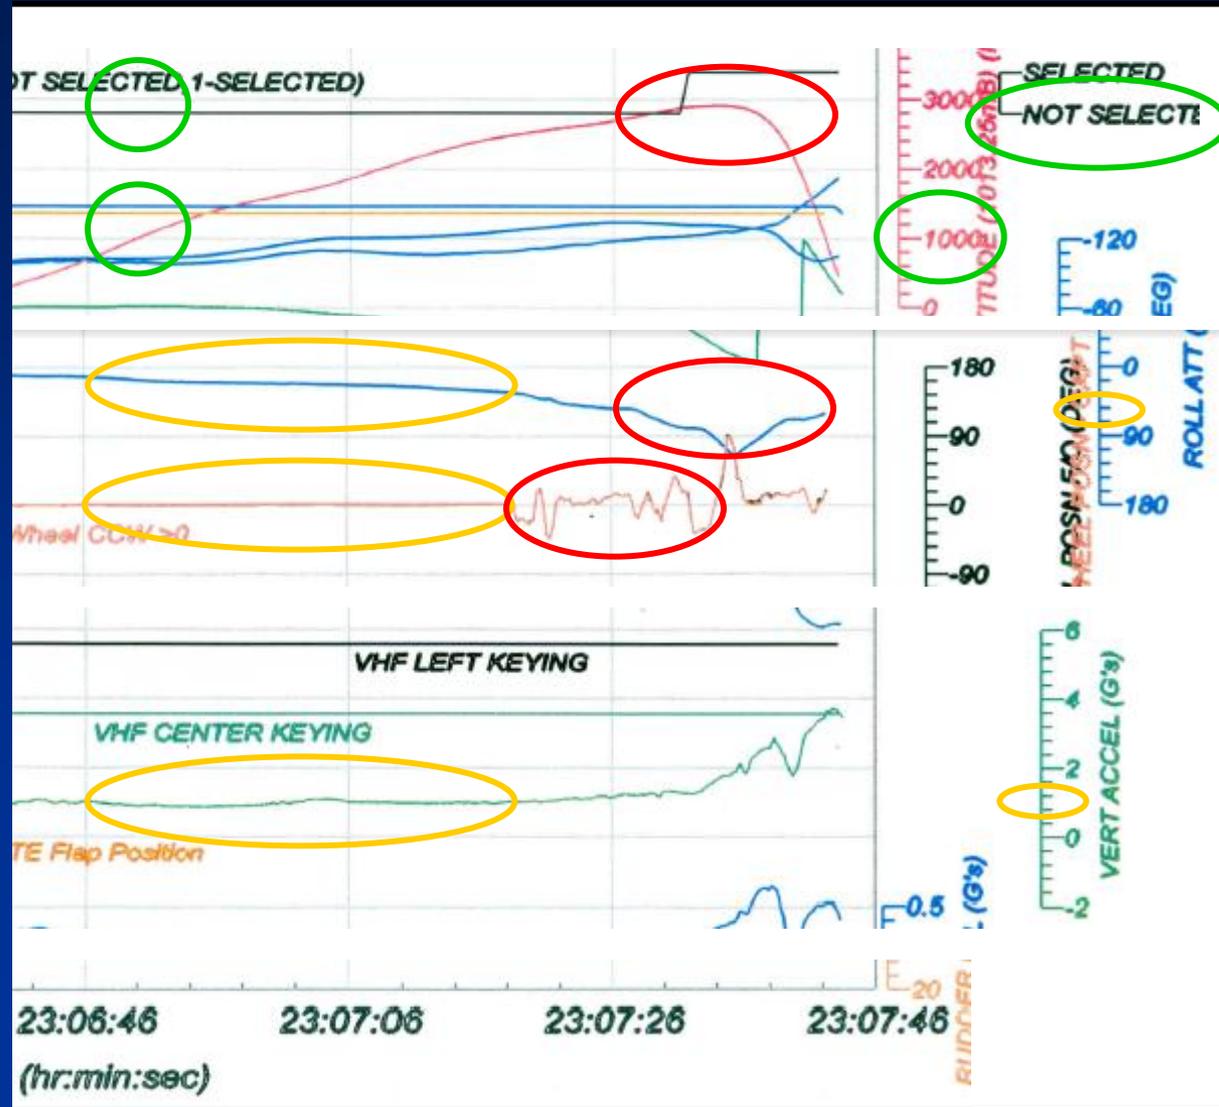
Accident: Kenya Airways 737-800 near Douala, Cameroon on 4 May 2007

- Capt is PF; 8682 ttl hrs; type: 824 (Capt on 737-700/800);
- ① - FO has 831 ttl hrs; type: 170; FO hadn't had CRM training yet
- Flight crew training did not provide: UAR, SD

- ② - Local weather: thunderstorms and moderate rain; 800 m visibility, scattered 300 ft, broken 1000 ft
- Initially canceled start-up due to heavy rain; prior to take-off they are focused on identifying a departure corridor away from weather

- On take-off the airplane has a tendency to bank right (not trimmed) and the Capt uses small left wheel inputs to maintain wings level
- At about 1000 ft, a period of 55 seconds commences where there are no control inputs; airplane begins slowly rolling right

- ③ - Attention at this time is on navigating through the weather
- ④ - 13 seconds after the last control input, Capt: "OK, command"; but the autopilot is not engaged (and there is no response from the FO); they are at 1600 ft and bank right of 11°

- They are attempting to use the heading bug to maneuver around the weather for 40 more seconds, but the heading bug has no effect since autopilot is not engaged.

- ⑤ - As bank angle nears 35°, the Capt exclaims and then EGPWS: "bank angle, bank angle"
- ⑥ - Capt makes wheel inputs to right, then left, then right with inputs to right dominating; airplane rolls to 45° right

- ⑦ - They engage the autopilot but due to force on wheel, transitions into CWS-R
- Capt makes inputs to right and left, and pulls back on wheel; bank angle eventually reaches 115° to the right, but is recovered to 70° right

- The FO states, "right captain, left, left, left, correction left."
- ⑧ - Capt and FO are both on controls; Capt rolling right; FO rolling left

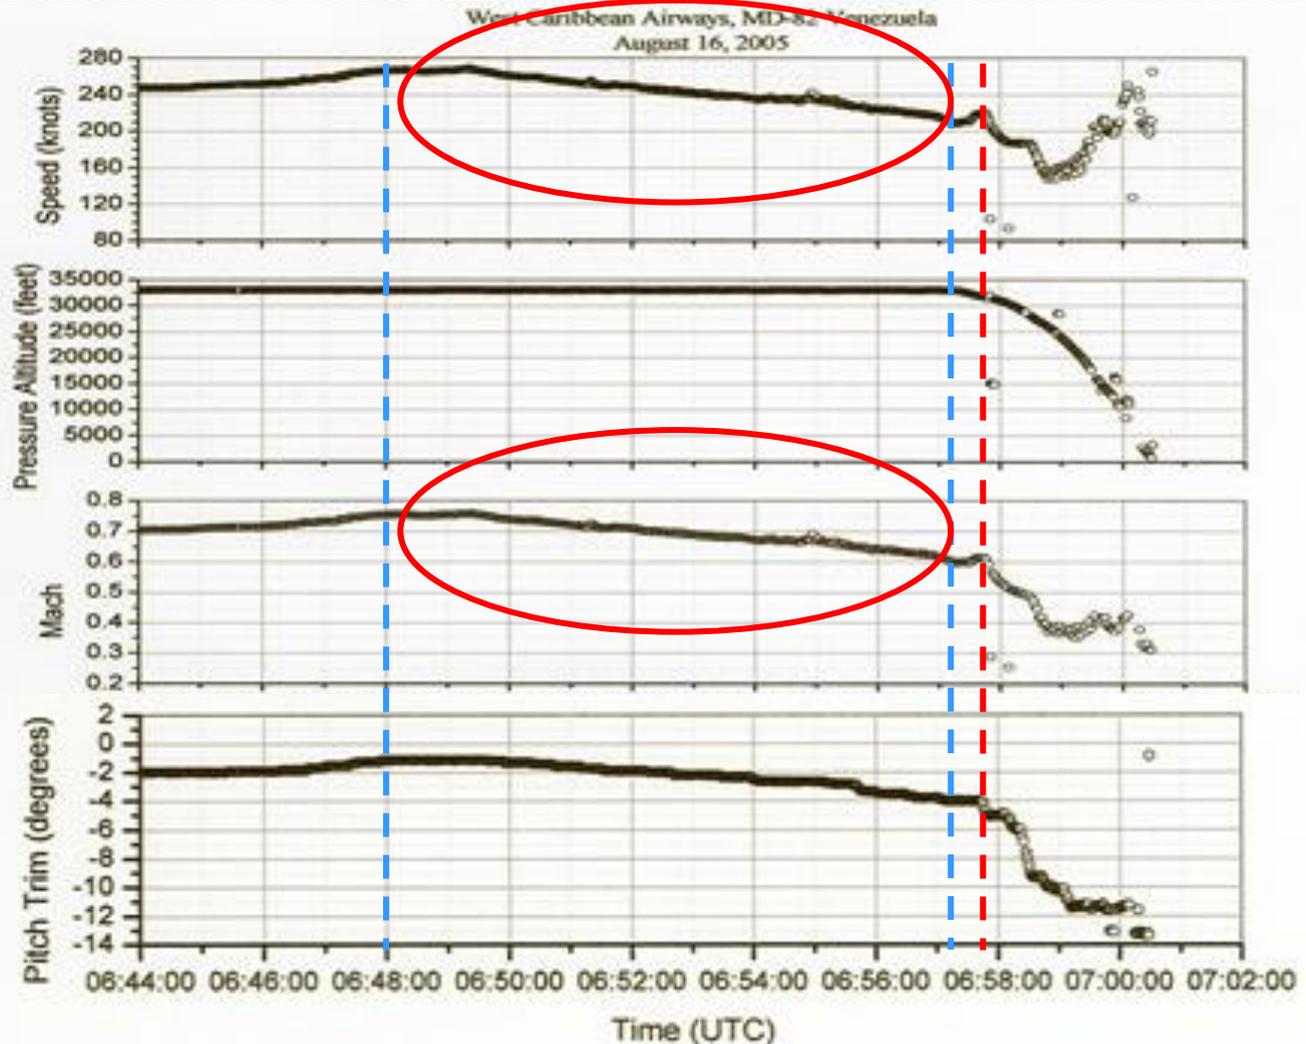
Accident: West Caribbean MD-82 over Venezuela on 16-AUG-2005

- Engine anti-ice turned off to climb to FL330
- Engine anti-ice re-engaged; EPR reduced
- A/P in altitude hold
- Airspeed and Mach decay over next 10 minutes
- Autopilot disconnected
- Stall warning – pilot responds with full aft column and NU trim

- ① - Significant safety oversight issues at operator for previous 6 months
 - CAPT experienced but low time in type; FO had low time but more in type
 - Takeoff at or near max allowable weight (performance limited)

- ② - Flight plan called for cruise at FL350; airplane not capable of achieving altitude with anti-ice
- ③ - Significant weather along the planned route; not noted on the flight plan

- ④ - Night, IMC. Middle of the night for crew's Circadian rhythm.
 - Initial cruise at FL310 encountered weather cells, routed around by ATC
 - Crew requested climb to FL330 but could not reach altitude in level change mode

- ⑤ - Crew turned off anti-ice; switched to VS; aircraft climbed at max power, losing airspeed
- ⑥ - At FL330, crew restored anti-ice, re-engaged A/P in ALT HOLD, commenced other activities

- ⑦ - Aircraft could not maintain altitude at selected airspeed; Mach began to decrease
 - As Mach decreased to 0.65, airplane also began to lose altitude

- Crew asked ATC for lower altitude and began to descend as Mach decreased below 0.60M
 - Just below FL320 stick shaker activated
- ⑧ - CAPT disengaged autopilot and pulled the column aft, then began to trim nose up

- ⑨ - Autothrottles remained engaged, throttles to idle (reasons unclear, possibly from surge)
- ⑩ - Aircraft entered full stall. FO recognized stall but did not intervene. CAPT did not respond to FO

- ⑪ - Crew mistook idle thrust as indication of engine flameout, contact ATC to declare emergency and request lower altitude
- ⑫ - CAPT continued to hold column aft as crew continued to call for lower altitudes and diagnose perceived engine trouble

- Crew apparently believed the reduced airspeed was the result of dual engine flameout. The CAPT never attempted to reduce angle of attack.
 - Descent reached 12,000 fpm just before the airplane impacted the ground.
