Background

Upset Accidents and Incidents

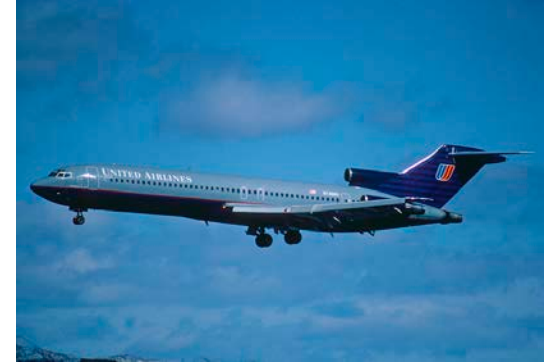
United 241 incident

- When: November 1968
- Where: Departure from Detroit
- What: B727

Started rapid climb at 4700 ft maintaining 1G

At 6000 ft in 20-deg bank, aircraft encountered an abnormal meteorological condition

Bank increased to 40 degs and an abnormal climb rate

Captain applies forward pressure and nose-down trim

High rate of descent and difficulty recovering

-1.5G at 8700 ft and 4.7G at 1200 ft

- Why: Trim overcontrol in recovery

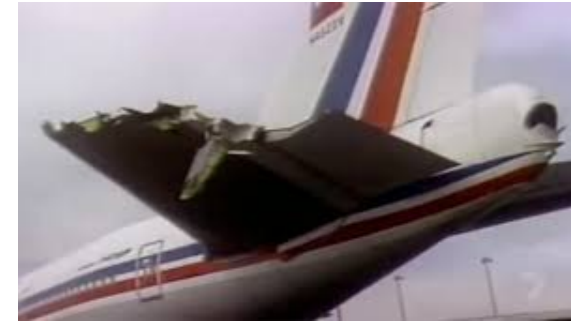
China Airlines 006 incident

- When: February 1985
- Where: 300 nmi NW of San Francisco, FL410
- What: 747 SP

Loss of No. 4 engine

Roll autopilot counters until it reaches limit...more roll

Almost 360 deg right roll, pitch down 69 deg

5.1g's reached during pull-up; exceeded Vmo twice

Recovered at 9,500 ft

Two serious injuries

- Why: Preoccupation with malfunction; failure to monitor instruments; likely spatial disorientation

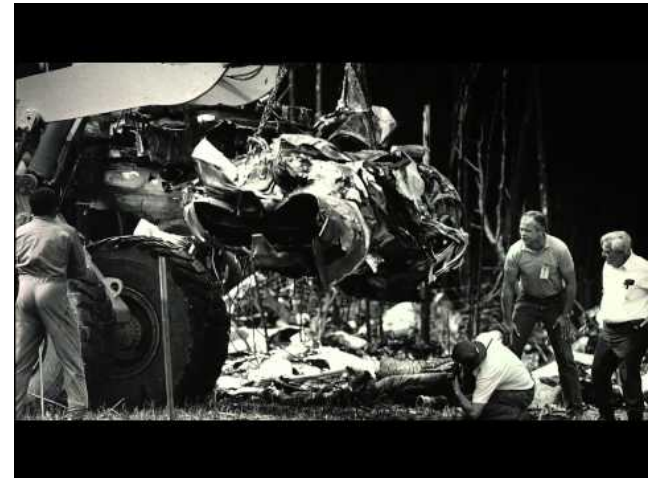
Midwest Express 105

- When: September 1985
- Where: Milwaukee, Wisconsin
- What: DC-9

Day, VMC

Uncontained right engine failure on takeoff at 450 ft AGL

Correct then incorrect pedal, followed by aft column

Continued climbing to 700 ft, rolled right near 90 degs

Accelerated stall

- Why: Improper response to engine failure, lack of crew coordination

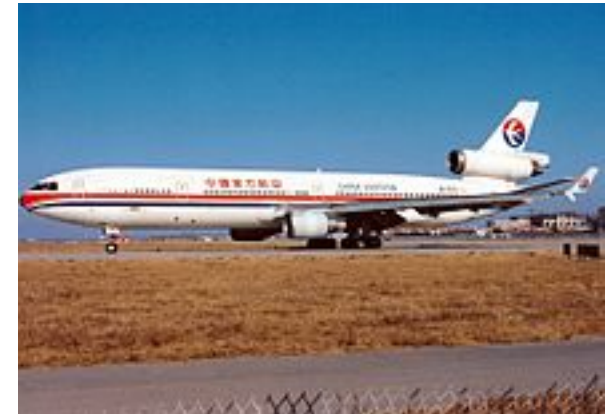
China Eastern Airlines 583

- When: April 1993
- Where: 950 nmi south Shemya, Alaska
- What: MD-11

Night, VMC, FL330

Inadvertent deployment of leading-edge wing slats

Several violent pitch oscillations in ensuing recovery

Simultaneous shaker and slat overspeed chime

+2.1G to -1.2G

- Why: Inadequate design of flap/slat actuation handle. Light control forces and reduced pitch stability made overcontrol easy to do

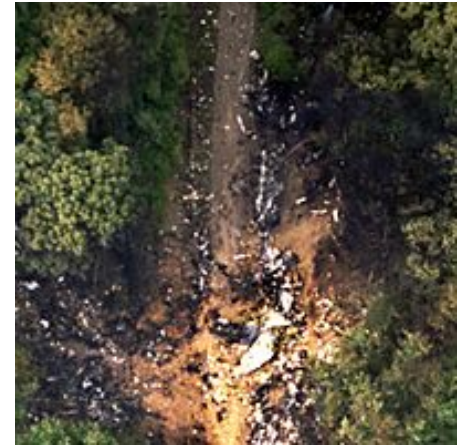
USAir 427

- When: September 1994
- Where: Approach to Pittsburgh International
- What: 737-300

At 6,000 ft, wake encounter from a leading 727

Rolled out to assigned heading, then into 28, and then
more than 70 deg roll left...shaker activates

Roll likely caused by rudder moving to stop arising
from a jam

Full aft column from pitch -30/90 deg roll until impact

Why: Rudder moved to its limit, likely in direction opposite
commanded as a result of jam in rudder power control unit

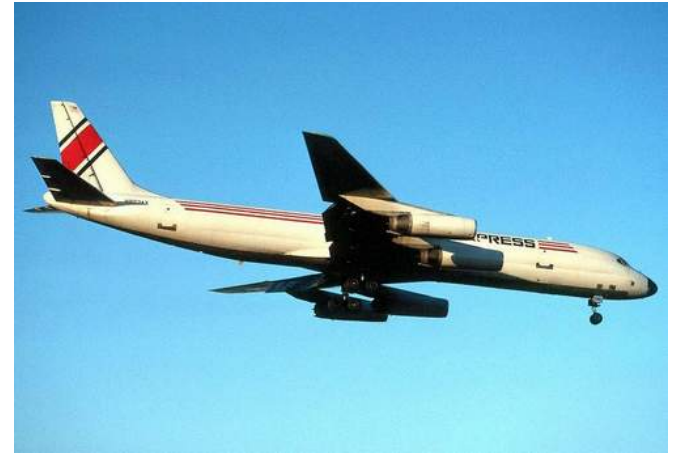
Airborne Express N827AX

- When: December 1996
- Where: Narrows, Virginia
- What: DC-8

Night, in and out of clouds, 14,000 ft

Approach-to-stall tests.

Expecting shaker at 128 kts. Got early buffet at 151

Set full power, resulting in compressor surges in No. 2

Maintained 10-14 degs pitch

Airspeed continued to decrease to full stall

Eventually applied full rudder

- Why: Inappropriate inputs in response to stall

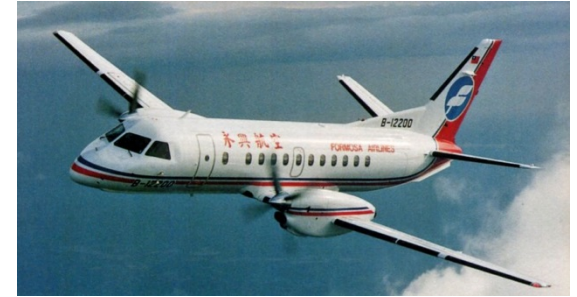
Formosa Airlines B12255

- When: March 1998
- Where: 7 miles NW HSZ airport, Taiwan
- What: Saab 340B

Right main bus inop in preflight, but captain proceeds

Several systems unavailable

Torque split arises after attempt to equalize temps

Roll and yaw asymmetry from torque split

Potential disorientation and fatigue

- Why: Loss of situational awareness; failure to comply with MEL; likely fatigue

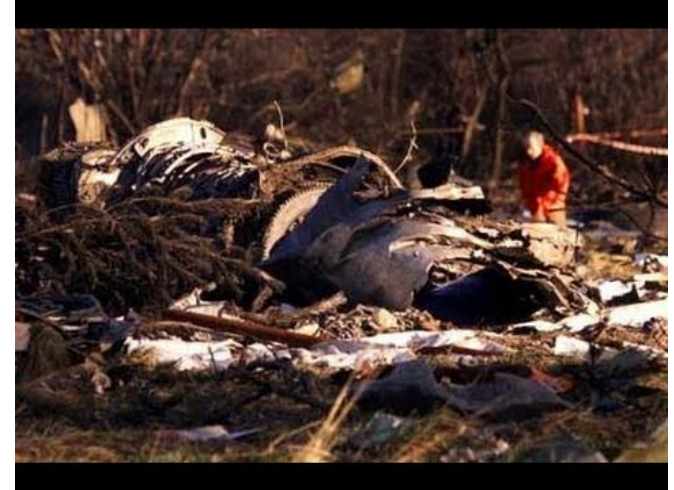
Korean Air Cargo 8509

- When: December 1999
- Where: Great Hallingbury, England
- What: 747-200

Night, scattered clouds 500 ft

Captain's ADI shows no bank while he increases it

Comparator alarm sounds. Flight Engineer says "bank"

Warnings canceled prior to impact at 90 deg bank

- Why: Poor crew resource management

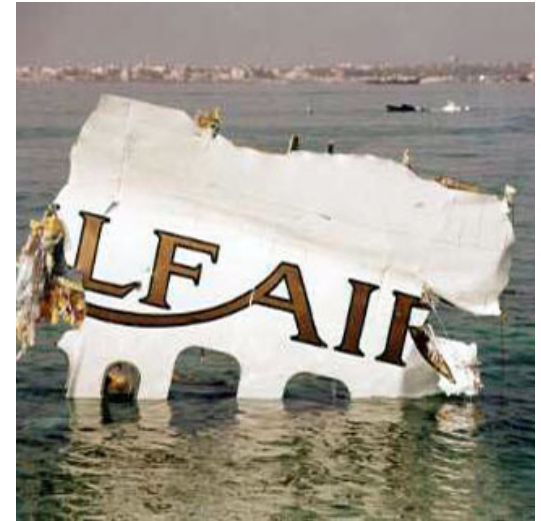
Gulf Air 072

- When: August 2000
- Where: Persian Gulf, Bahrain
- What: A320

Dark night, VMC

On second go-around, captain commanded half the pitch req'd, and did not maintain runway heading
With TOGA and low pitch, aircraft rapidly accelerated
Flap overspeed warning; commanded flaps up
Captain deflected stick forward and got -15 deg pitch
Did not respond to multiple GPWS alerts

- Why: Likely spatial disorientation, incorrect go-around procedure, poor CRM

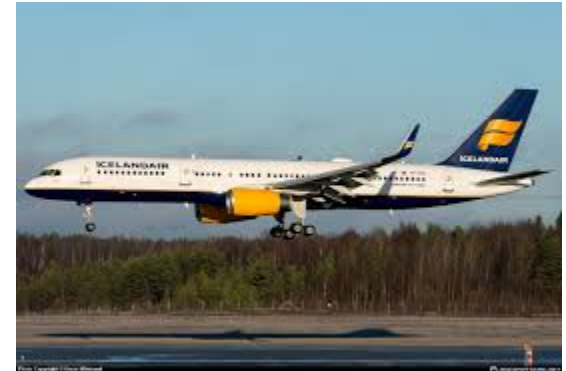
Icelandair 315 incident

- When: January 2002
- Where: Approach to Oslo airport
- What: B757

Day, IMC

Go around after unstable approach (near MCP alt)

After go-around transient, aircraft tries to level and
slow to MCP speed of 150 kts

Captain put in inputs to prevent stall

Pitch goes between +40/-49;

Load factor goes between 3.6 and -0.6g's

Aircraft had two more flights afterwards w/o inspection

- Why: Loss of situational awareness; mode switching challenges

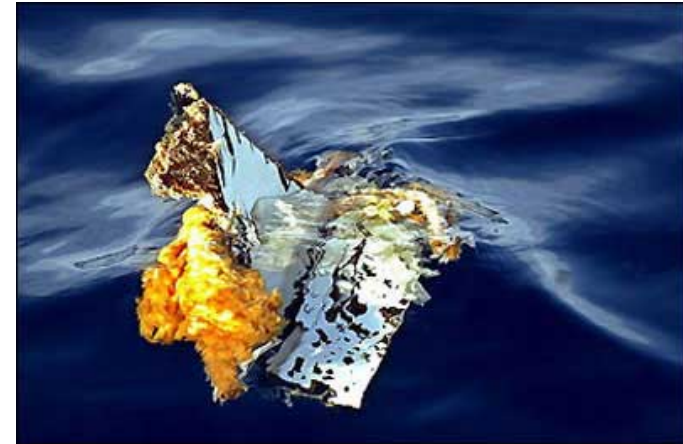
Flash Airlines 604

- When: January 2004
- Where: Red Sea near Sharm el-Sheikh A/P
- What: 737-300

Night, VMC

Left turn to intercept VOR after takeoff

A/P disconnects. Captain requests heading select.

Co-pilot warned that bank was increasing

Captain neutralizes wheel, then increases right bank

Banks 111 degs and 43 pitch down

Airplane hits water at 24 degs right bank and 4G's

- Why: Findings inconclusive (disorientation? System failure?)

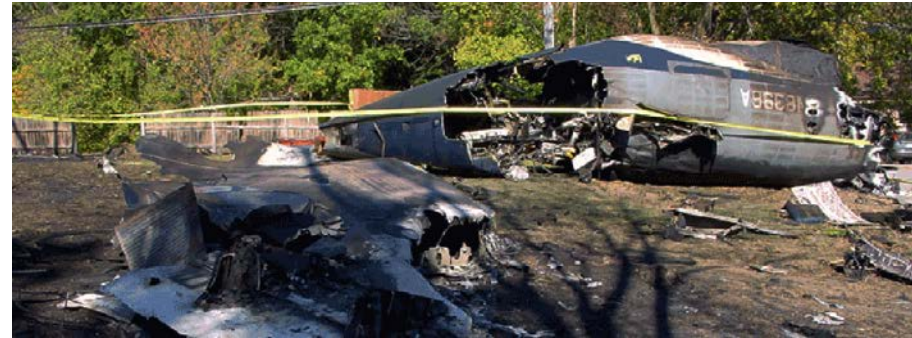
Pinnacle Airlines 3701

- When: October 2004
- Where: Jefferson City, Missouri
- What: CRJ-200

Night, VMC

Reposition flight; Climbed to FL410

Shaker and pusher activations; Dual engine flameout

Recovered from upset at FL340

Started performing double engine failure checklist

Did not obtain necessary speed for restart (300 kts)

Moved to APU-assisted start; unable due to core lock

- Why: Unprofessional behavior; lack of airspeed monitoring; improper response to stall; improper engine restart

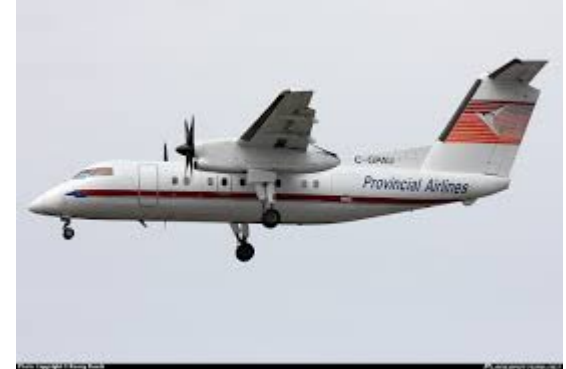
Provincial Airlines C-GZKH incident

- When: May 2005
- Where: Climbout from St. John's, Newfoundland
- What: de Havilland DHC-8

Day, IMC

Inadvertently selected vertical speed mode (1190 fpm)

At 7000', engine anti-ice selected. Pneumatic not selected.

Through 8000', gradual speed decrease over 5 mins

Shaker activates at 14,800' and 104 kts

- Why: Inappropriate mode select; lack of monitoring of speed during climb out; lack of recognition of stall cues

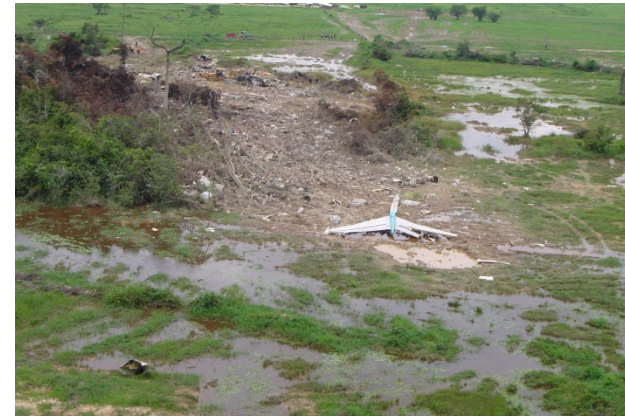
West Caribbean Airways 708

- When: August 2005
- Where: Wreckage in Venezuela
- What: MD-82

Night, poor weather

Vertical speed mode climb to FL330...Mach EPR limited
Engine anti-ice cycled

Tried to cruise at FL 330, $M=0.75$. Again Mach EPR lim
Poor weather. Continuous speed drop.

Buffeting started. Descent requested.

Shaker activated in descent at FL320 and remained on

- Why: Lack of knowledge on operating limits, lack of speed monitoring, lack of proper response to stall

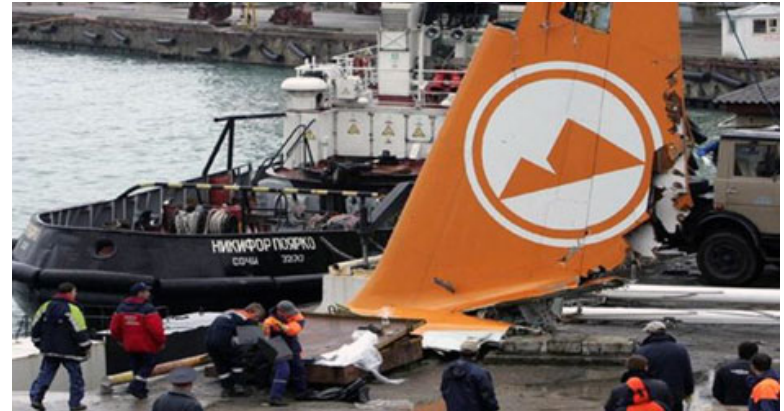
Armavia 967

- When: May 2006
- Where: Black Sea near Sochi, Russia
- What: A320

Night, IMC

Decided to divert, then decided to land

ATC instructed go-around after Wx dropped below mins

Thrust levers placed into climb; flaps and gear extended

“Speed, speed, speed” alert; Levers moved to TO/GA

Disengaged A/P, decrease pitch, banked right, used rudder

- Why: Likely spatial disorientation; poor CRM, improper go-around procedure; dual (and opposite) sidestick inputs

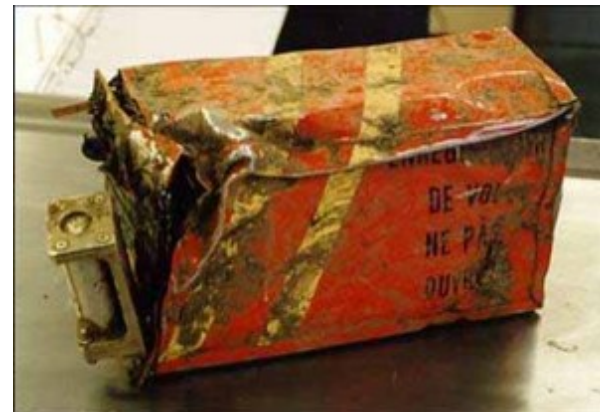
Adam Air 574

- When: January 2007
- Where: Makassar Strait off Indonesia
- What: 737-400

Day, IMC; stormy weather

FL350; troubleshooting IRS malfunction...A/P disconnect

Slow right roll began “bank angle” alert

Bank angle reached 100 degs; pitch 60 degs down

Pulls 3.5g (prolonged shaker) and 490 Kts

- Why: Preoccupation with troubleshooting IRSs; inadvertent A/P disconnect; possible spatial disorientation

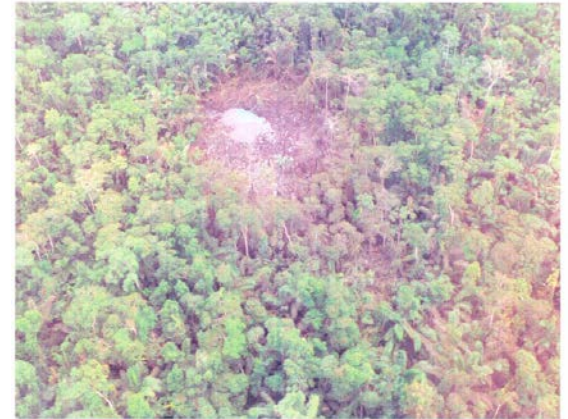
Kenya Airways 507

- When: May 2007
- Where: Doula Intl Airport, Cameroon
- What: 737-800

Night, IMC

After takeoff, captain gave command to engage A/P

Command not acknowledged; A/P not engaged

Several heading changes input into MCP, but no A/P

Captain engages A/P and increases bank angle

Bank reaches 115 degs and pitches down at 2900 ft

Pilots used opposite inputs during attempted recovery

Bank is 60 degs at impact

- Why: Lack of monitoring, spatial disorientation, lack of crew coordination

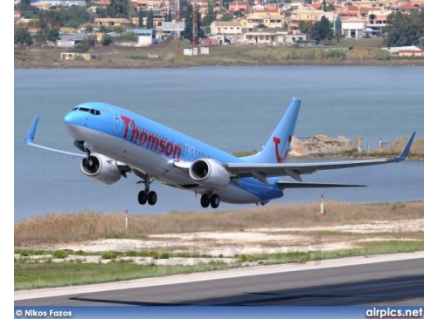
Thomsonfly G-THOF incident

- When: September 2007
- Where: Approach to Bournemouth Airport, U.K.
- What: 737-300

Night ILS approach

Uncommanded autothrottle disengagement

Autopilot trims stabilizer up to stay on path

Go around called after aircraft slows below speed

Pitch up to 44 degs, speed 82 kts

Full column forward ineffective, trim not applied

Thrust reduced to 86%. Recovered.

- Why: Unnoticed autothrottle disconnect, lack of trim awareness and application

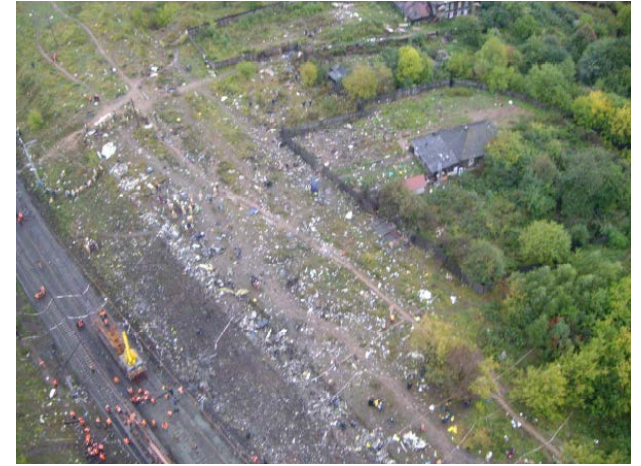
Aeroflot 821

- When: September 2008
- Where: Perm, Russia
- What: 737-500

Night, rainy

Approach was not stabilized

Possible western versus eastern attitude display issue

Significantly below Vref during approach

After base turn, aircraft roll 360 degs

- Why: Poor crew coordination, fatigue, spatial disorientation, captain alcohol consumption

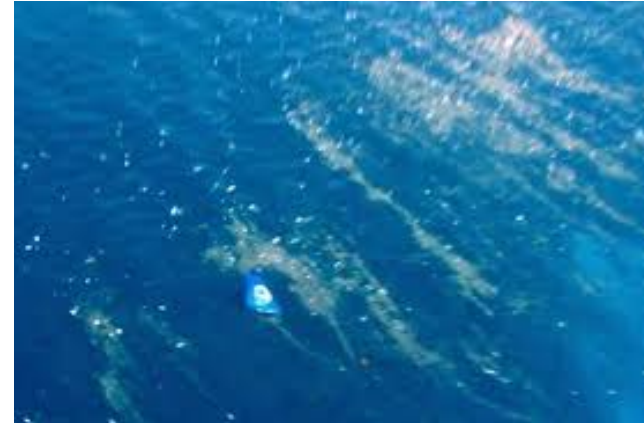
XL Airways GXL888T

- When: November 2008
- Where: Off coast of Canet-Plage, France
- What: A320

Day, light rain

Water penetrated AoA sensors during a rinse

At FL320, AoA sensors 1 and 2 stopped moving (froze)

Later on approach, crew checked normal law protections

Stabilizer trimmed full nose up during decel

Drop to Direct Law likely unnoticed

Loss of control and crash into sea

- Why: System failure due to AoA vanes freezing. Lack of trim awareness. Lack of understanding in stall recognition

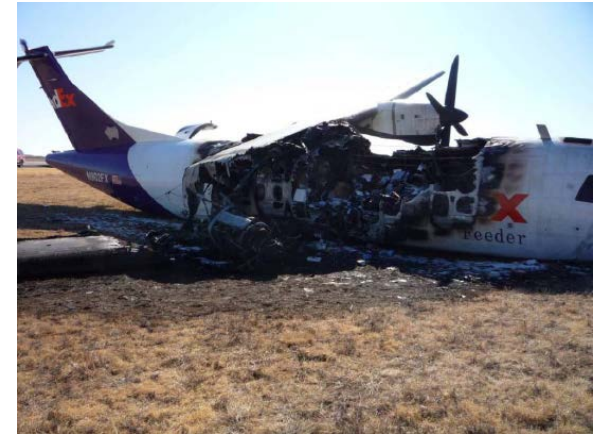
Empire Airlines 8284

- When: January 2009
- Where: Lubbock, Texas
- What: ATR-42

Night, IMC

Flap asymmetry (at F15, one side 0 and other 8-10 deg)

During troubleshooting, speed 160 to 125 kts in 26 sec

Ultimately shaker concurrent with TAWS; AoA increases

Stall; series of pitch, roll, yaw oscillations until impact

- Why: Continued approach after flap anomaly; lack of monitoring to maintain safe speed

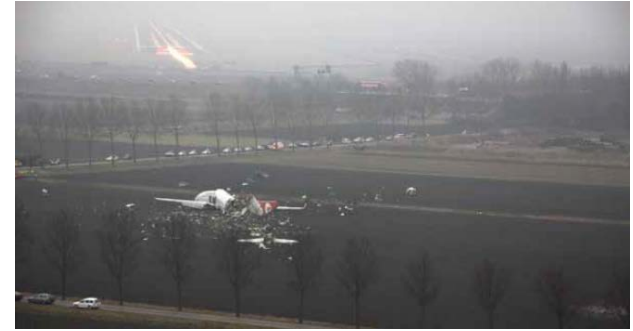
Turkish Airlines 1951

- When: February 2009
- Where: Approach to Schiphol Airport, The Netherlands
- What: 737-800

Nonstandard ATC approach; then unstabilized approach

Left radio altimeter passed -8 feet to autothrottle

Autothrottle moved to 'retard flare' mode on approach

Autopilot increased AoA to stay on path during decel

Speed decay unnoticed until shaker activation at 460 ft

- Why: Unstable approach, lack of monitoring speed, pitch increase, and A/T mode. Stall recovery procedure improperly applied.

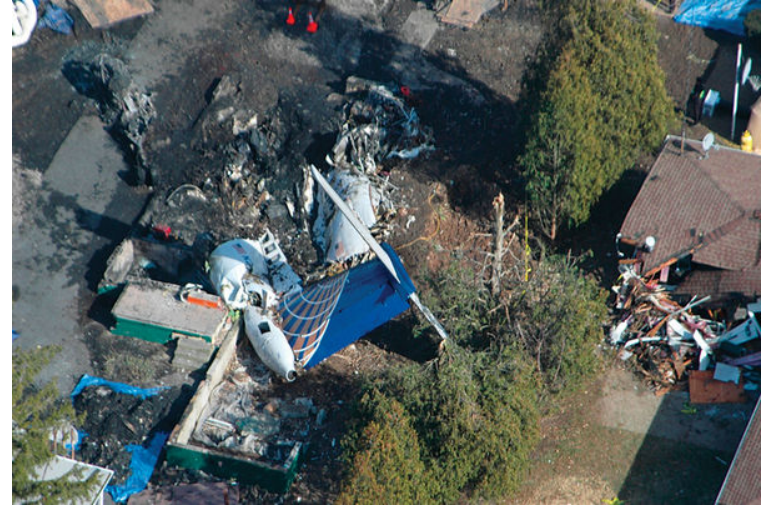
Colgan Air 3407

- When: February 2009
- Where: Clarence Center, New York
- What: DHC-8-400

Night VMC

Briefed Vref of 118 kts, but ref speeds switch “increase”

Shaker engaged at 131 kts, likely causing surprise

Captain pulled and resisted shaker

Tried to control roll during stall until impact

- Why: Lack of airspeed monitoring, unexpected stall warning activation, inappropriate response to stick shaker and pusher

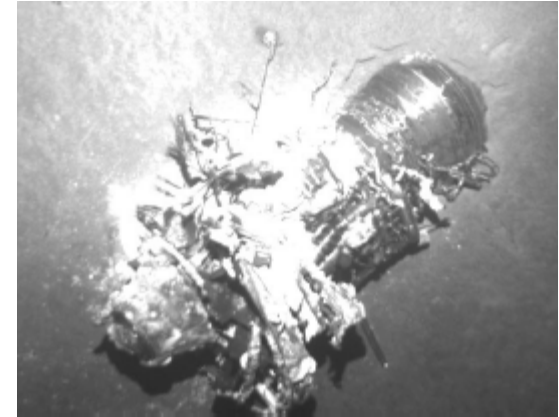
Air France 447

- When: June 2009
- Where: International waters, Atlantic Ocean
- What: A330
 - Night IMC
 - Unreliable airspeed caused ALT 2B flight control law
 - Pilot inputs resulted in a stall
 - Stabilizer moved to nose-up limit and remained there
 - Tried to control roll during stall until impact
- Why: Unreliable airspeed procedure not applied, lack of stall recognition, recovery inputs disallowed return to safe flight

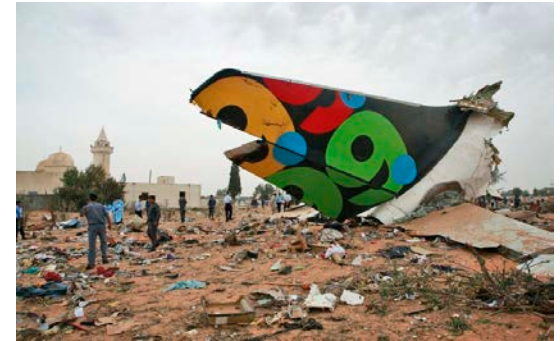
Afriqiyah Airways 771

- When: May 2010
- Where: Approach to Tripoli Intl Airport
- What: A330

Night, IMC

Continued below NDB MDA without ground visual ref
TAWS activated, then go-around

Go around pitch not maintained (nor FD commands)

Dual inputs, but not enough to cause warning

Captain took control and pushed down (F/O pulled)

- Why: Spatial disorientation, poor CRM, dual inputs, possible fatigue

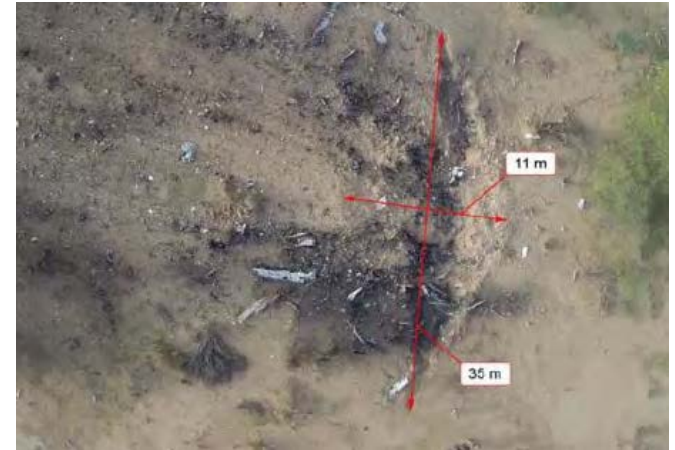
Air Algerie 5017

- When: July 2014
- Where: 80 km SW of Gossi, Mali
- What: MD-83

Night

FL310, several heading changes to fly around cell

EPR erroneous on both engines (likely icing of sensors)

A/T then did not apply enough thrust

A/C slowed from 290 kts to 200 kts in 5.5 mins

A/P disengaged 20 sec after stall begins (AoA=25 deg)

Roll 140 degs, pitch down 80 degs

- Why: Crew did not activate engine anti-ice; lack of speed monitoring; lack of proper stall recovery inputs

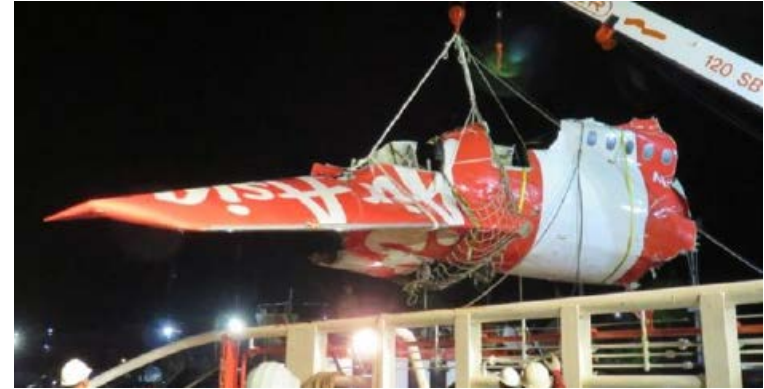
Air Asia 8501

- When: December 2014
- Where: Karimata Strait, Indonesia
- What: A320

Dawn? (619 local) VMC

Repeated Rudder Travel Limit Unit failure at FL320

Alternate law entered after reset of FAC CBs

Sideslip from rudder causes roll and rise of FD

Pilot flying inputs results in stall

Continuous stall warning during last 3 mins

- Why: Potential ambiguous guidance on clearing failure, lack of upset training on how to recover from a full stall
