Sixth Meeting (RASG-MID/6)
(Bahrain, 26-28 September 2017)

WAKE TURBULENCE SEPARATION IN RVSM AIRSPACE

Interim Report

Type of Occurrence:	Accident
Date:	7 January 2017
Location:	Enroute, above the Arabian Sea
Aircraft:	<ol style="list-style-type: none">1) Airplane2) Airplane
Manufacturer / Model:	<ol style="list-style-type: none">1) Bombardier / CL-600-2B16 (604 Variant)2) Airbus / A380-861
Injuries to Persons:	<ol style="list-style-type: none">1) Two severely injured passengers, two passengers and one flight attendant suffered minor injuries2) None
Damage:	<ol style="list-style-type: none">1) Aircraft severely damaged2) None
Other Damage:	None
State File Number:	BFU17-0024-2X
Published:	May 2017

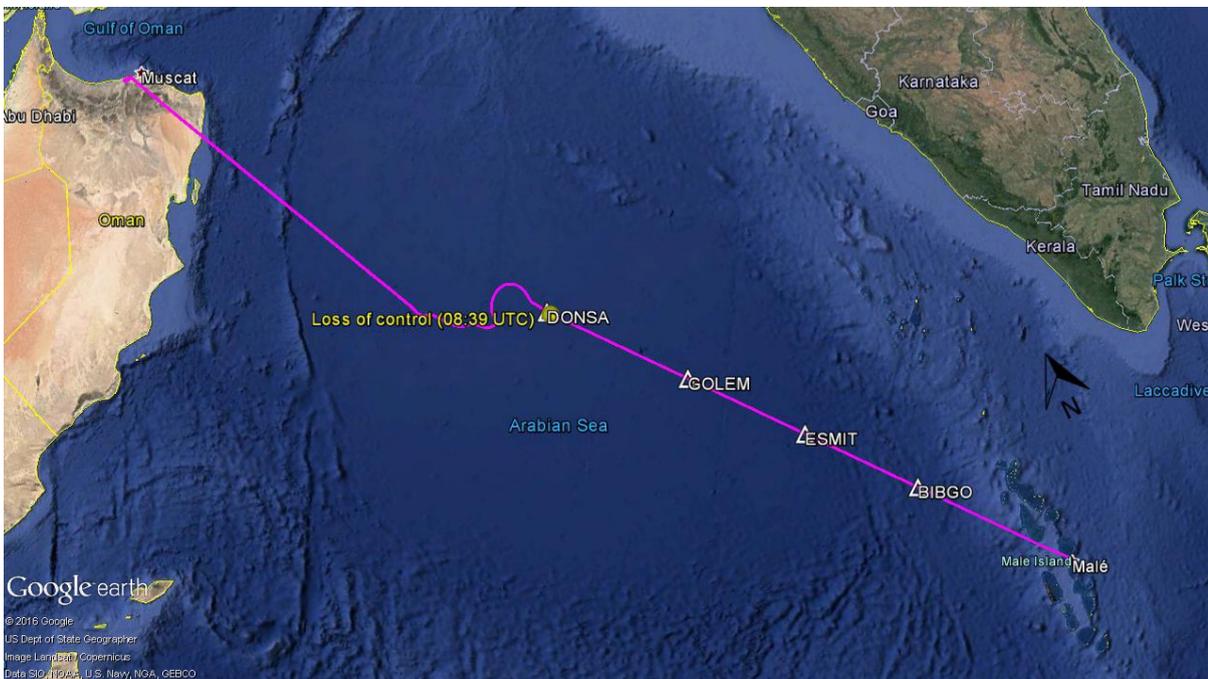
Reconstruction of the CL604 flight path (according to FDR data)

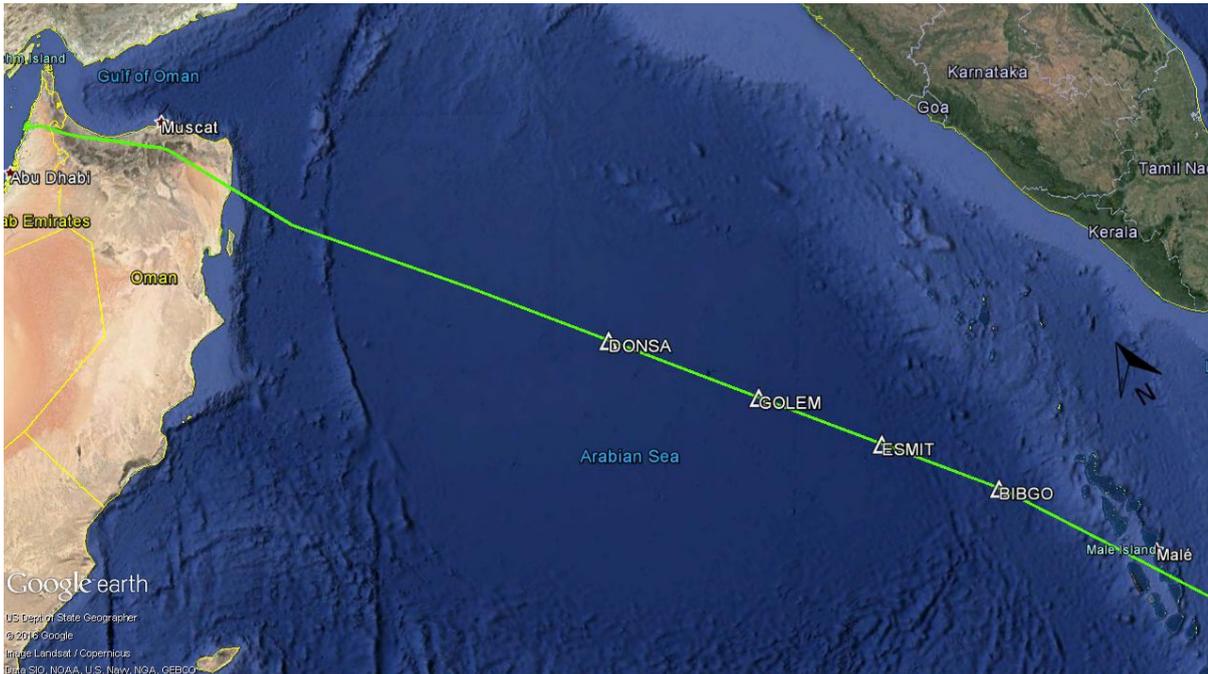
Reconstruction of the A380 flight path (according to DAR data)

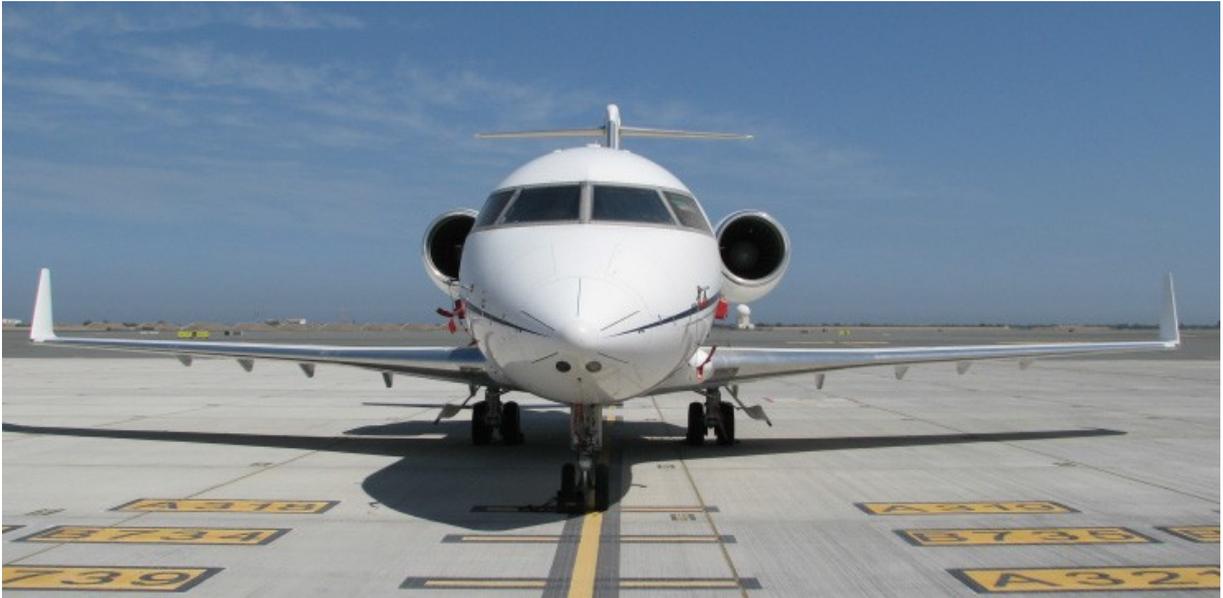
The aircraft manufacturer determined that the airframe structure could not be restored to an airworthy state as it exceeded the airframe certification design load limits during the upset encounter. Therefore the aircraft is considered to be damaged substantially.

During a BFU investigation of the airplane no outer damages on fuselage, wings, and empennage, including control surfaces, were visible. There was no evidence of leakages (oil, fuel).

Outer condition of the airplane

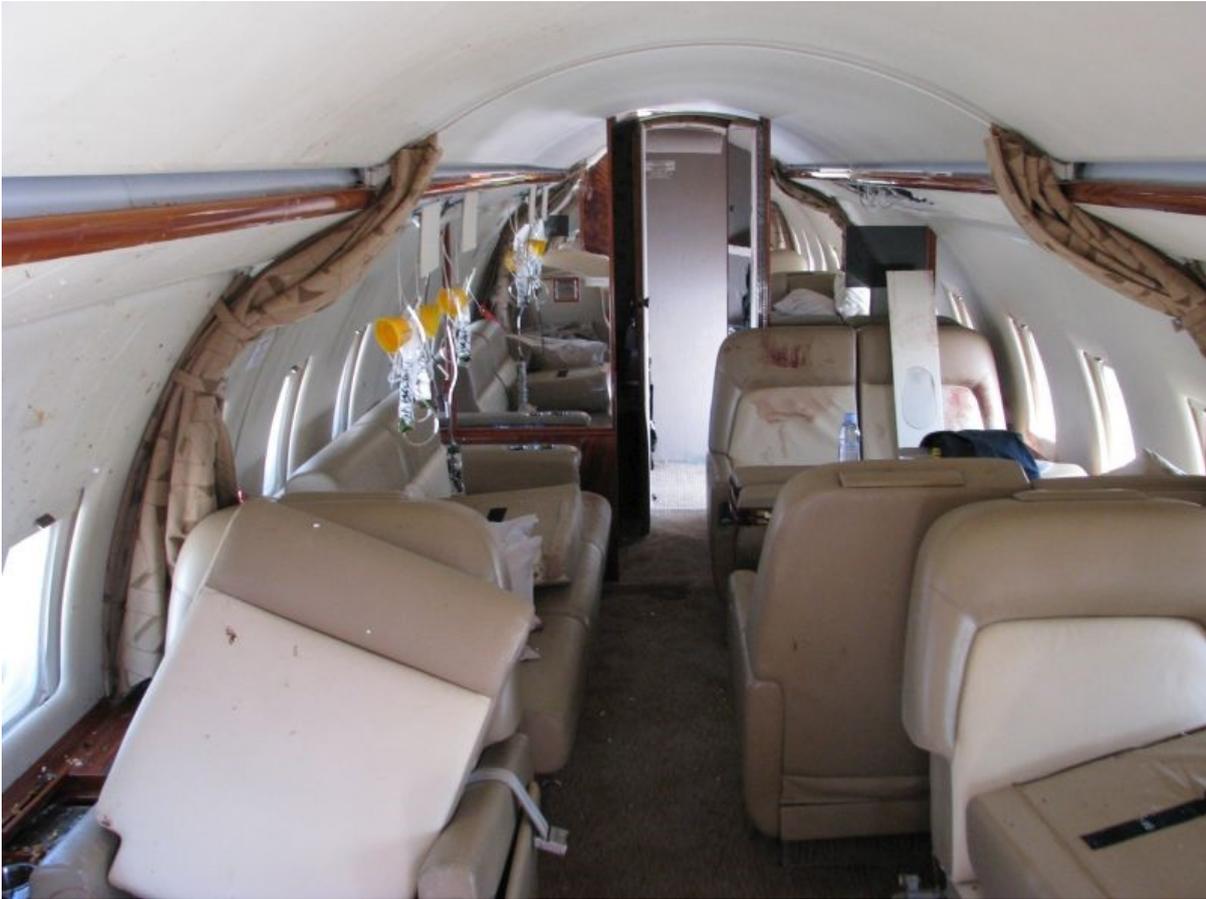
The inside of the passenger cabin showed damages on the seats and the panelling, as well as traces of blood. The armrests of the four seats in the front, installed in club arrangement, were either deformed or had fractured.

On the left side of the cabin two oxygen masks had fallen from their casings.

Damages in the cabin (viewed opposite to the direction of flight)

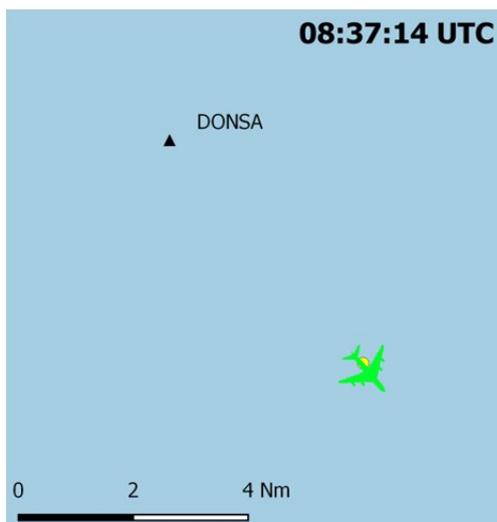
At about 0837:14 UTC the A380 passed at FL350 the position, where later the CL604 was subject to temporary loss of control.

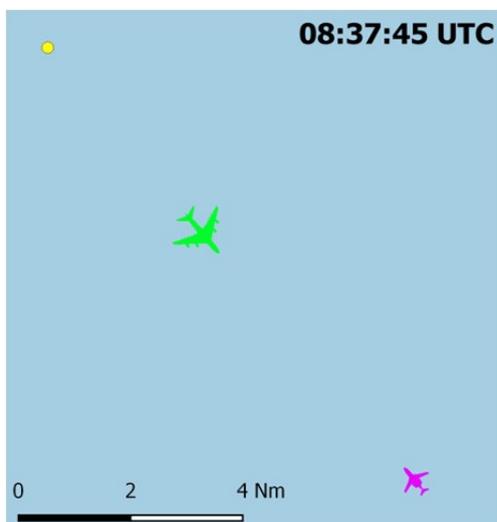
At about 0837:45 UTC the A380 TCAS captured the CL604 on opposite track (TCAS message proximate). At that time the distance between the two aircraft was 6 NM and 1,000 ft vertical.

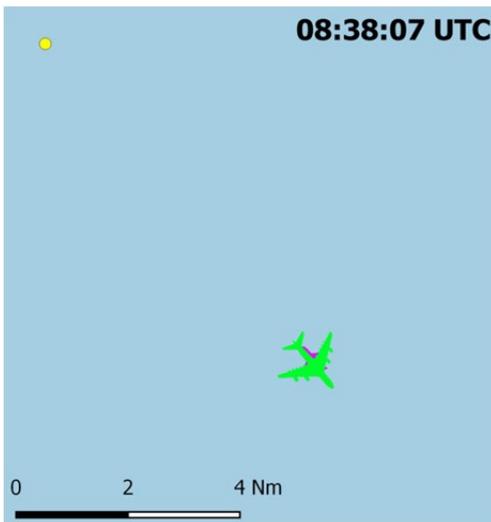
At about 0838:07 UTC the A380 passed the CL604 overhead with a vertical distance of 1,000 ft slightly to the right.

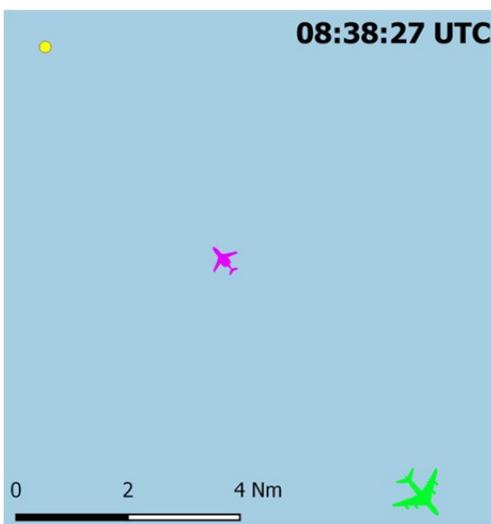
At about 0838:27 UTC the two aircraft left the capture area of their respective TCAS (TCAS message proximate). At that time the distance between the two aircraft was about 6 NM.

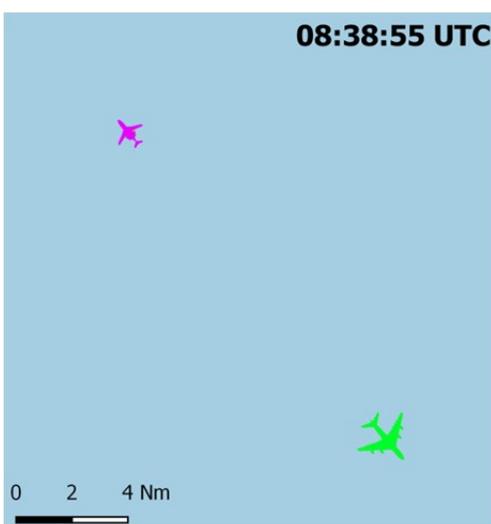
At about 0838:55 UTC at FL340 the CL604 encountered the wake vortex. At that time the A380 was about 15 NM south-east.

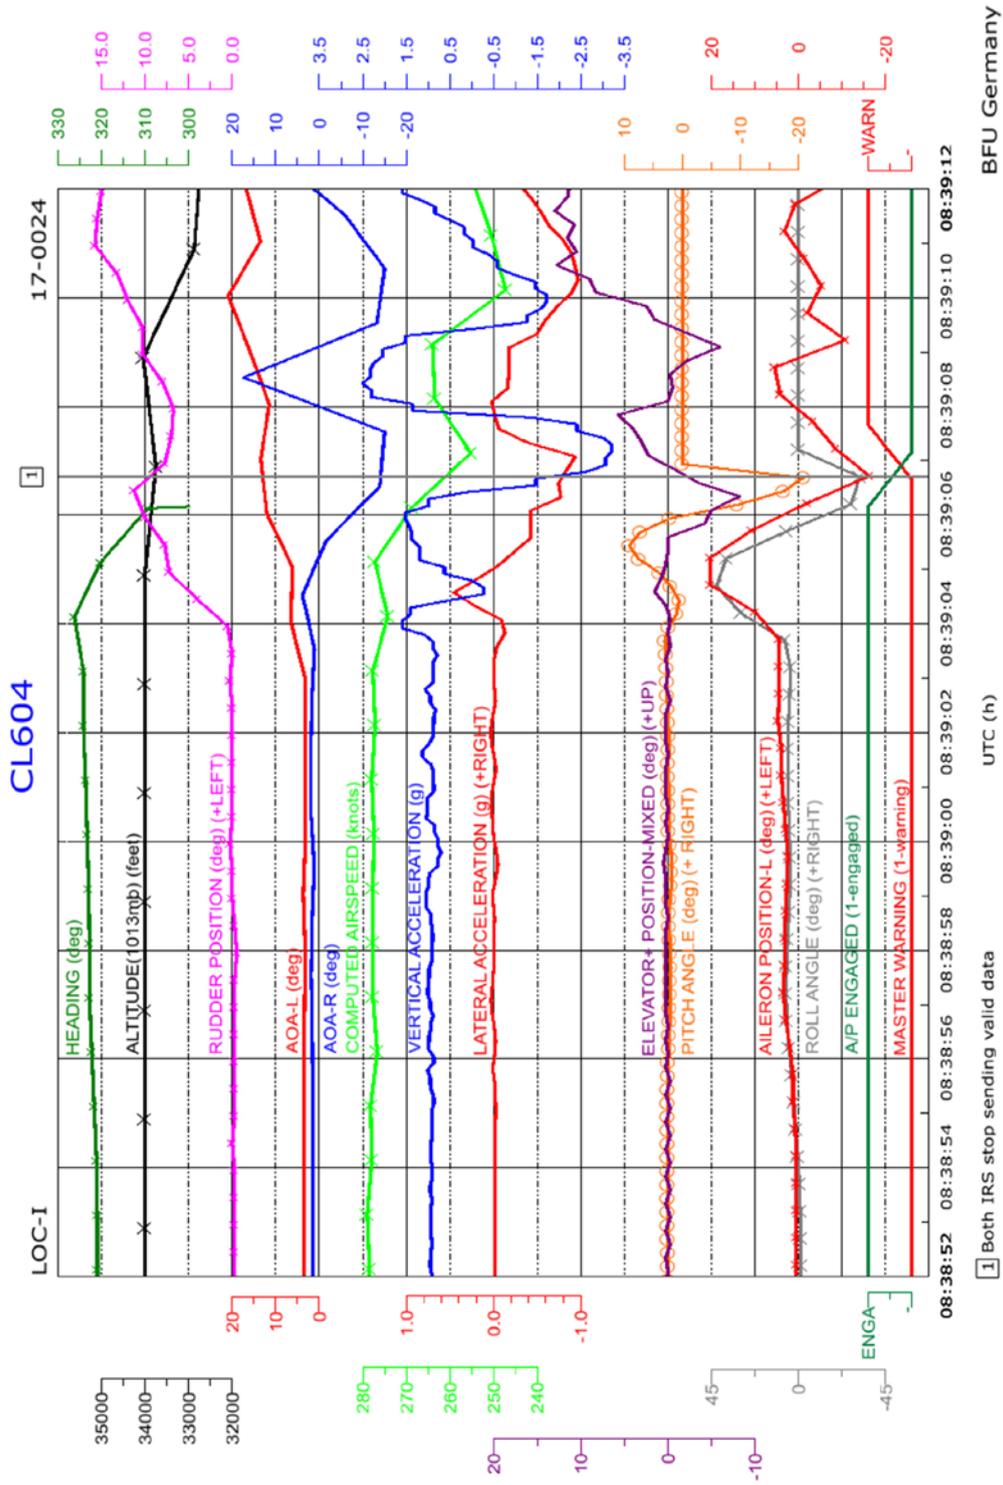
Excerpt of the CL604 FDR at the beginning of the occurrence

At 0838:54 UTC the CL604, with engaged autopilot, began to slightly roll right. At the same time a counter-rotating aileron deflection was recorded and fluctuation of the vertical acceleration began. In the subsequent approximately 10 seconds the airplane had a right bank angle of 4° to 6°. At 0839:03 UTC the right bank angle

began to increase. Within one second the bank angle increased to 42° to the right. At the same time the aileron deflection to the left increased to 20° and the vertical acceleration to 1.6 g. In the following second vertical acceleration changed to -3.2 g.

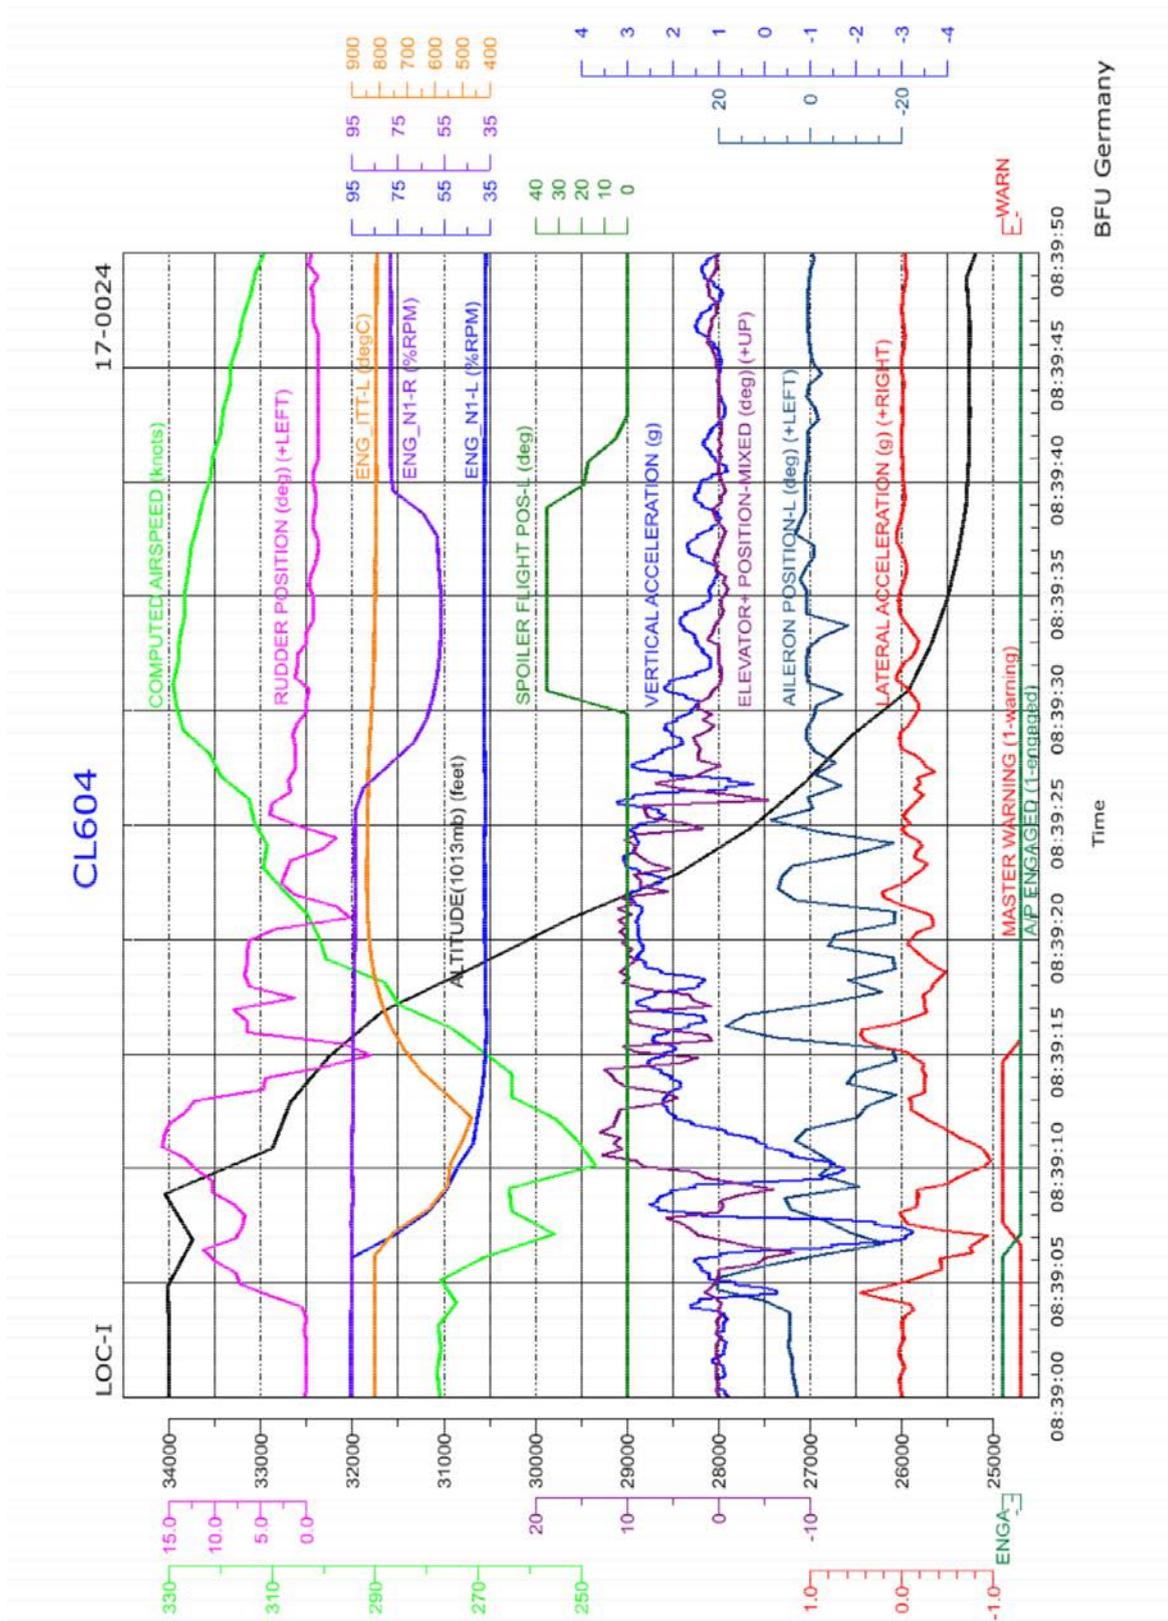
Excerpt of the CL604 FDR during altitude loss

Between 0839:09 UTC and 0839:41 UTC the FDR recorded a loss of altitude of approximately 8,700 ft. Large control surface deflections and acceleration were recorded. The speed increased and at 0839:31 UTC reached approximately 330 KIAS. At 0839:30 UTC the spoilers extended and 13 seconds later were retracted again. The N1 of the left engine had decreased to approximately 40% when the Interstage Turbine Temperature (ITT) began to increase and nine seconds later had reached 850°. The left engine was shut off.

Both IRS stop sending valid data

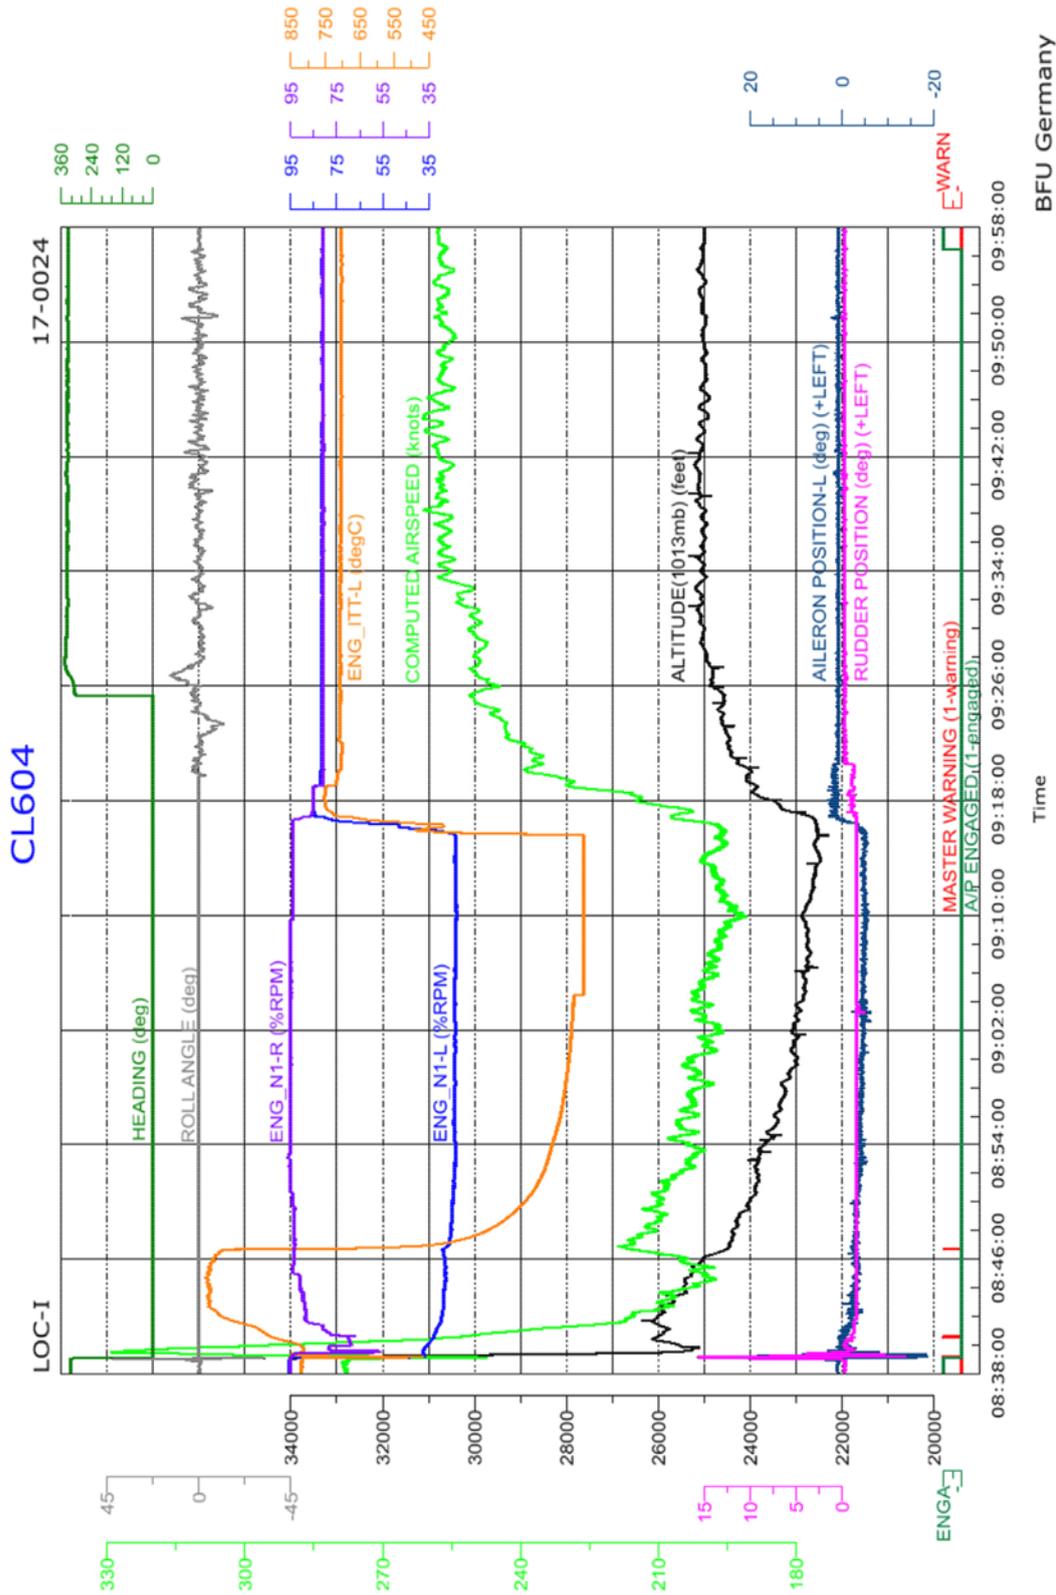
Excerpt of the CL604 FDR during recovery

At about 0915 UTC the crew restarted the left engine. Subsequently the airplane climbed to FL250. At about 0956 UTC the autopilot was re-engaged.
