Rapid Descent and Crash into Water  
Atlas Air Inc. Flight 3591  
Boeing 767-375BCF, N1217A  
Trinity Bay, Texas  
February 23, 2019

NTSB/AAR-20/02  
PB2020-101004

Rapid Descent and Crash into Water

Atlas Air Inc. Flight 3591

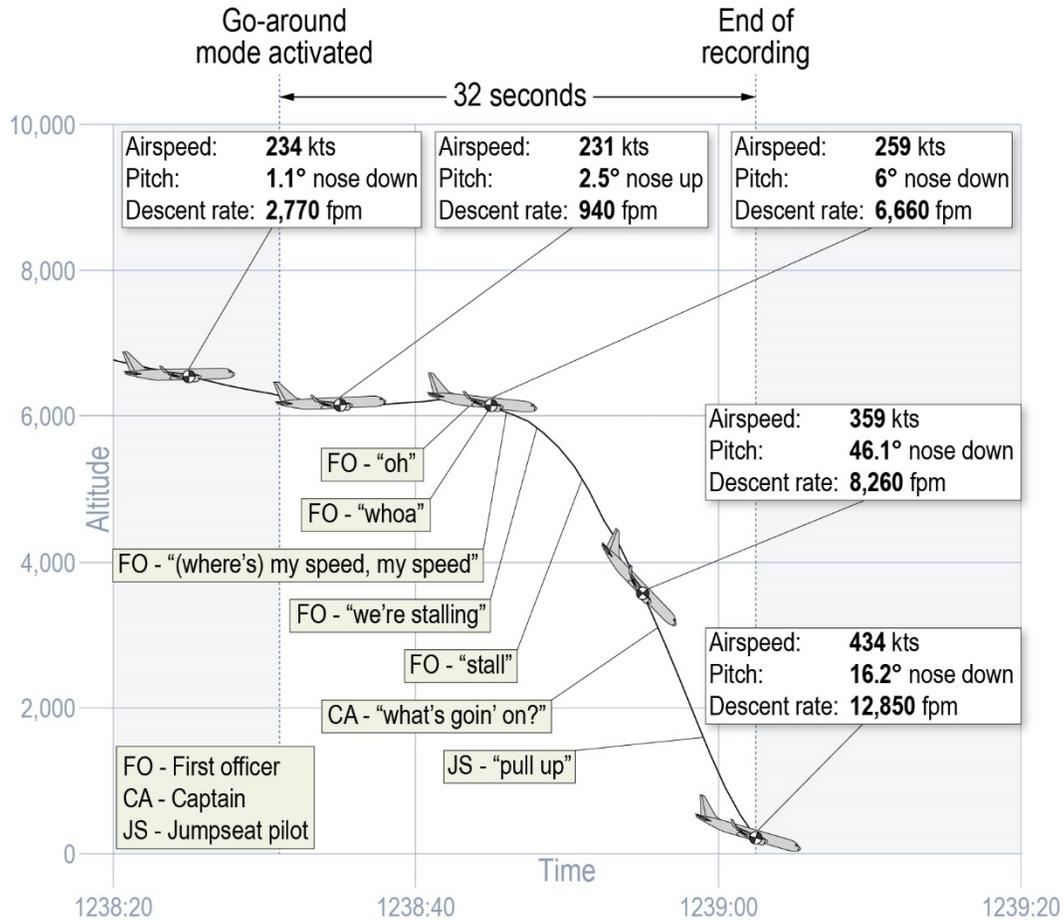
About 1238:36, the speedbrakes were retracted, then the airplane's elevators moved in response to manual control inputs to command nose-down pitch.<sup>7</sup> The amount of nose-down pitch continued to increase, and the airplane entered a steep descent. Beginning at 1238:44, the FO said, "oh," then said in an elevated voice "whoa... (where's) my speed, my speed...we're stalling;" he then exclaimed "stall" at 1238:51. A review of FDR data determined that the airplane's airspeed and pitch parameters were not consistent with the airplane at (or near) a stalled condition, and none of the stall warning system indications activated.

Figure 1. Selected airplane parameters and crew statements during final seconds of flight.<sup>8</sup>

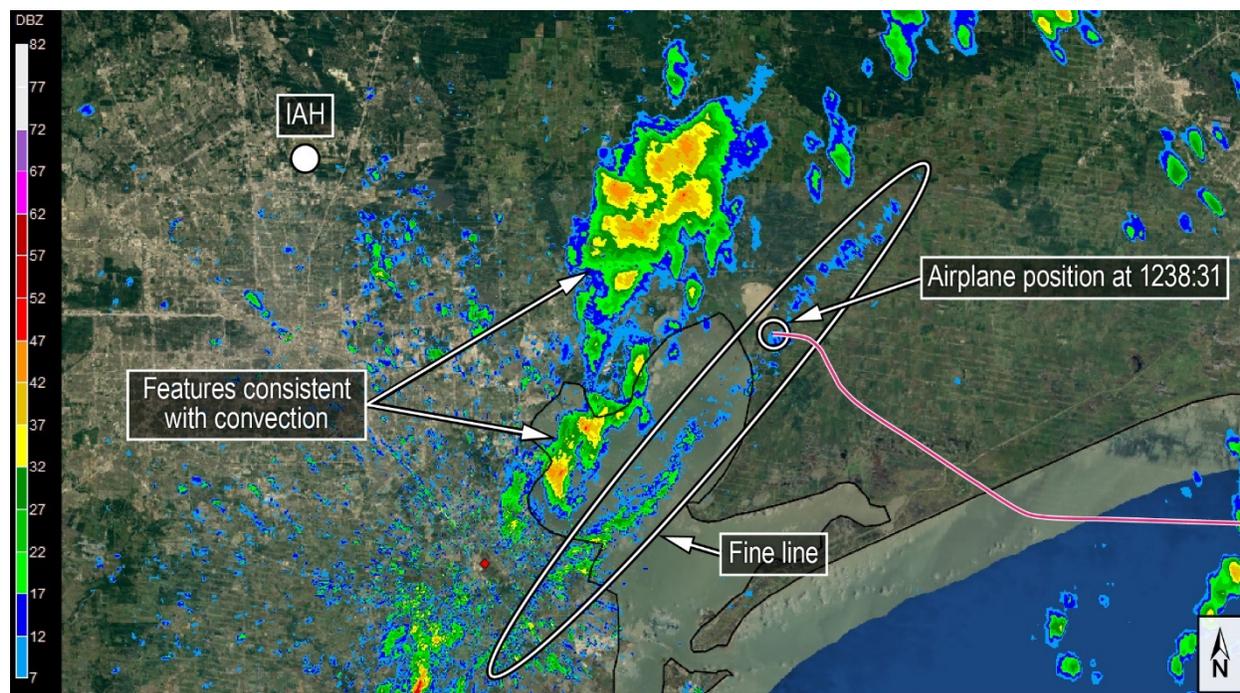
“fine line.”<sup>19</sup> At 1238:31, which was the time of the go-around mode activation on the accident flight, the airplane’s position coincided with that of the fine line (see figure 8).

Note: The magenta line shows the accident airplane’s ground track, and its position at 1238:31 is indicated by a white circle.

**Figure 8.** Weather radar imagery showing locations of features consistent with convection and a fine line relative to the accident airplane’s ground track.

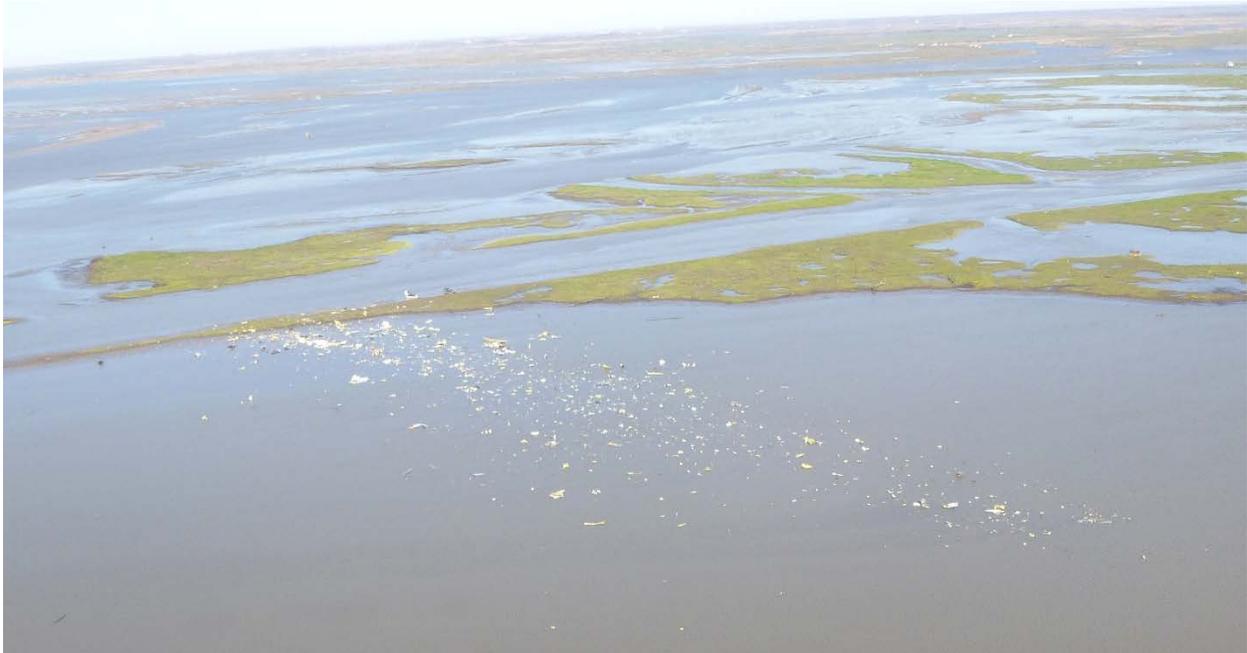
**Figure 9.** Wreckage scattered in a marshy area of Trinity Bay.

Most pieces were immersed in or submerged beneath water up to 3 ft deep and buried beneath up to 10 ft of soft mud, while lightweight cargo and composite airplane structure were found floating in the bay or along the shore up to 20 miles south of the initial impact point. Continuous wreckage recovery efforts lasted for almost 7 weeks and included the use of equipment specialized for shallow water operations.

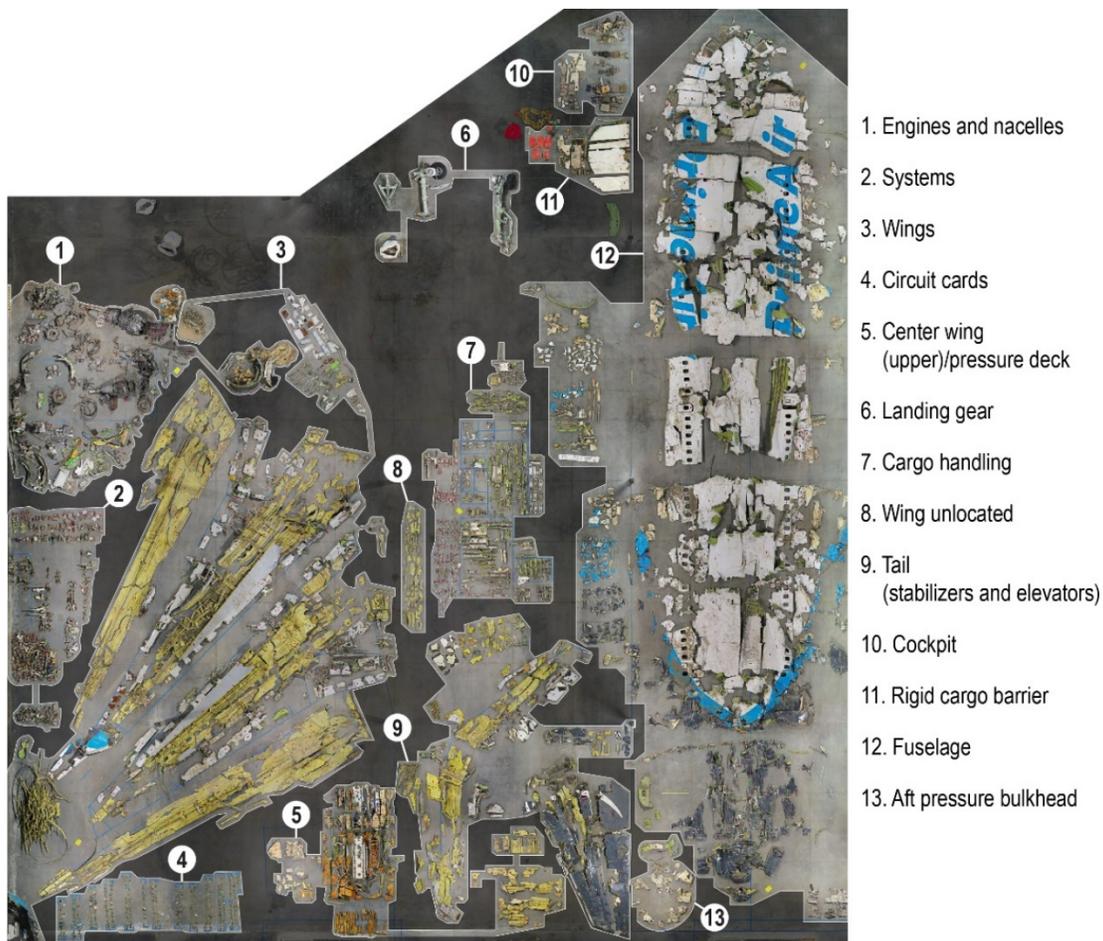
**Figure 10.** Wreckage reconstruction.

Examination of the airplane structures revealed no evidence of fire, preexisting cracking, or preexisting corrosion, but corrosion associated with the wreckage's exposure to water and mud was noted. All examined fracture surfaces showed features consistent with overstress separation. Most of the rigid cargo barrier (installed in the forward end of the fuselage) and pieces of the aft pressure bulkhead were recovered, and examination revealed no impact marks other than damage consistent with the airplane's crash into the marsh. The cargo locks showed varying levels of damage, consistent with the airplane's impact.

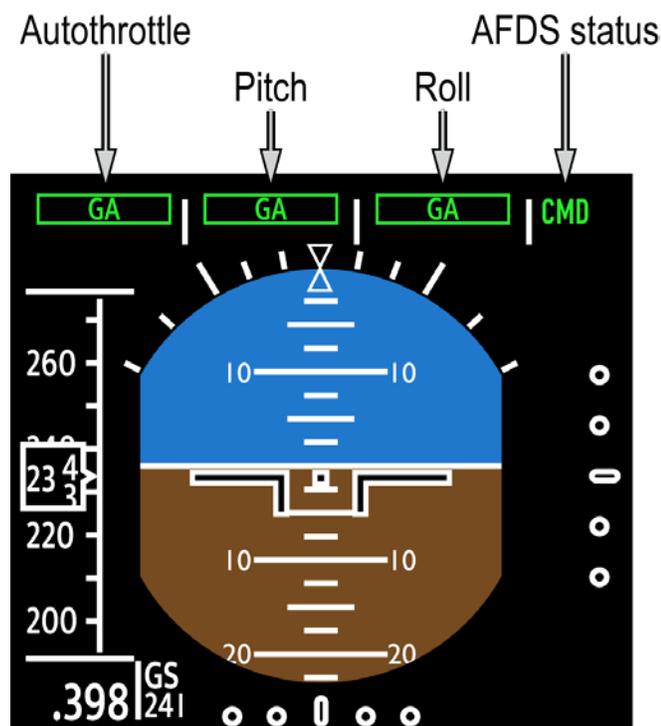
Concurrent with go-around mode activation, the flight mode annunciator at the top of each ADI display announced “GA/GA/GA/CMD” in green (with a temporary box around each “GA”) to indicate, respectively, that the go-around mode was active for autothrottle, pitch, and roll and that the autopilot function of the AFDS was engaged (see figure 11).<sup>33</sup>

**Figure 11.** Exemplar ADI showing go-around mode annunciators at the top.

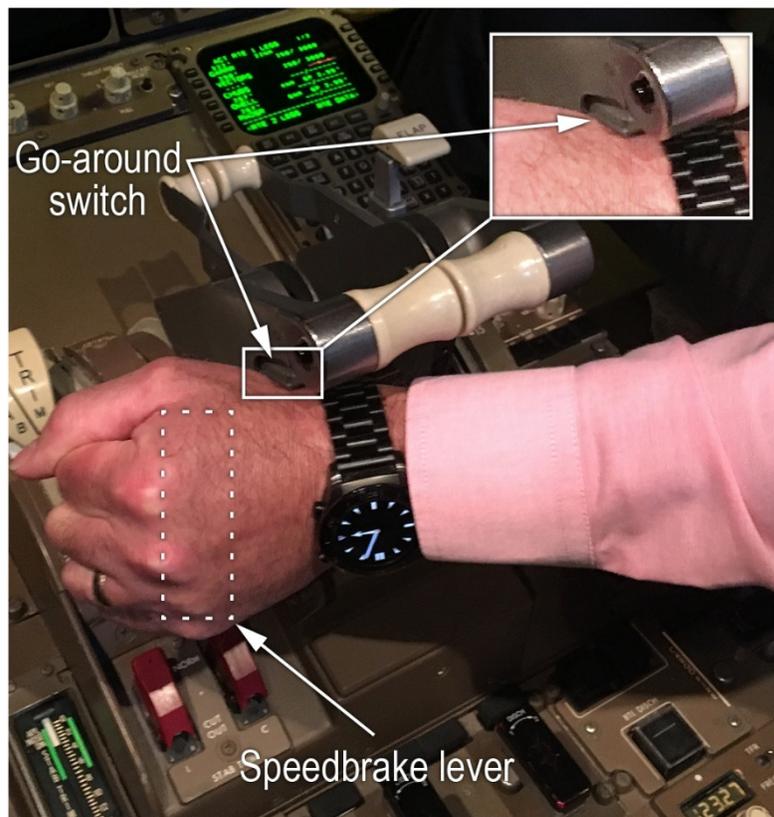
Investigators performing the simulator scenarios had the pilot hold the speedbrake lever using a variety of different hand grip and arm positions. The investigators observed that, when the right-seat PF kept his left hand on the speedbrake lever during the descent (consistent with Atlas’ procedures), the PF’s left hand and wrist could be under the thrust levers and close to the left go-around switch. (The distance between the hand/wrist and the go-around switch varied with different hand grip and arm positions.) The scenarios showed that, if a PF were wearing a watch on the left wrist (as photographs showed the accident FO had done at times), this could result in decreased clearance beneath the go-around switch (see figure 12).

**Figure 12.** Position of left hand and wrist for exemplar PF in right seat of the simulator holding the speedbrake lever.
