ACCIDENT INVESTIGATION REPORT BRIEF

(REF. BEA09072018-01)

ATR 72-600/CN-COH (RAM EXPRESS)

AL HOCEIMA (GMTA) / MOROCCO

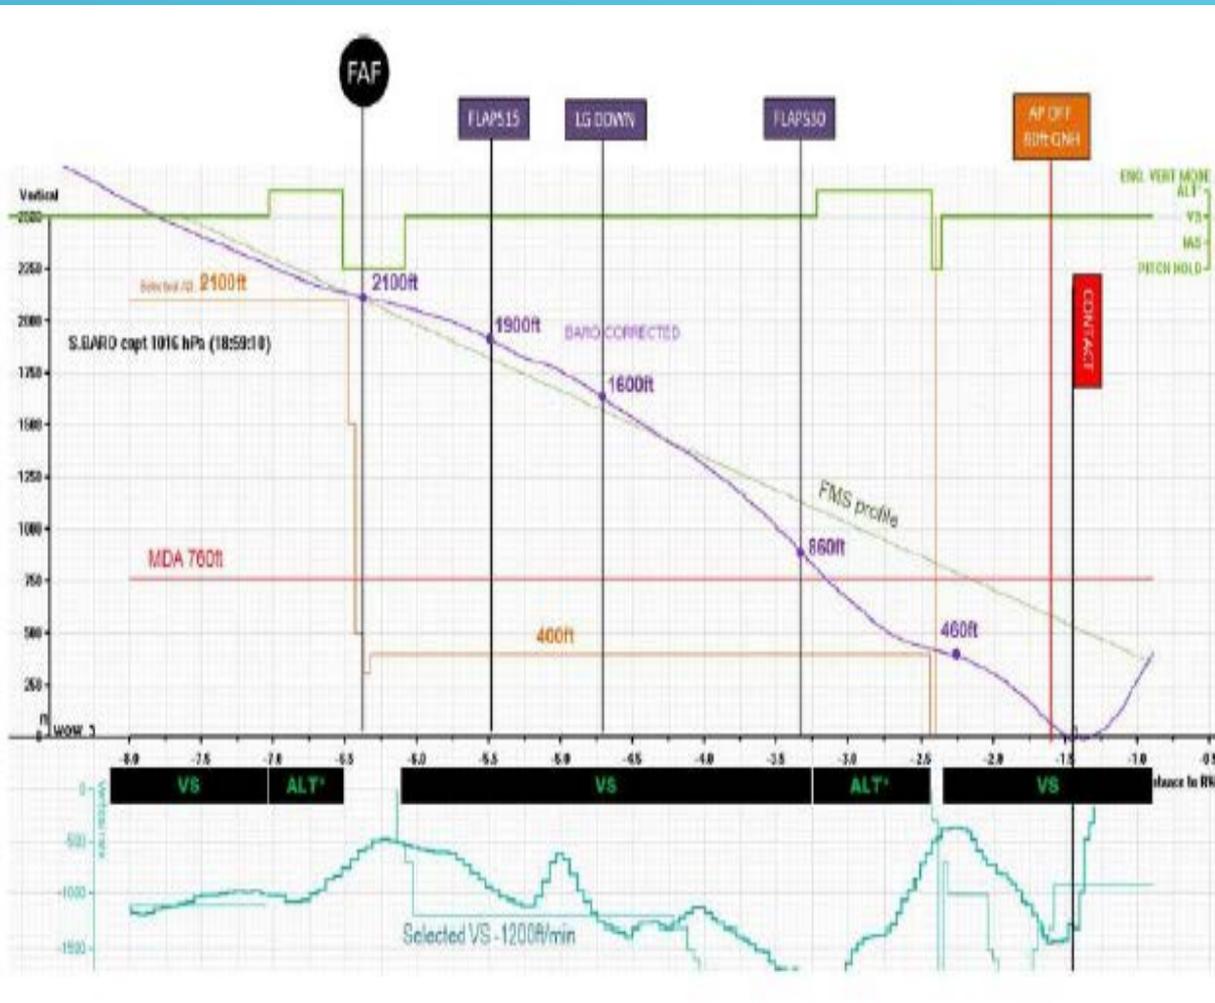
3RD APPROACH'S PROFILE TO AL HOCEIMA

- ❖ LNAV mode was active;
- ❖ V/S engaged (AP):
 - - 1500 ft/mn,
 - - 1600 ft/mn,
 - -1800 ft/mn.
- ❖ IAS: 230 kt.

When the Approach becomes unstable **below 1000 ft AGL**, the crew must immediately engage a **go-around**

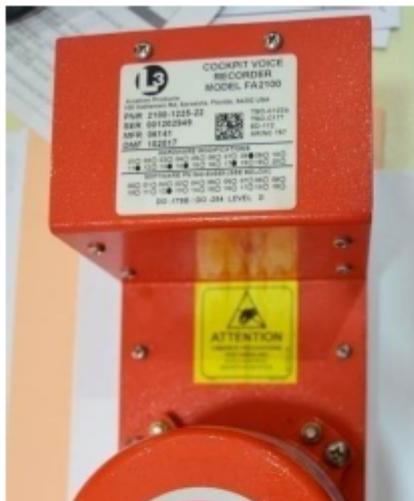
1.11.1. Cockpit Voice Recorder (CVR)

Manufacture: L3Com
Model: FA2100
P/N: 2100-1225-22
S/N: 001202949
Medium: Solid State
State of the recorder: No damage (visual inspection)
Read-out equipment: L3Com Recorders Portable Ground Support Equipment (RPGSE)
Analysis system: ROSE
Recording configuration: 2heures, 4 channels
Recording quality: Good and clear
Contents: 2 hours
Channel1: CM1/Channel2: CM2 /Channel 3:CM3/Channel4: AREA

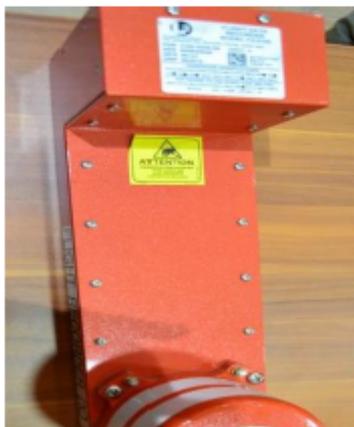
1.11.2. Flight Data Recorder (FDR)

Manufacture: L3COM
Model: FA2100
P/N: 2100-4245-00
S/N: 000820548
Medium: Solid State
State of the recorder: No damage (visual inspection)
Read-out equipment: L3Com Recorders Portable Ground Support Equipment (RPGSE)
Analysis Equipment: ROSE
Recording Length: Approximately 50 hours flight data
Recording quality: Good

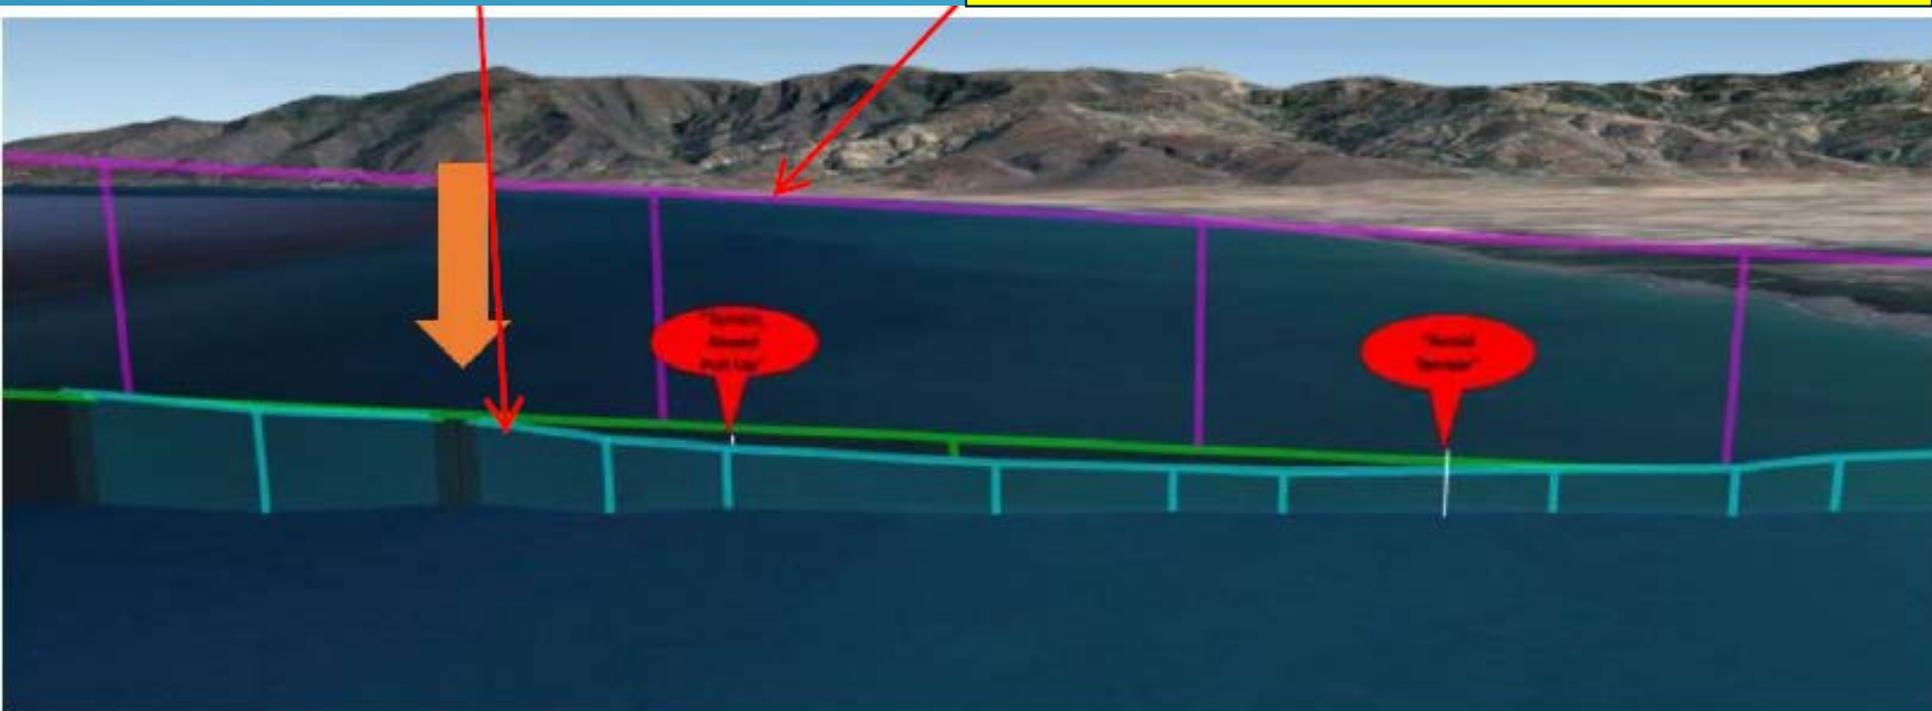
1ST VERTICAL PATH ON THE APPROACH TO AL HOCEIMA

Trajectory in Magenta shows the descent plan at 3 degrees

Trajectory in blue shows the path of the aircraft

Trajectory in green shows the lower limit of the landing cone defined by TAWS

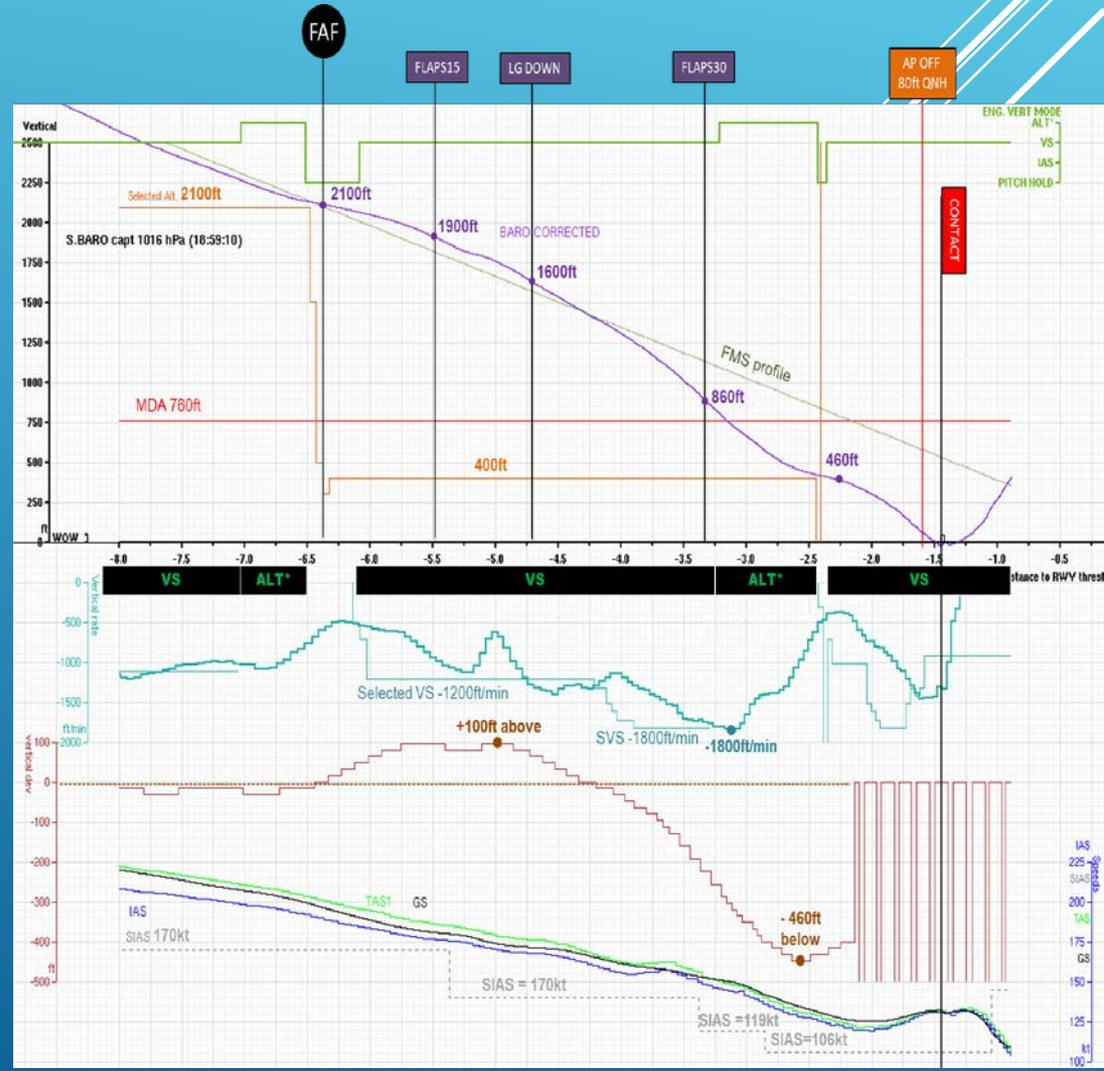
1. GPWS switched OFF at 6000ft
2. Selected Altitude below MDA
3. Vertical path below FMS profile from 1400ft till impact
4. AP OFF 80ft
5. Go Around 30ft
6. Contact with sea approx 1.4Nm from Runway Threshold
