General Aviation Accidents Investigative Challenges

2nd Meeting of the AIIG, 13-15 SEP 2022 Jeddah, Saudi Arabia

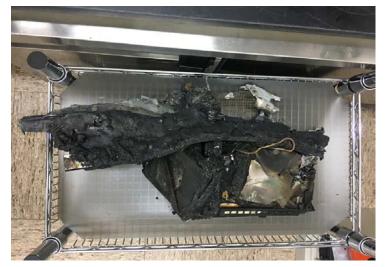
Complete burned panel transported to AIB lab

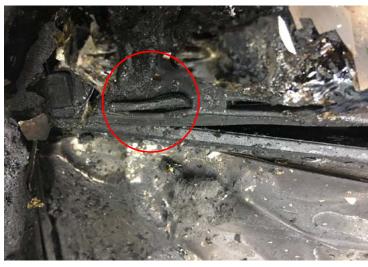
SD Card located

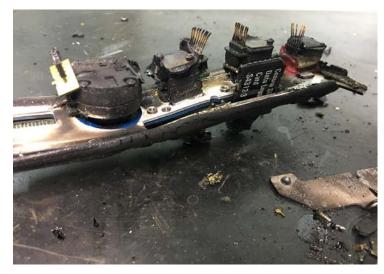
SD Card Recovered

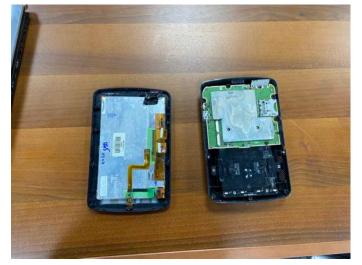
Disassemble the unit

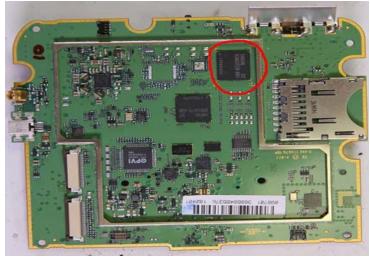
Locate memory NVM chip

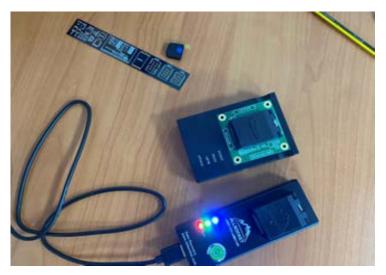
Special tool download
