Air Accident Investigation Sector Case Study

Runway Incursion- Serious Incident

Date	9 January 2022
Place of Occurrence	Dubai International Airport
Operator	Emirates Airlines
Aircraft Type	777-31H(ER) and 777-36N(ER)
State of Occurrence	The United Arab Emirates

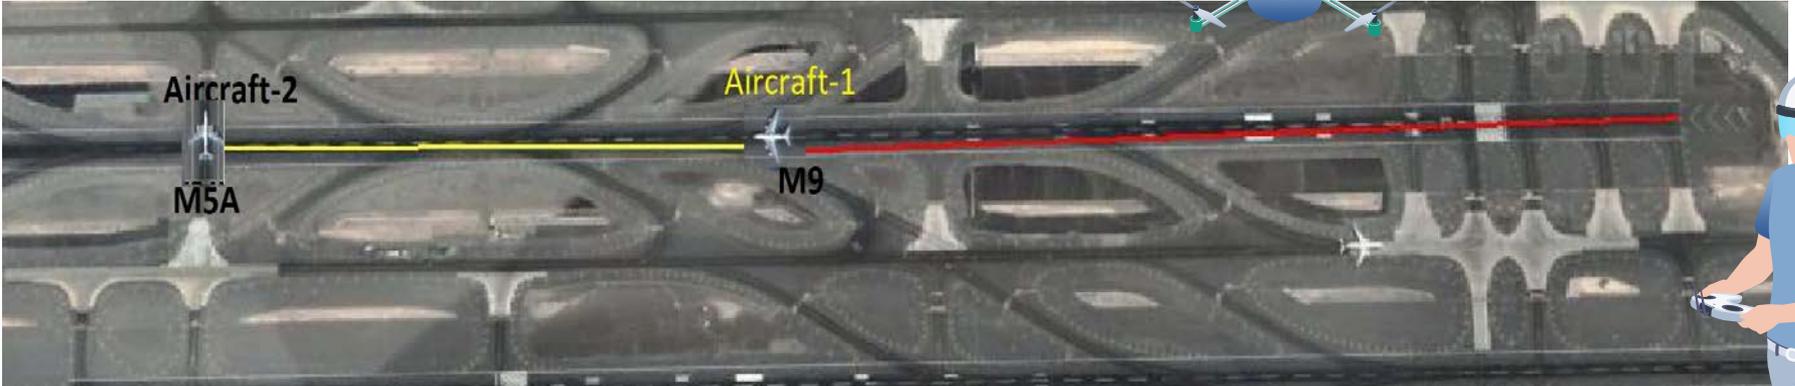
Runway Incursion-Serious Incident
