African Regional Runway Safety Seminar

AIRCRAFT INCIDENT REPORT

Reference :	CA18/3/2/0659	
Aircraft Registration	ZS-OKD	Date of Incident	18 June 2008		Time of Incident	0855 Z
Type of Aircraft	Boeing 737-236A (Aeroplane)		Type of Operation		Scheduled Commercial	
Pilot-in-command Licence Type	Airline Transport	Age	39	Licence Valid	Yes	
Pilot-in-command Flying Experience	Total Flying Hours	7195.7		Hours on Type	1702.5	
Last point of departure	OR Tambo International Aerodrome (FAJS), Gauteng Province					
Next point of intended landing	Durban International Aerodrome (FADN), KwaZulu-Natal Province					
Location of the incident site with reference to easily defined geographical points (GPS readings if possible)						
Partly off the runway approximately 30m from the threshold of Runway 24 at Durban International Aerodrome.						
Meteorological Information	The weather at Durban International Airport was cloudy with hard rain					
Number of people on board	2+4+87	No. of people injured	0	No. of people killed	0

Name of Owner/Operator : Comair Ltd
Manufacturer : Boeing Aircraft Company
Model : Boeing 737-236A
Nationality : South African
Registration Marks : ZS-OKD
Place : Durban Internation

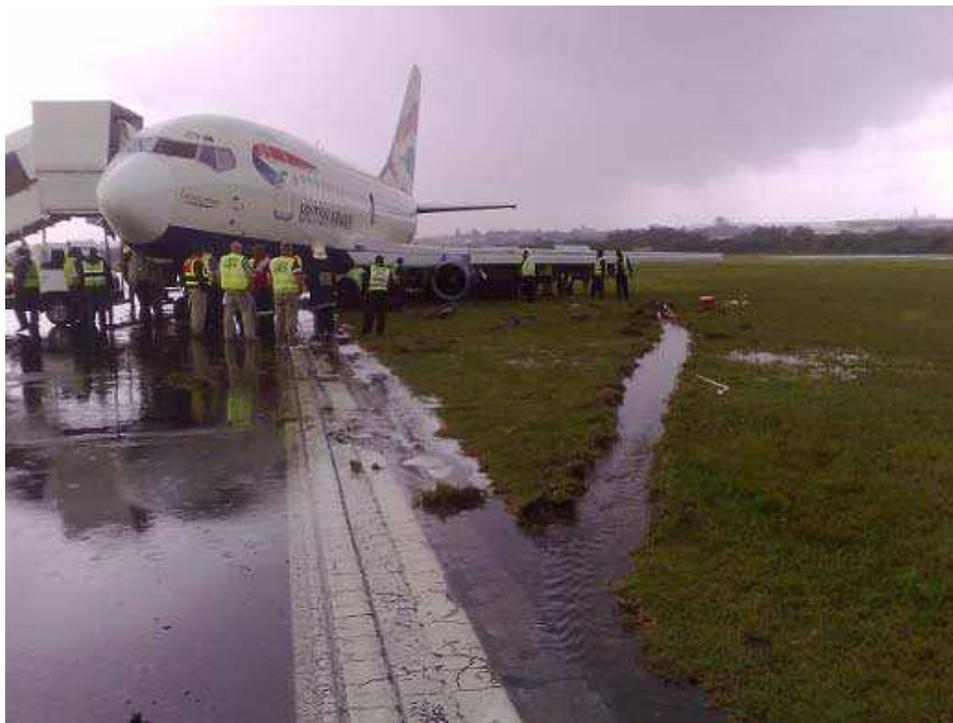
1.3.1 The aircraft sustained damage to the left-hand main landing gear door, main landing gear wheels and left-hand engine

Photo1: Indicating damage to aircraft.

Limited damage to the left wing area.

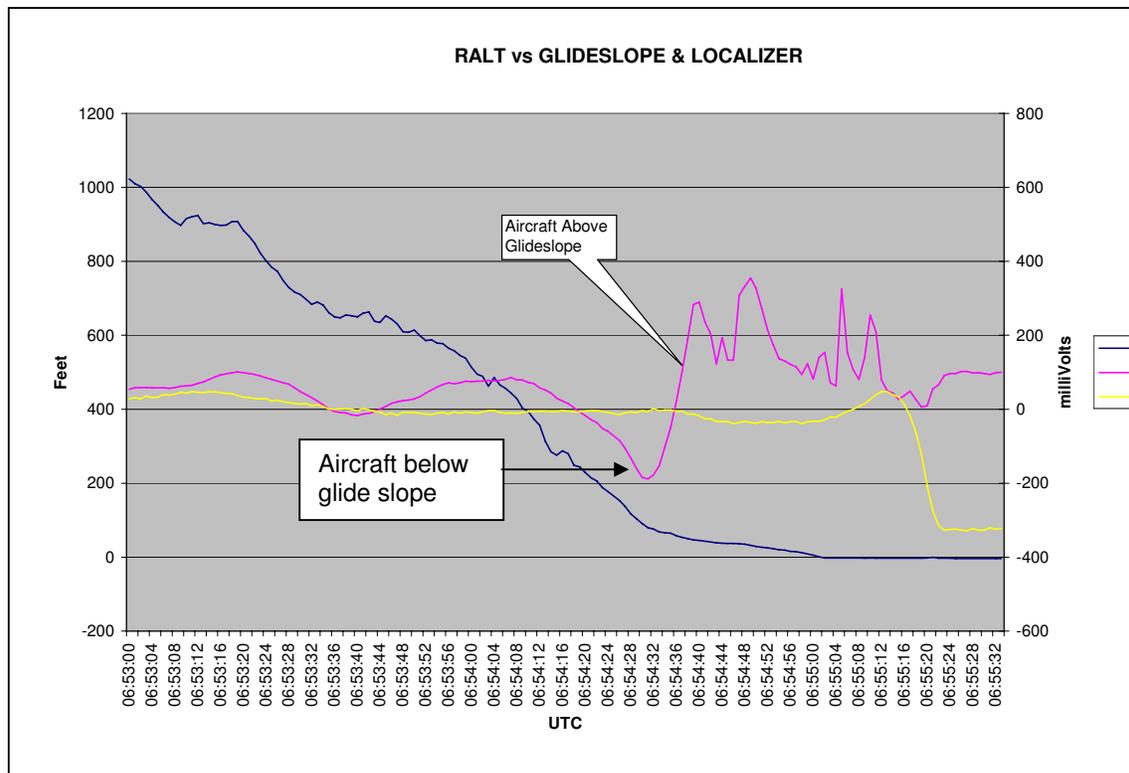
1.11.4.1 RALT vs. GS & LOC – the graph below shows the relationship between Radio Altitude and the Glide Slope and Localizer deviations. The graph shows that the aircraft was below the glide slope before the pilot attempted to correct, resulting in the aircraft being above the GS. Also, the aircraft appeared to “float” during the final stages of the landing. It is clear that the aircraft descended slowly, as it takes 30 seconds from 80 feet (RALT) to Touch-Down.

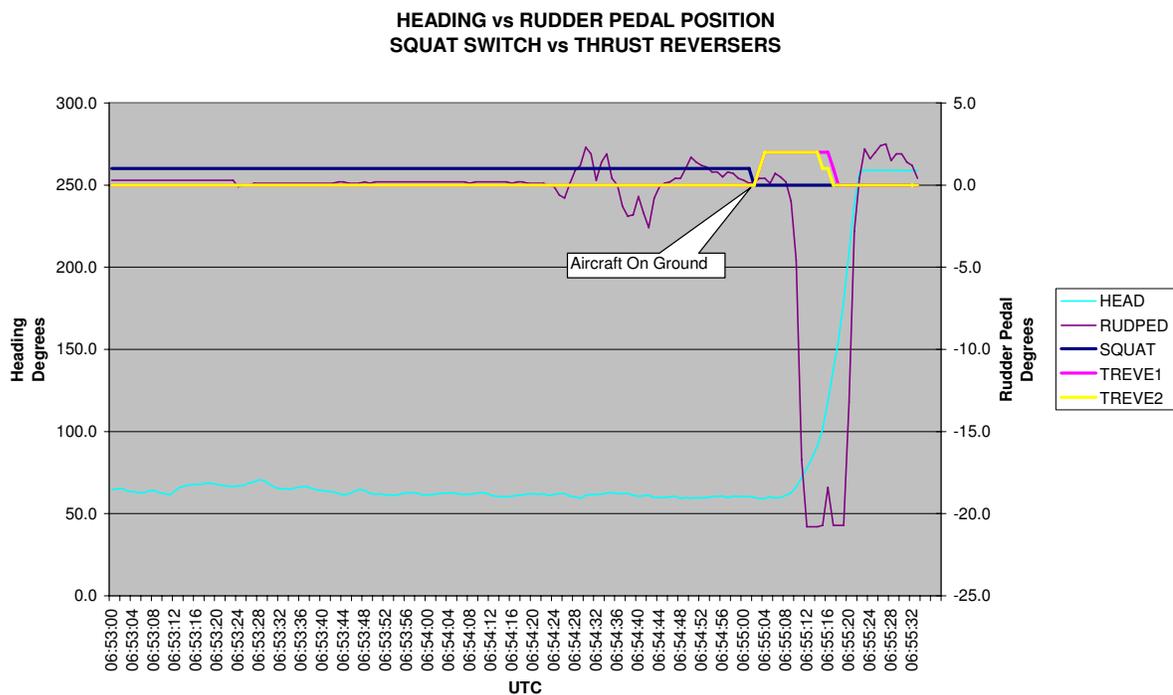
1.11.4.2 HEAD vs. RUDPED – The graph reflects information regarding Heading, plotted against the Rudder Pedal position, as well as Thrust Reverser and Squat Switch Positions. The data indicated that the aircraft had now touched down and then the Left Rudder Pedal was pushed forward, (the right pedal position is recorded, the negative values indicates that the right pedal was pushed back). However, the aircraft was turning to the right, (the value for Heading is increasing from $\pm 60^\circ$ to 259°). It can also be seen on the graph that the Engine no. 2 Thrust Reverser closed before the Engine no. 1 Thrust Reverser. The data also indicates that Maximum Thrust Reverse was selected.

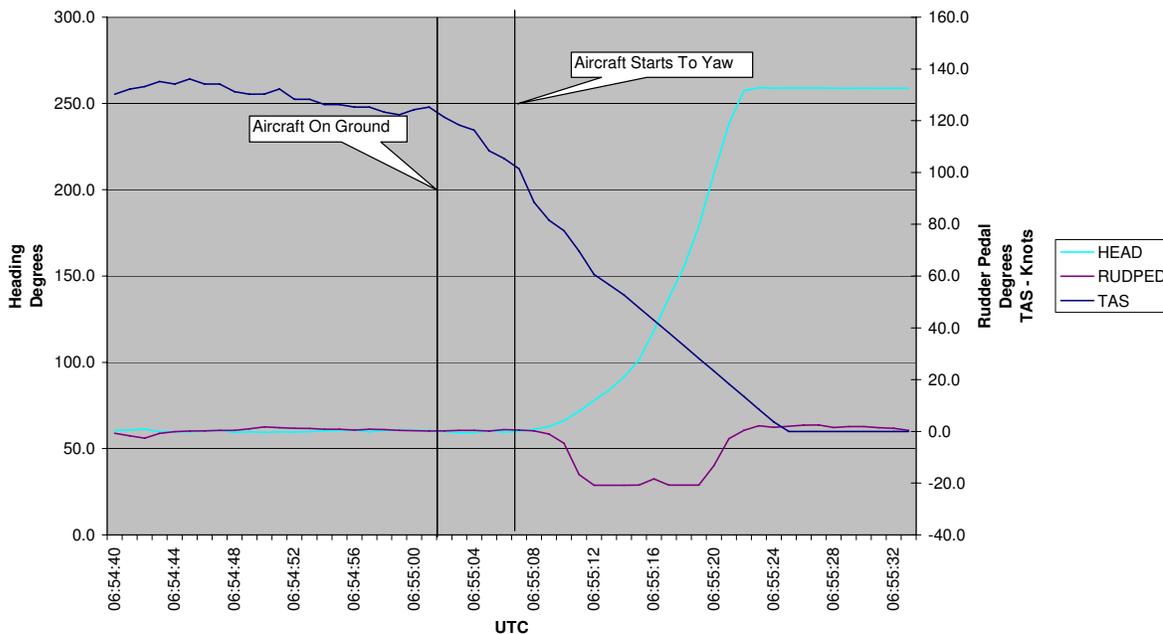
HEADING vs TAS & RUDDER PEDAL POSITION

1.11.4.3 TAS vs. RUDPED – The graph below reflects information regarding Heading plotted against the Rudder Pedal position, as well as the True Airspeed (TAS). The graph indicated that the Heading and the Rudder Pedal input started to change at almost the same point in time. The time scale covers the last 54 seconds of the event.

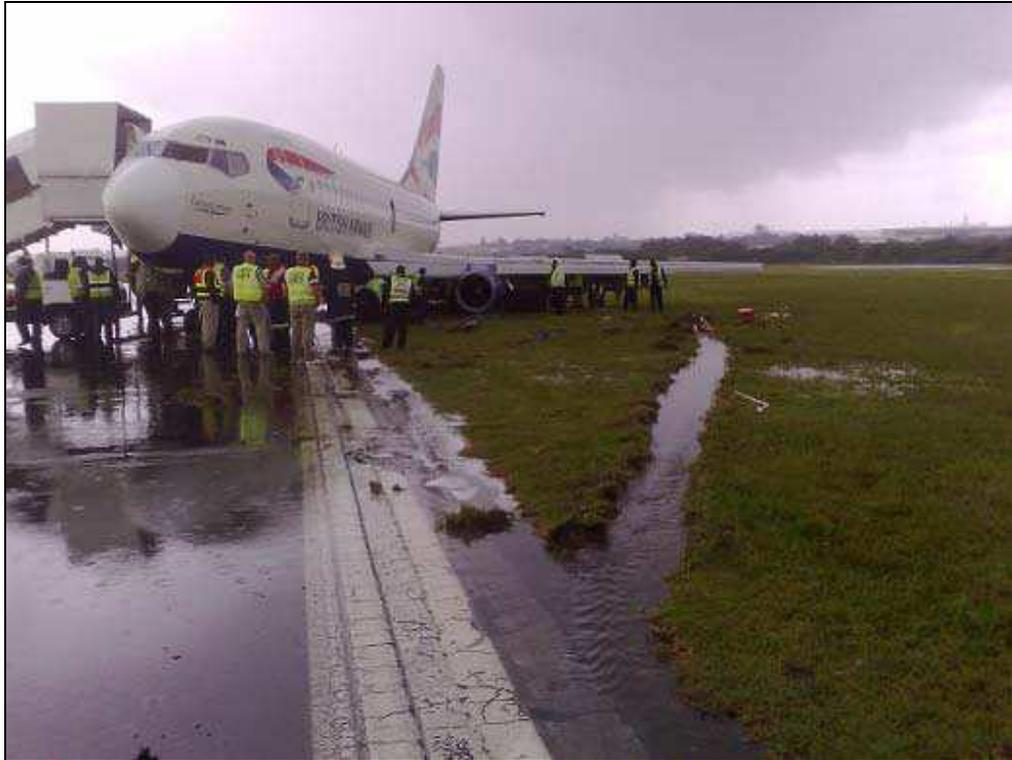
1.12.1 The aircraft's approach was above the GS resulting in a deep landing on Runway 06. It was reported by ATC FADN that the aircraft had touched down in the middle of the runway and started to veer to the right before it groundlooped through 200°. The aircraft then partially skidded off the runway onto the grass-covered, water-logged surface on the right side of Runway 06, causing the left main undercarriage to sink into soft soil. The aircraft came to a stop at GPS Position: S29°57'41.91"E030°57'26.16" approximately 30m from the threshold of Runway 24.

Figure 4. Shows the final position of the aircraft as it came to rest

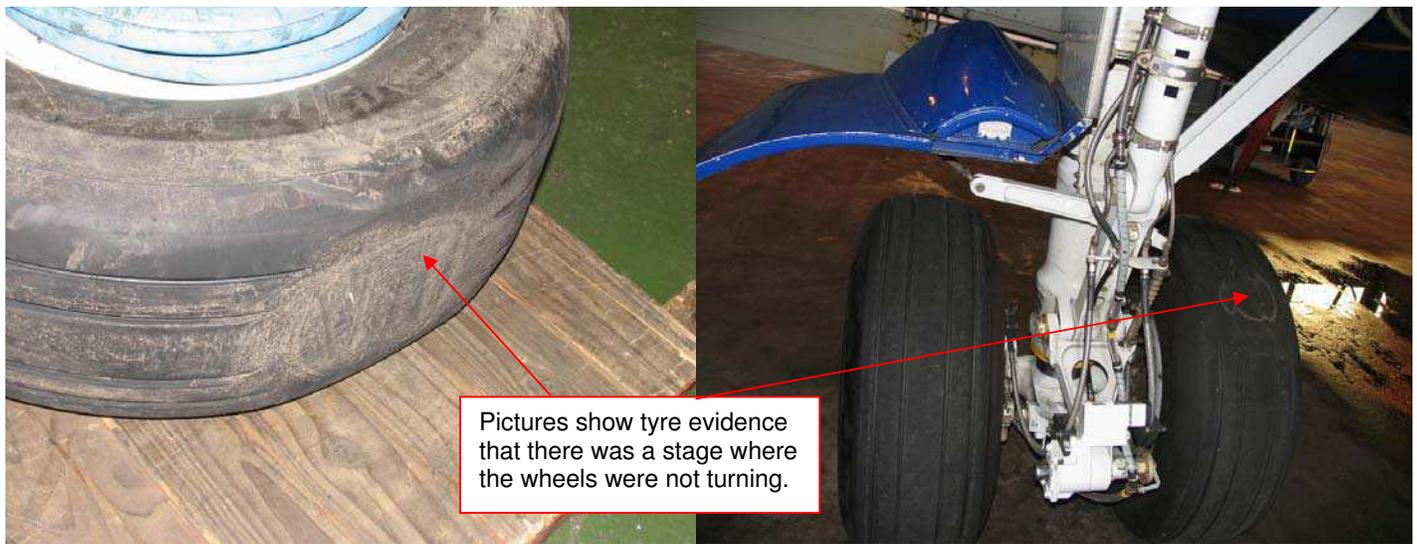
1.16.3 The inspection of the aircraft wheels during the investigation revealed flat spots on the two inner main wheel tyres. The flattened 'heated' area on the two wheel tyres appear to be consistent with a non-turning wheel (hard barracking effect), The pictures below show the flat spot on the aircraft's inner main wheels.
