Lessons Learnt from CFIT

CFIT workshops 15, 16 Dec 2021 - ICAO AFI Region

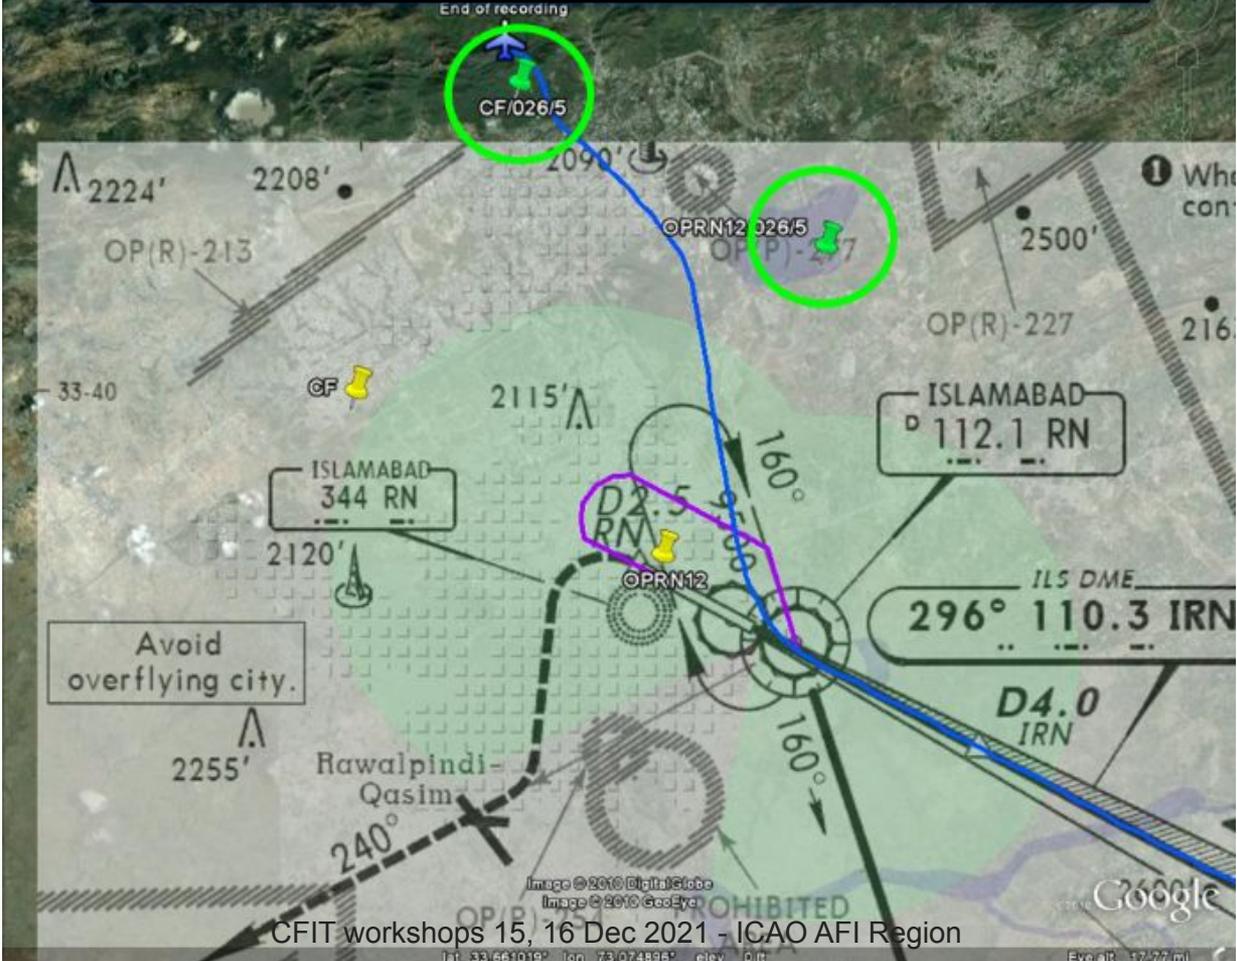
CFIT during approach – Islamabad 2010

- The aircraft was to perform a circling approach procedure for runway 12.
- Before starting the approach, the flight crew created FMS waypoints that did not match the published approach procedures.

- Weather reports indicated rain, poor visibility, and low clouds. The aircraft descended **below the MDA** (i.e. 2 300 ft instead of maintaining 2 510 ft).

- The approach was **continued despite low visibility** and insufficient visual ground references.
- As configured in the FMS, the aircraft flew toward the waypoints inserted by the flight crew, away from the published approach path, toward the hills.

- As the aircraft neared the hills, air traffic control sent calls to the flight crew and the **TAWS** triggered **TERRAIN** and **PULL-UP** warnings with increasing severity **for more than one minute**.

- The **flight path was not corrected**. The aircraft impacted the hilly terrain 9.6 NM from the airport.

- **Design aspect**
Some ideas to be further matured
- **Operational aspect**
CRM reinforcement

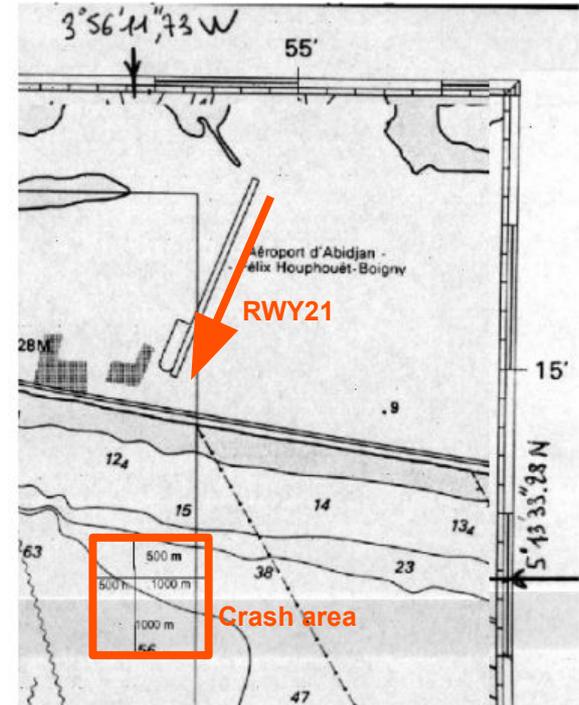
CFIT after Liftoff – A310 Abidjan 2000

- The aircraft flew into the sea after takeoff
- Stall warning triggered continuously after takeoff
- Investigation identified a broken angle-of-attack (AOA) vane
 - High AOA data sent to the Flight Warning System
- Crew applied the stall warning procedure in response to the spurious alert

- **Broken probe monitoring**

- [0, +8°] domain between 90 kt and 110 kt
- Any sensor out of domain is rejected

- **At higher airspeed, the triplex monitoring takes over**

- If one source goes away from the others, it is rejected by the system

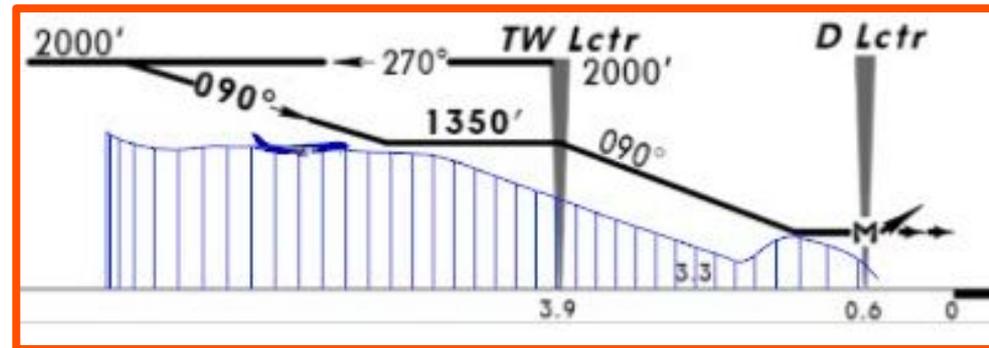
CFIT during Go-Around – A330 Tripoli 2010

- No precision locator approach
- Fog forming over the airport before sunrise
- No visual reference with runway below minimum
- Go-around upon **TOO LOW TERRAIN**
 - AP disconnected / TOGA / CONF 3 / Gear UP
- Go-around pitch not flown / FD bars not followed
- Nose down inputs due to spatial disorientation
- A/C started to descent
- Late response to increasing TAWS alerts
 - **DON'T SINK**
 - **TOO LOW TERRAIN**
 - **PULL UP**

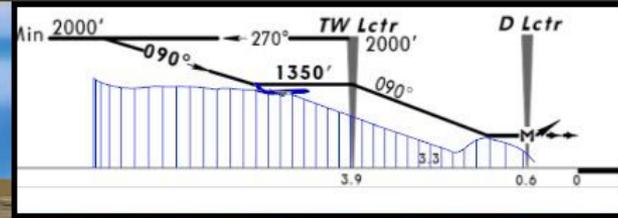
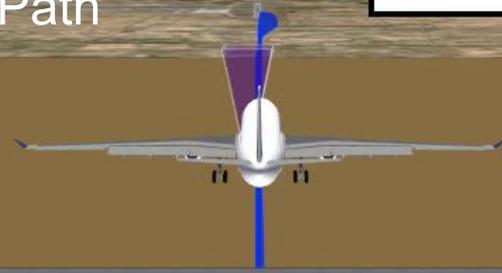
A330 Tripoli 2010 Descent Below the Path

FD and FPV not computed

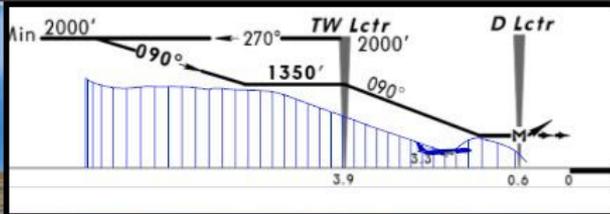
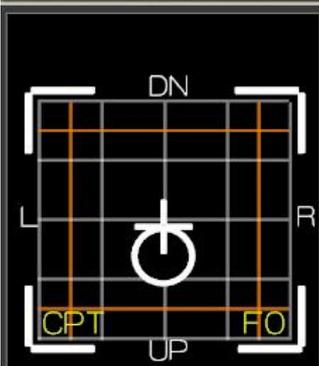
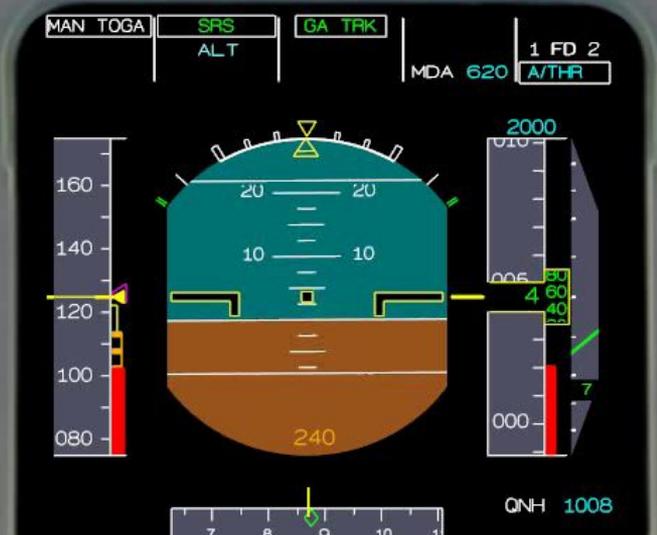
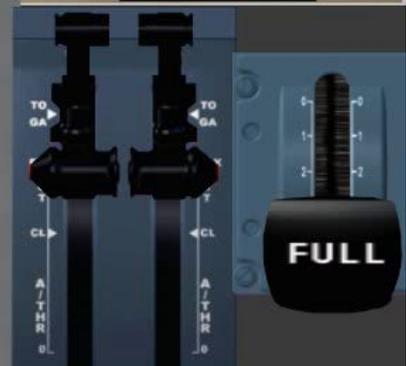
A330 Tripoli 2010
G/A upon TAWS Alert

TOO LOW TERRAIN

FD and FPV not computed

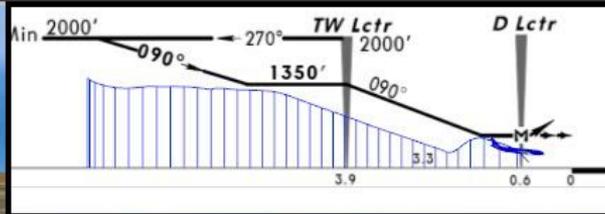
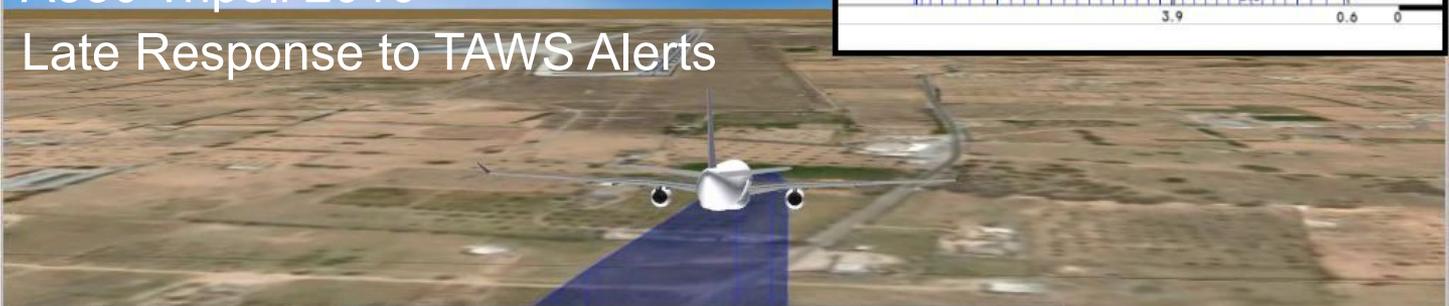
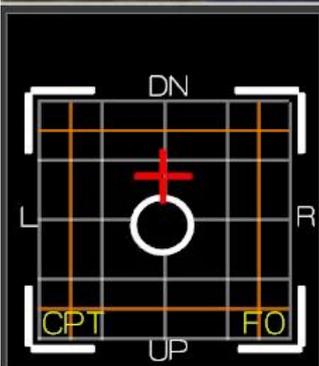
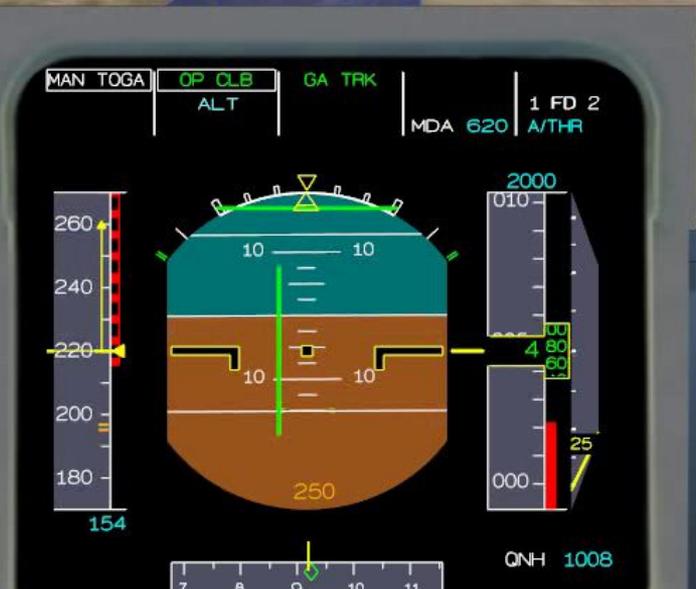
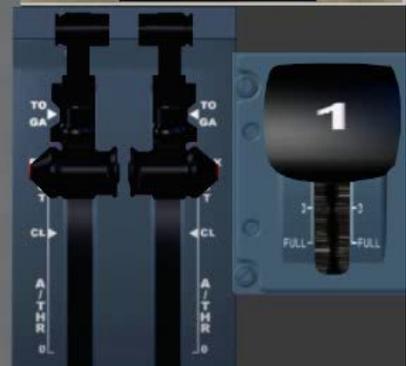
Late Response to TAWS Alerts

PULL UP

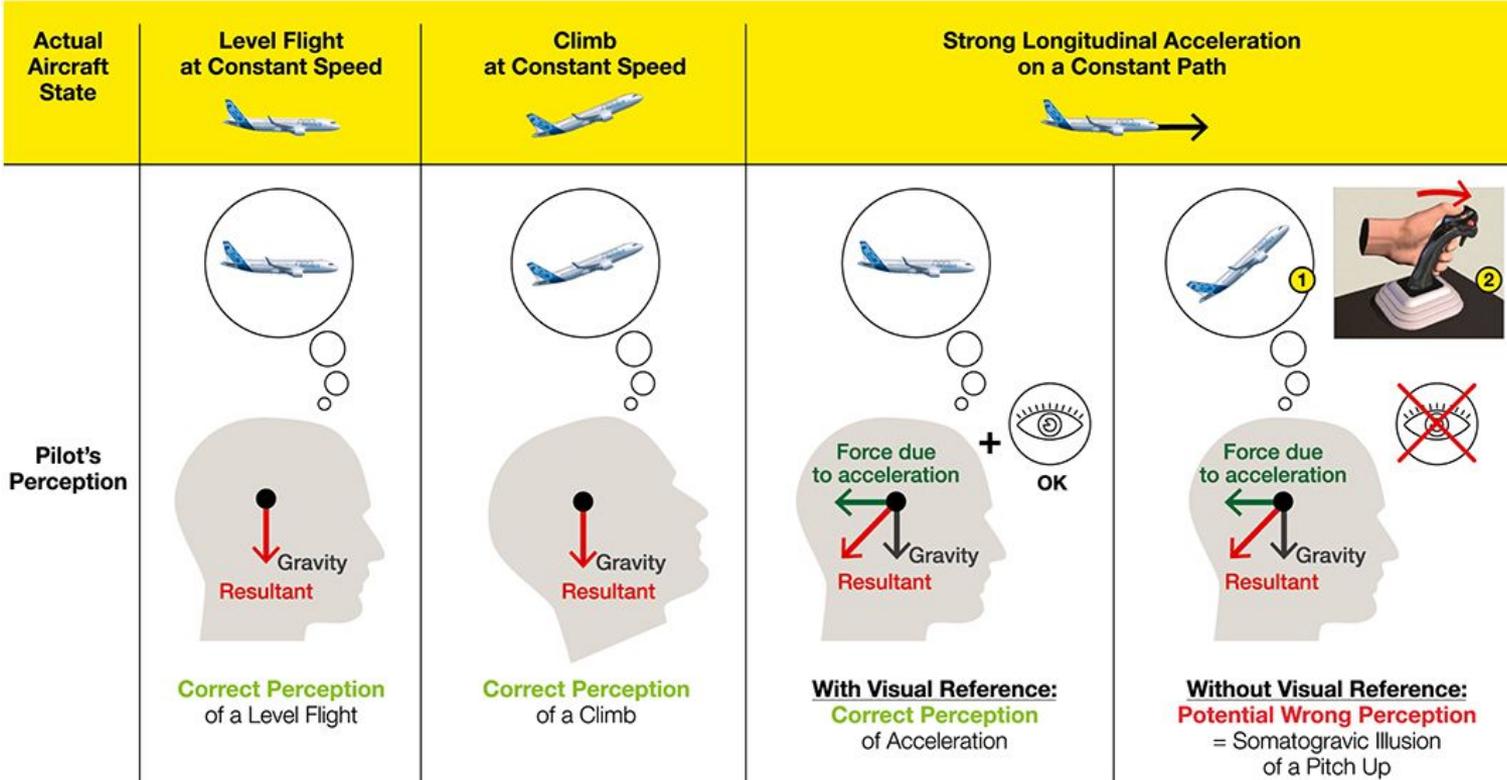
SOMATOGRAVIC ILLUSION

- First TAWS alert **TOO LOW TERRAIN** was followed by a GO-AROUND
- When subsequent TAWS alerts **DON'T SINK & TOO LOW TERRAIN & PULL UP** were triggered the flight crew did not respond in time
