# Obstacle Spot Checking OLS

Session 2.2: Data Assessment & Analysis 5 December 2017

AERODROME SAFEGUARDING WORKSHOP (Cairo, Egypt, 4-6 December 2017)

Presented by: Michelle Soliman, Aerodrome Ops Inspector General Civil Aviation Authority, United Arab Emirates

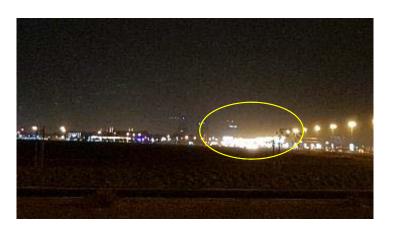
## Obstacle ID: 3291 Millennium – Fujairah Mall (Fujairah Commercial Complex)

- Flights are not permitted over this area due to established city
- Lighting applied from "ground level" in consideration of surrounding structures
- Medium intensity Type A lighting on top of tower and medium intensity Type C on corners of mall structure

#### Compliant

...in excess of regulation...

No action required

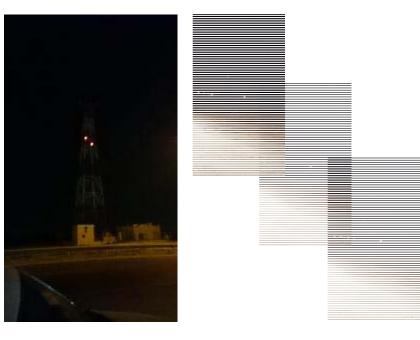
#### Obstacle ID: 1202 Etisalat Comms Tower – Dibba Road

Assessment: Compliant

- Lighting Low and Medium Intensity Type B observed at night
- · Marking observed

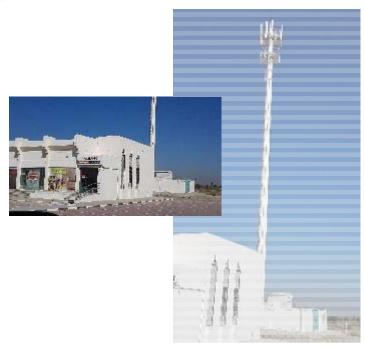
#### Obstacle ID: 2032 Comms Tower – RAK Bank

**Compliant**Action: Review
requirement for marking

- Lighting observed
- No marking is observed
