Nairobi | September 2019

Aeronautical Information Requirements

An Airline Perspective

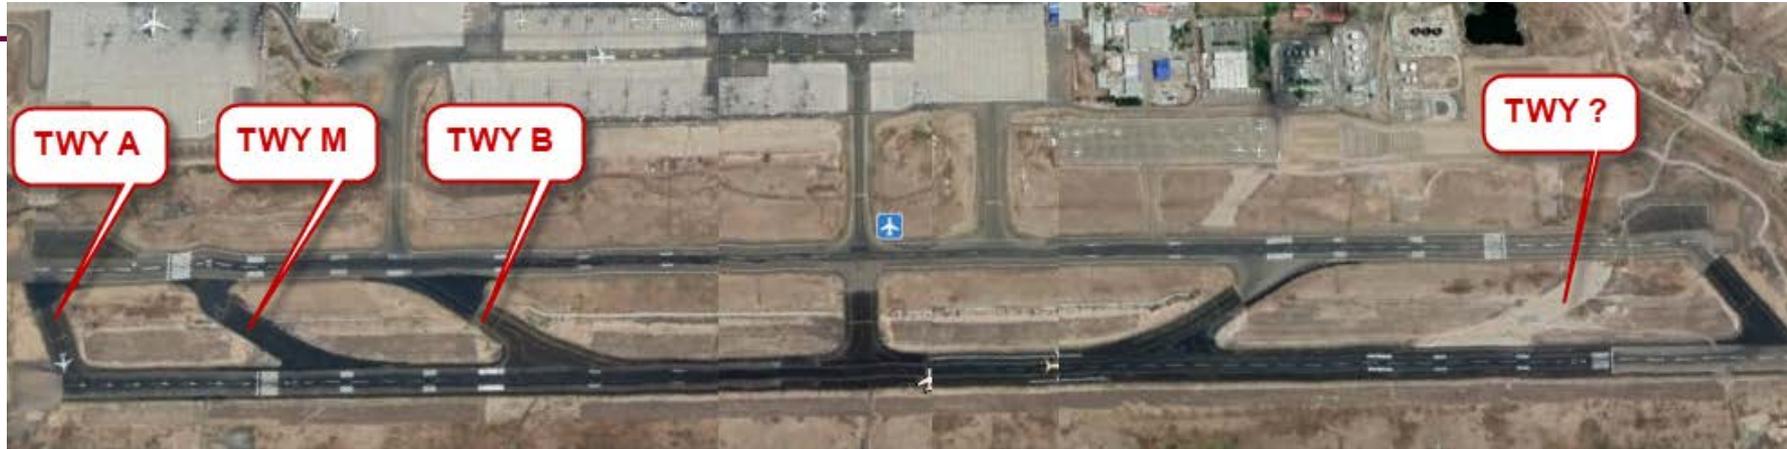
Case study No.1 – CONT'D

First NOTAM to advise of TWY construction since query raised in MAY2019

- 1) **BTN TWY 'B' AND TWY 'A'.**
- 2) FROM TWY 'A' TO CARGO TERMINAL.
- 3) **BTN TWY 'D' AND TWY 'E'.**
- 4) **BTN TWY 'H' AND THE BEGINNING OF RWY 25R.**
CAUTION ADVISED DUE TO VEHICLE MOVEMENT
AND FOLLOW STRICTLY ATC INSTRUCTION.

E) **NEW TWY 'M' BTN TWY 'B' AND 'A' IS INSTALLED AND OPERATIONAL.**

- MAY2019, Flight Crew reported : TWYs under construction , poor marking and lighting to indicate closure
- No AIS publications available on construction of New TWYs. Potential risk of aircraft entering a construction area during ground maneuvering.

- No NOTAM or AIP SUP detailing TWY Specifications
 - **Location, Length, Width, PCN, Speed Restrictions, Lighting, HST status**
- If AIP SUP had been issued with relevant details and drawing, Navigation charting data houses could have updated charts used by flight crew showing TWY construction location(s).
