# Runway Safety Initiatives

Presented to: ICAO RRSS, Dubai

By: James White, FAA Airport Safety and Standards

Date: June 2014

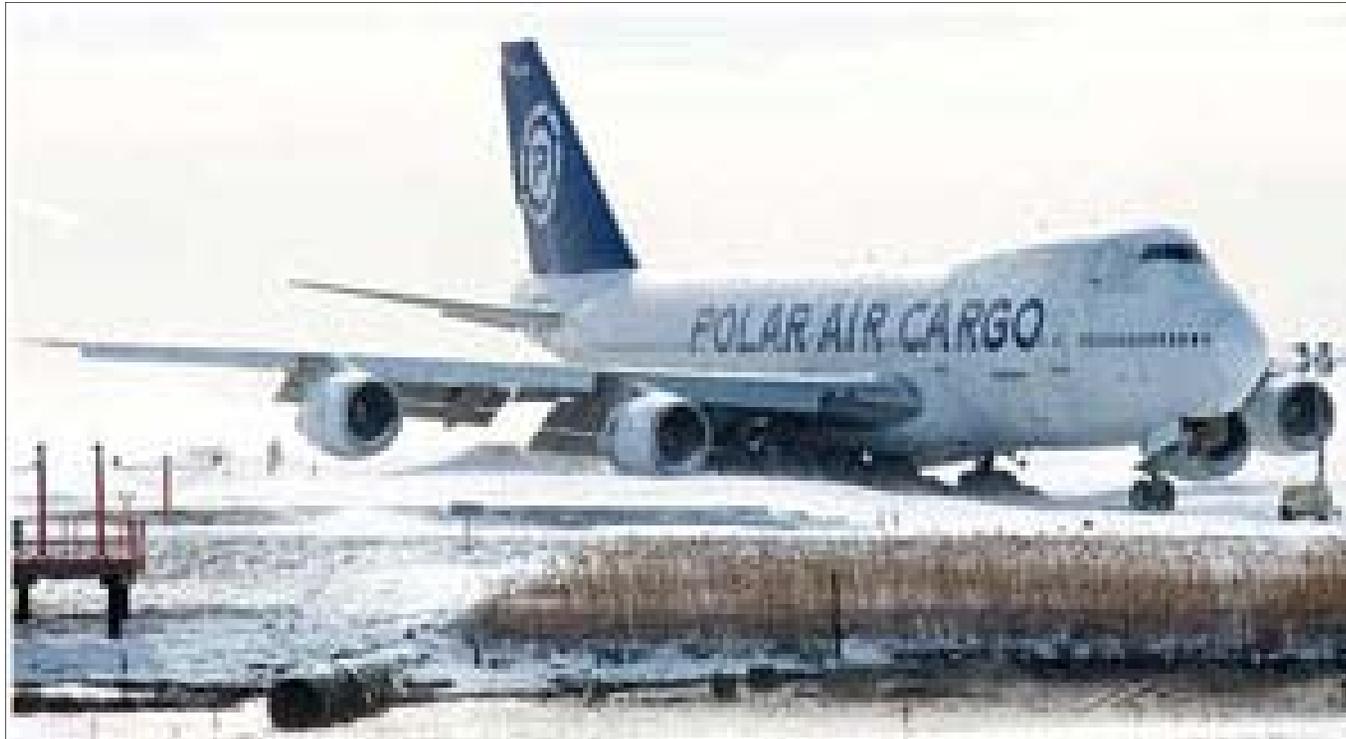
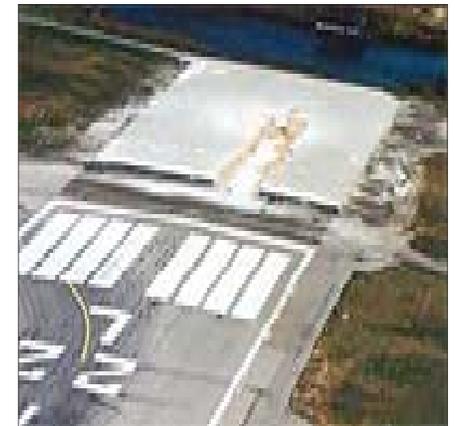
**EMAS capture of a Boeing 747 at JFK International Airport, NY  
January 2005**

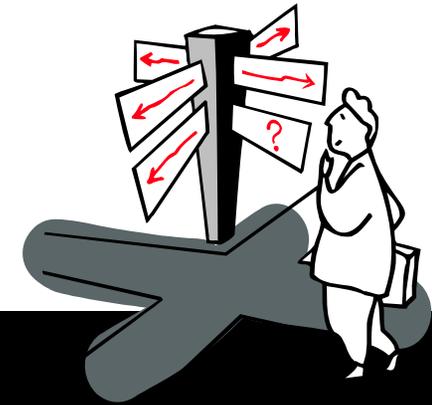
## ***Wrong Runway Event Risks***

- 1. Short taxi distance***
- 2. Airport complexity***
- 3. Single taxiway leading to multiple runway thresholds***
- 4. Close proximity of multiple runway thresholds***
- 5. More than two taxiways intersecting in one area***
- 6. Short runways (i.e. < 5000 ft.)***
- 7. Joint use of runway/taxiway***

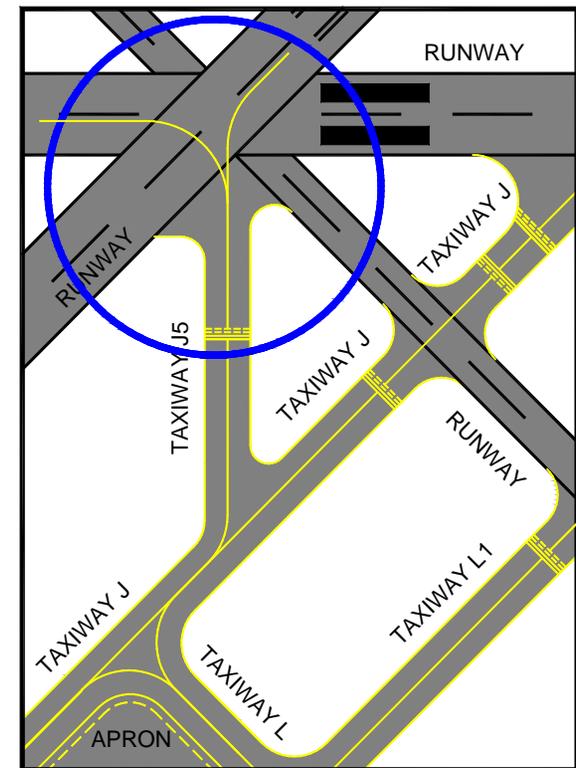
**Avoid This!**

(d) Taxiway intersecting two or more runways

- **Optimum design is right-angle**
  - No less than 45 degrees
  - Exception for High Speed Exits
- **Not Recommended:**
  - Y-shaped taxiway crossing
  - Taxiway crossing a High Speed exit
  - Taxiway connecting to V-shaped runways
  - Aligned taxiway (Prohibited)
  - Direct access from a ramp/ terminal to the runway
  - High-speed exits leading directly onto another runway

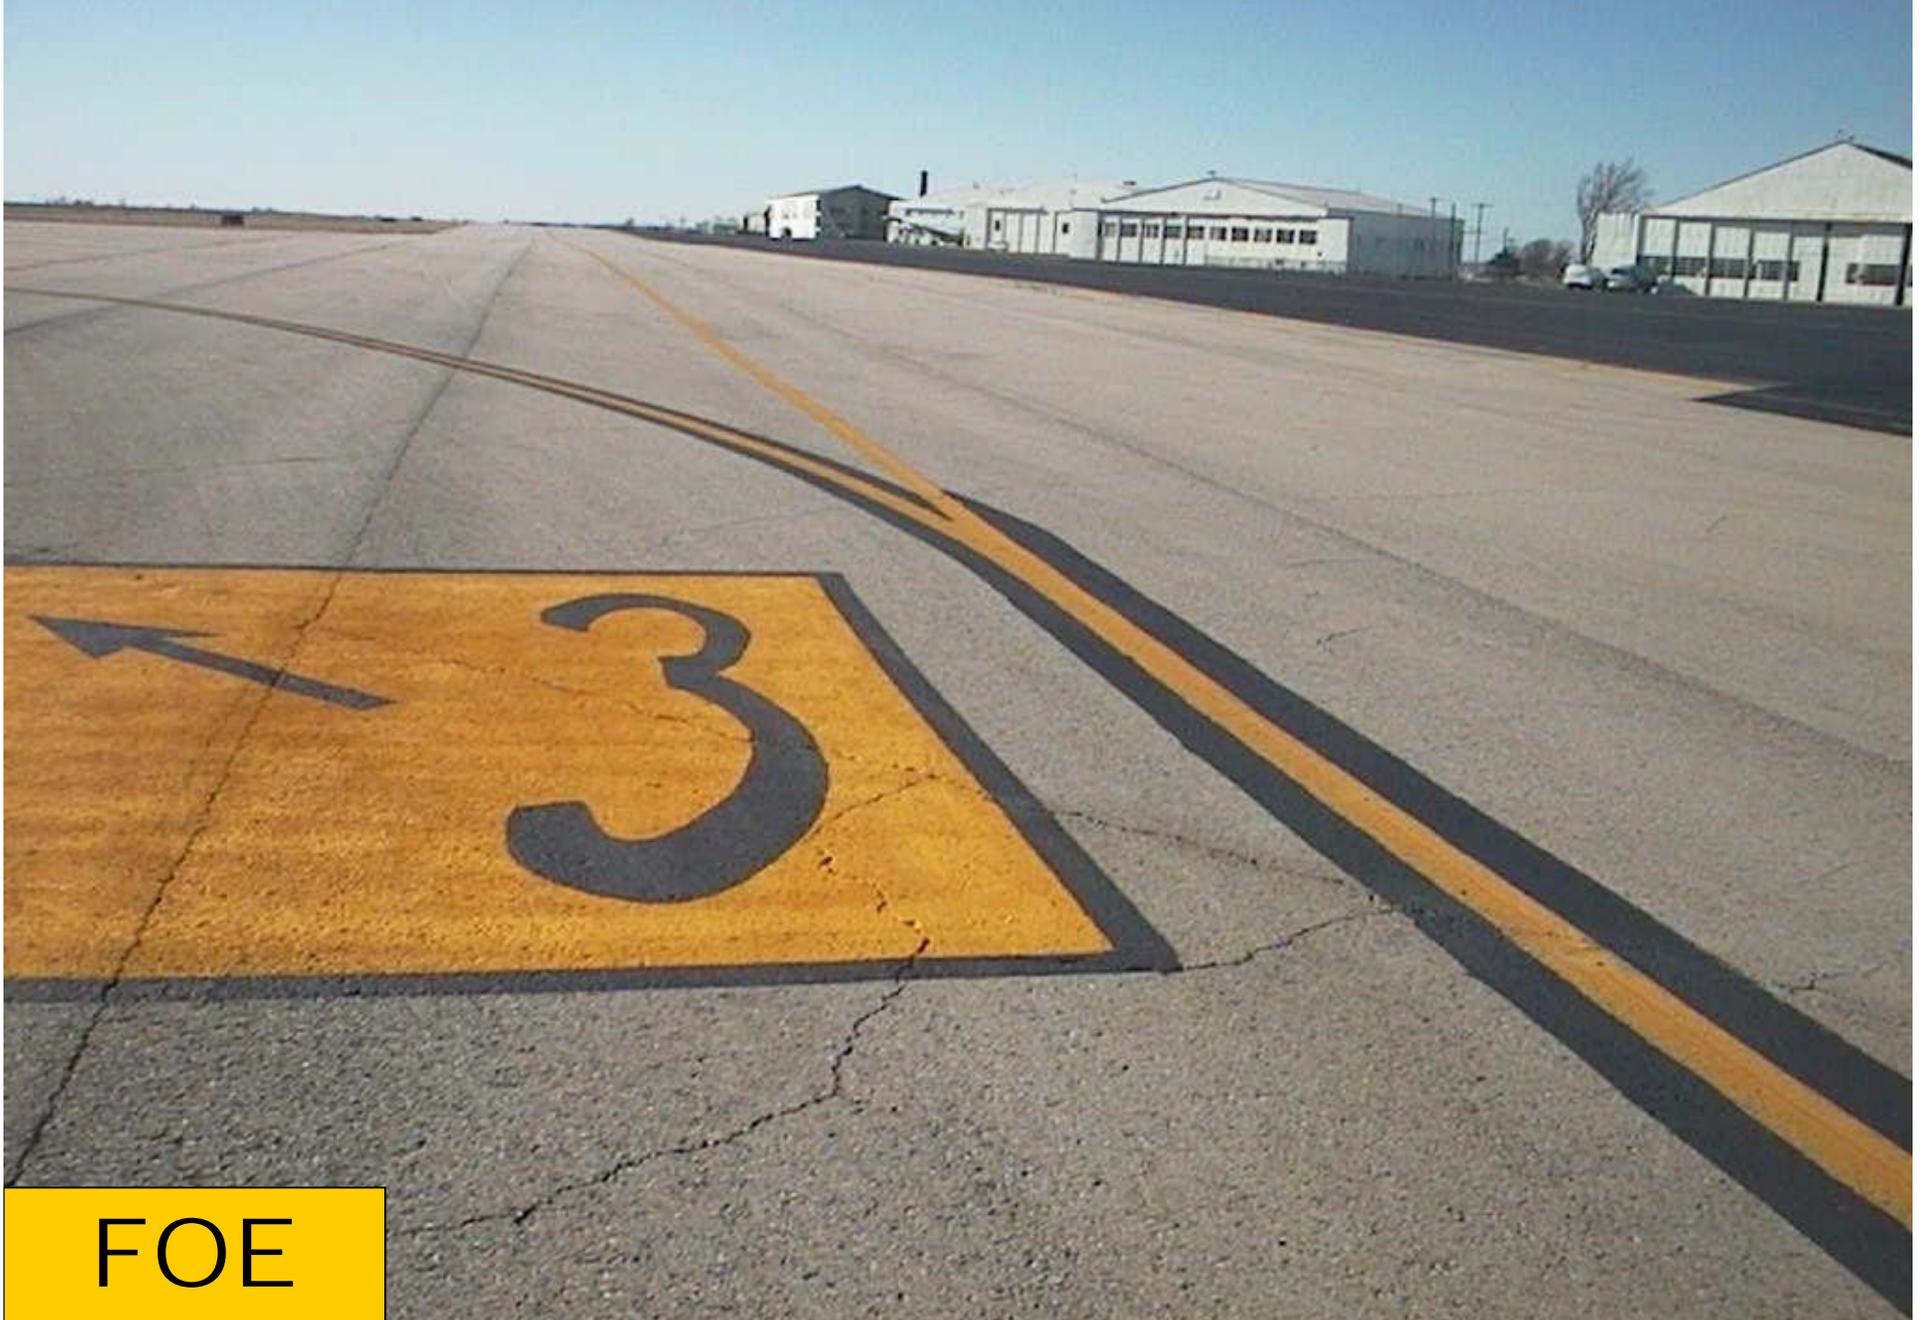
# Recommendation Implemented

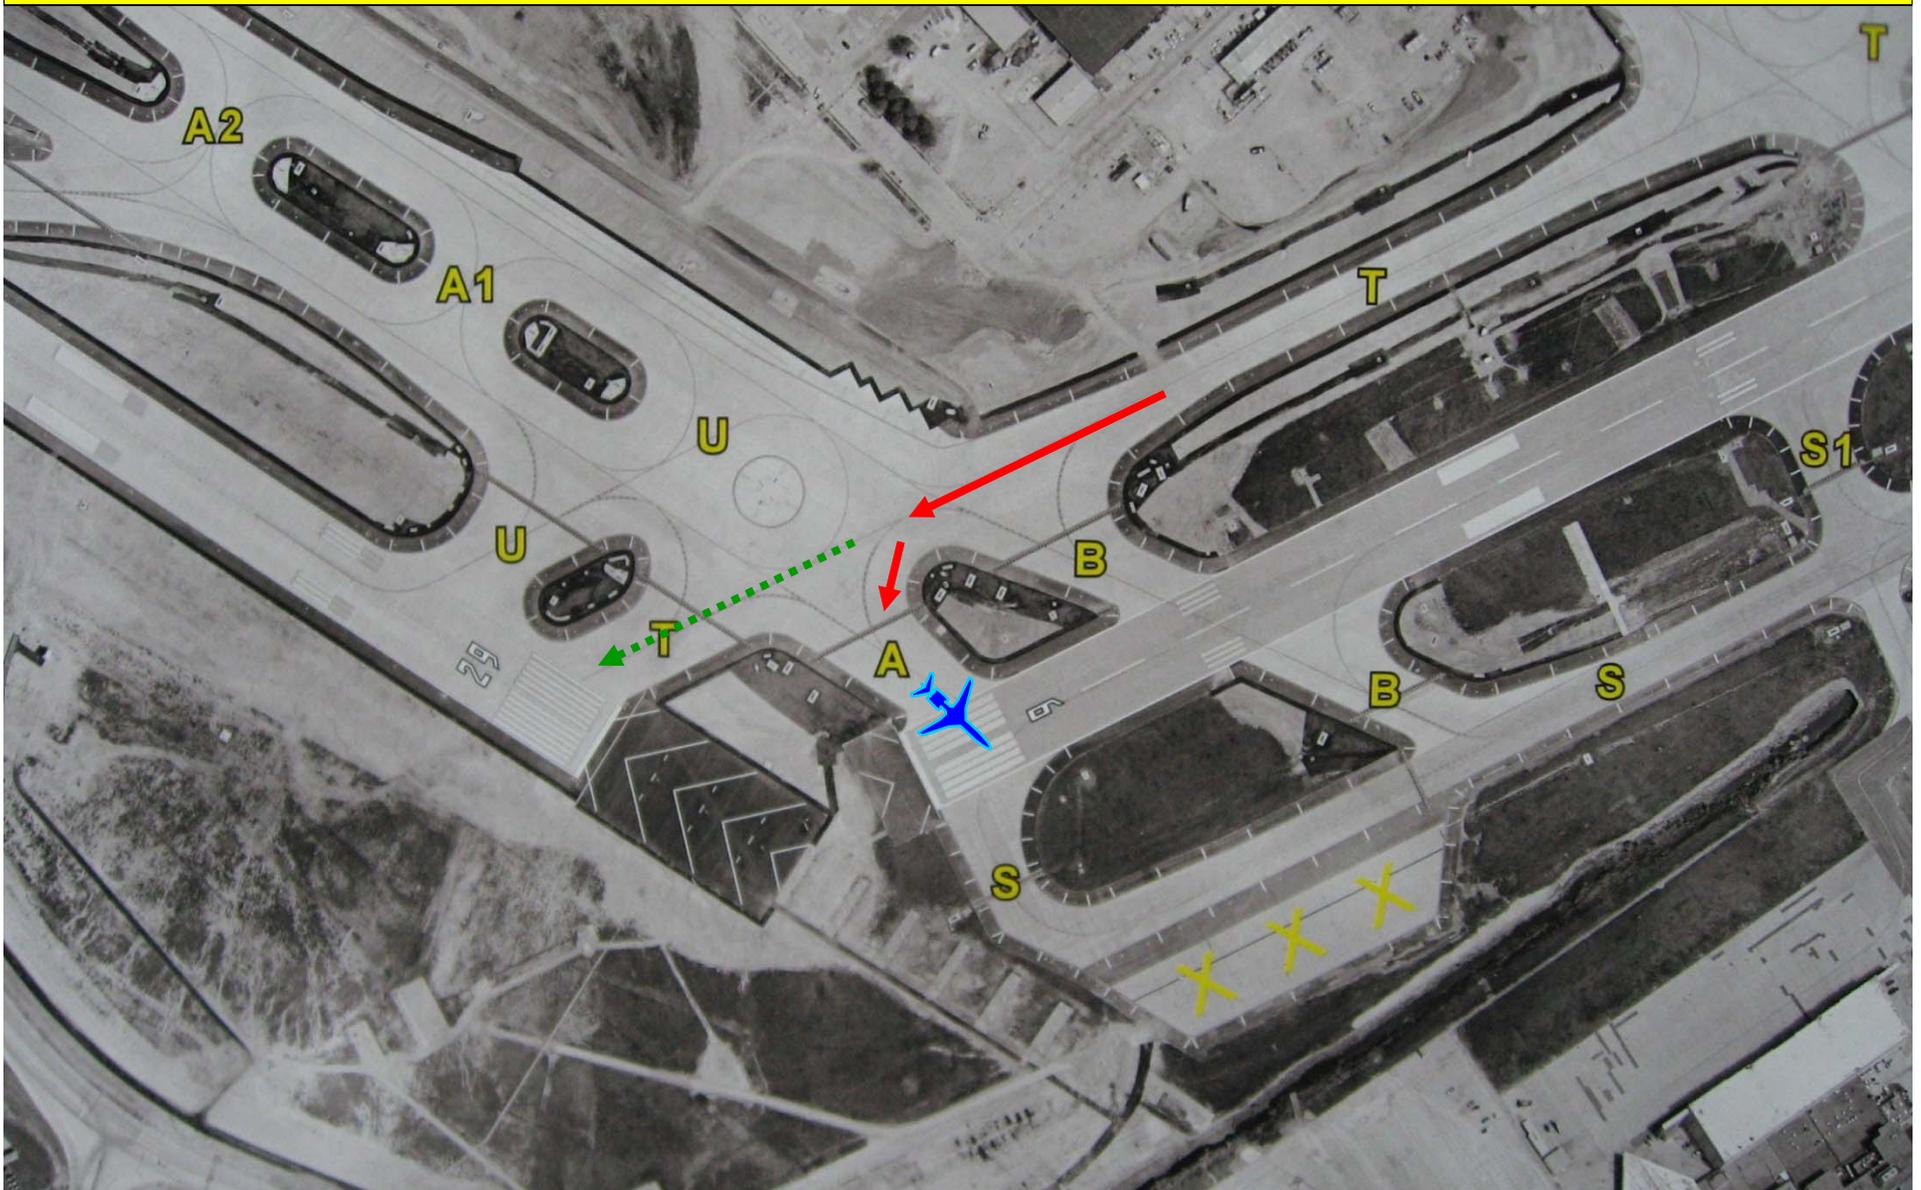
## STL PD Runway Incursions on Runway 6

On 4/7/08, a CRJ-900 taxiing to Runway 29 on Tango, instead turned left on Taxiway Alfa and entered Runway 6. There was no loss of separation.

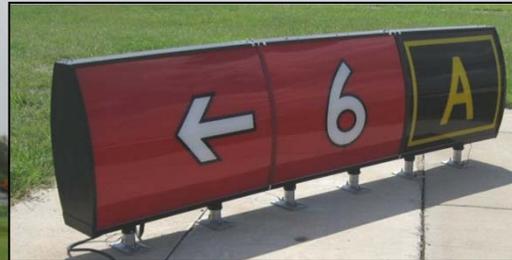
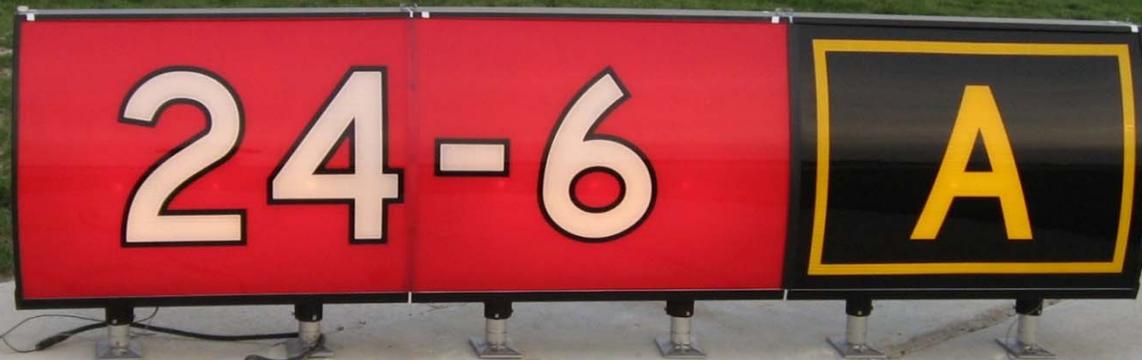
Modified Sign

## STL RSAT Action Items for the Alfa/Tango Intersection

Action - Modify the Runway 6 holding position sign on the right side of Taxiway Alfa by replacing the 24 designation panel with an arrow panel pointing left.

*Example of an RSAT Recommendation for holding positions when there is a history of pilots failing to hold short.*

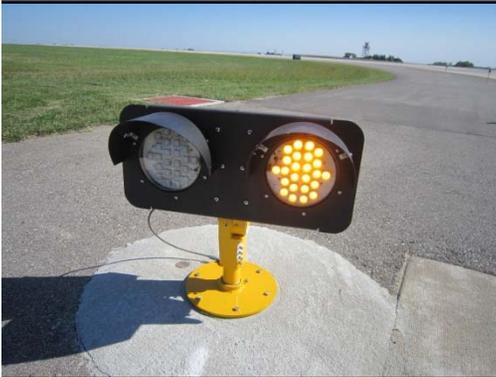
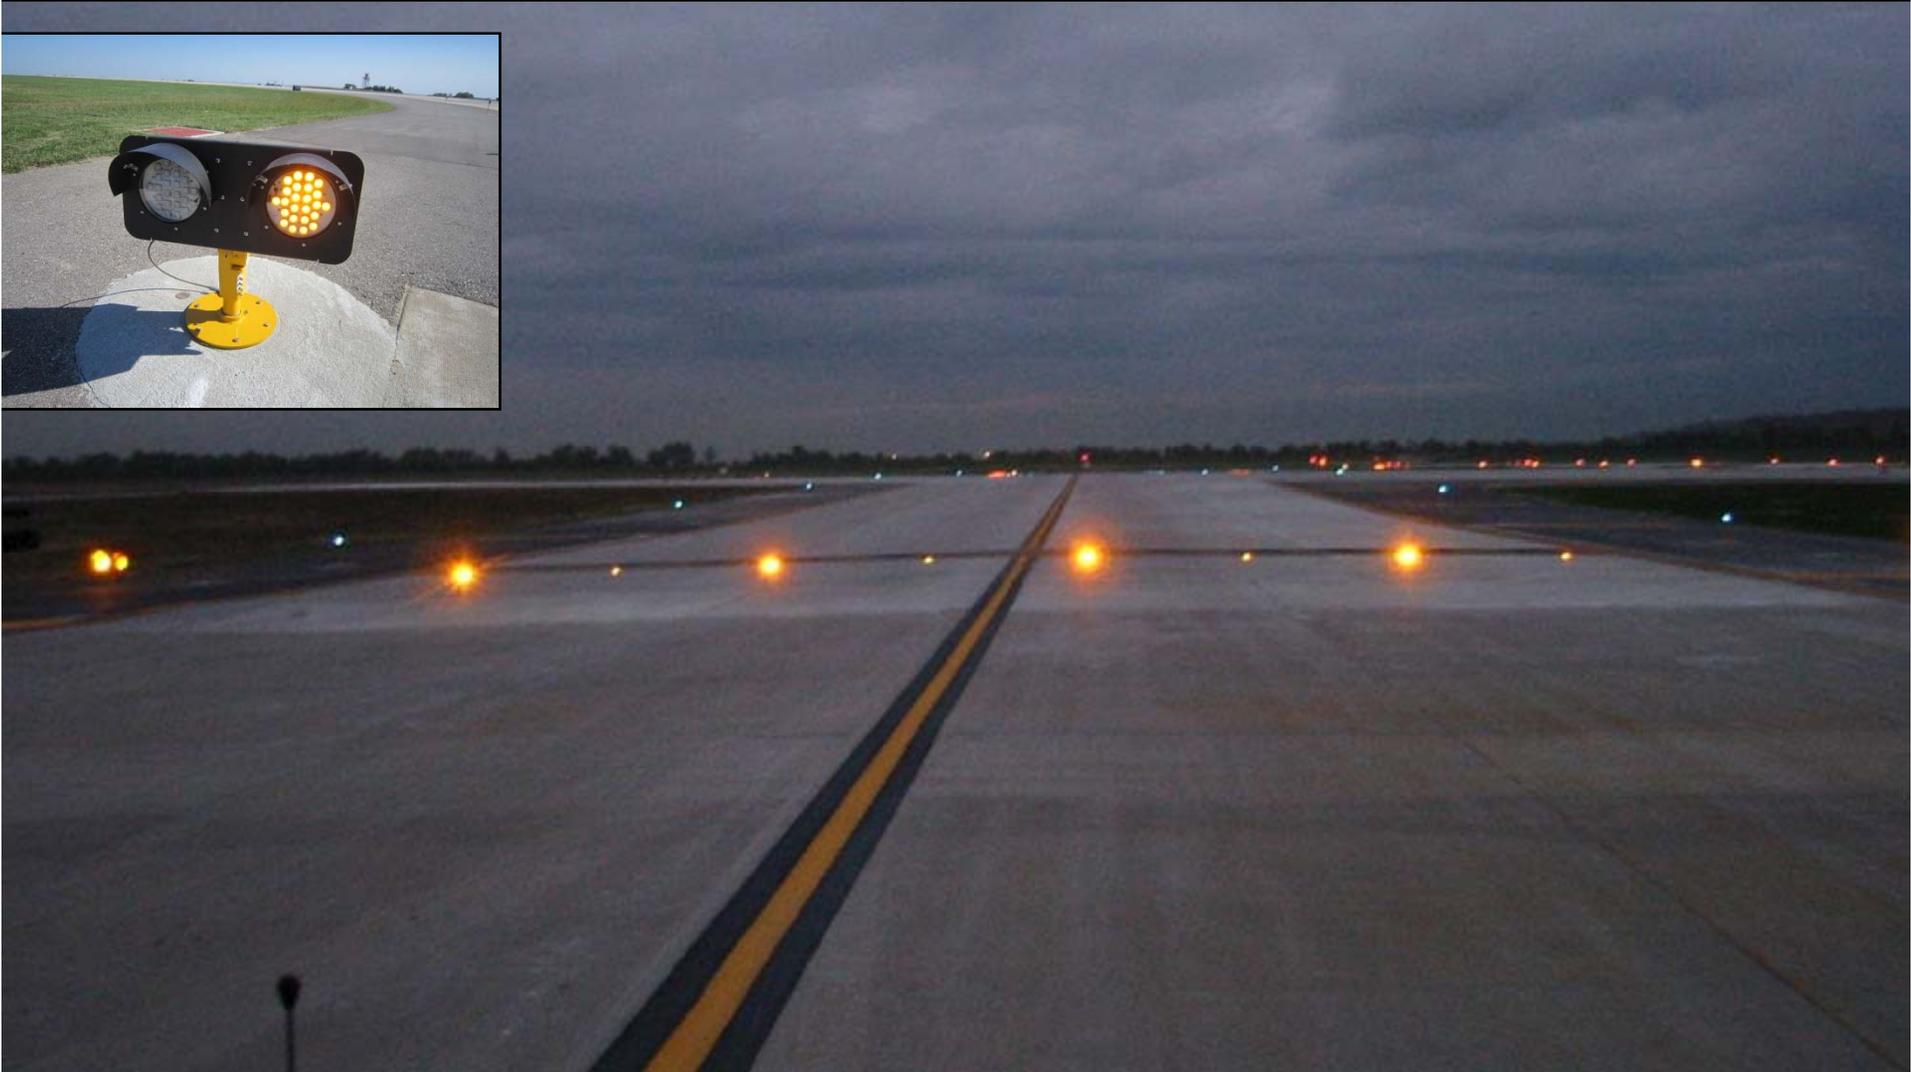
Elevated and In-pavement Runway Guard Lights are a common RSAT recommendation to enhance the identification of runway-holding positions at intersections with a history of runway incursions.

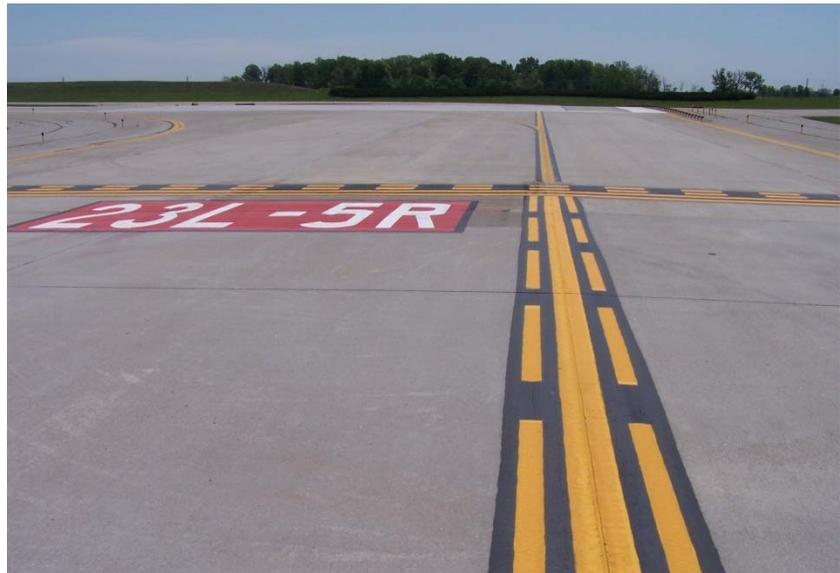
Enhanced Markings

# Enhanced Taxiway Markings

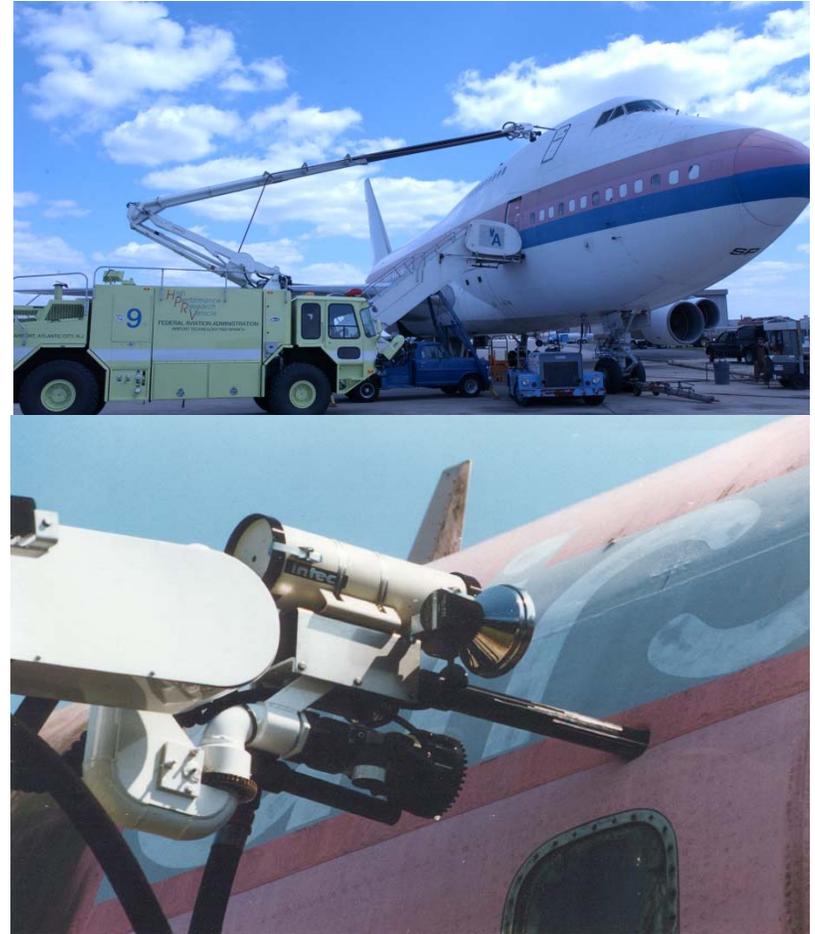
# ARFF – High Reach Extendible Turret (HRET)

## Current Generation

- 2nd level penetration possible, however, vehicle will be too close to burning aircraft and aircraft must be level.
- Penetrating nozzle should be as close to 90 deg. to skin as possible.
- Penetrating nozzle should be in-line with boom arm.

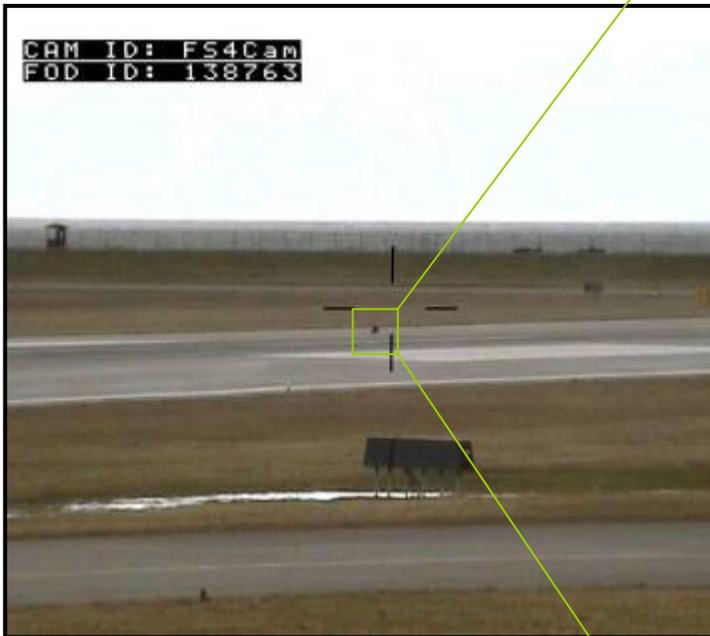
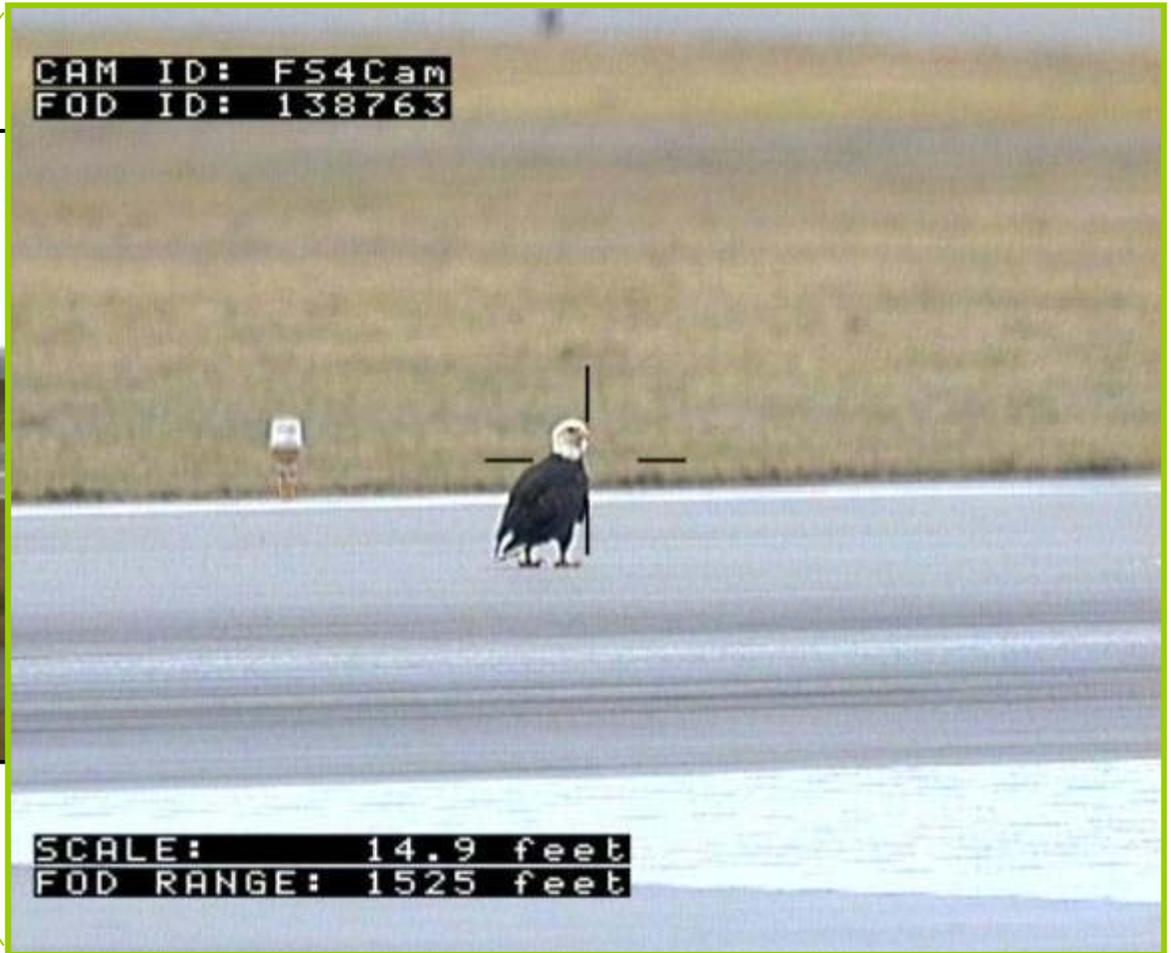
# Tarsier Camera in operation

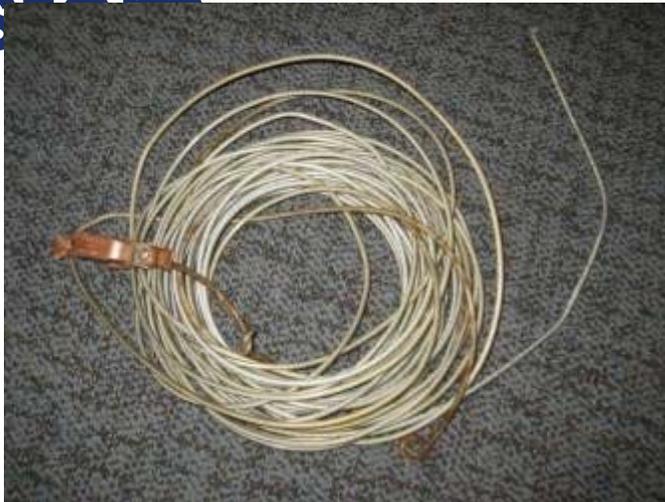
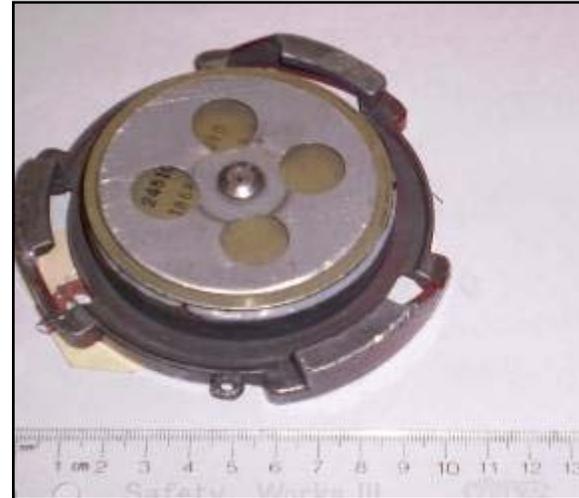
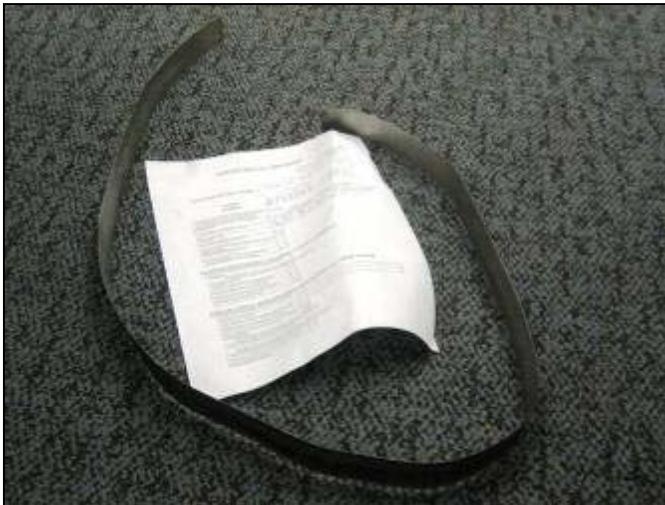
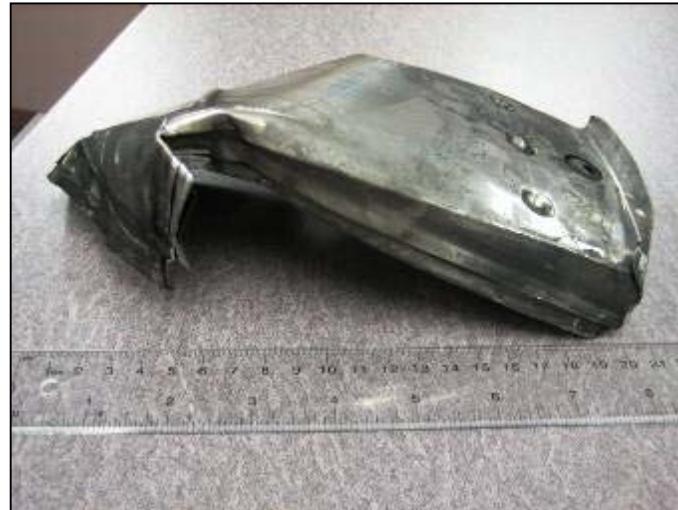
# Example FOD finds by the QinetiQ system

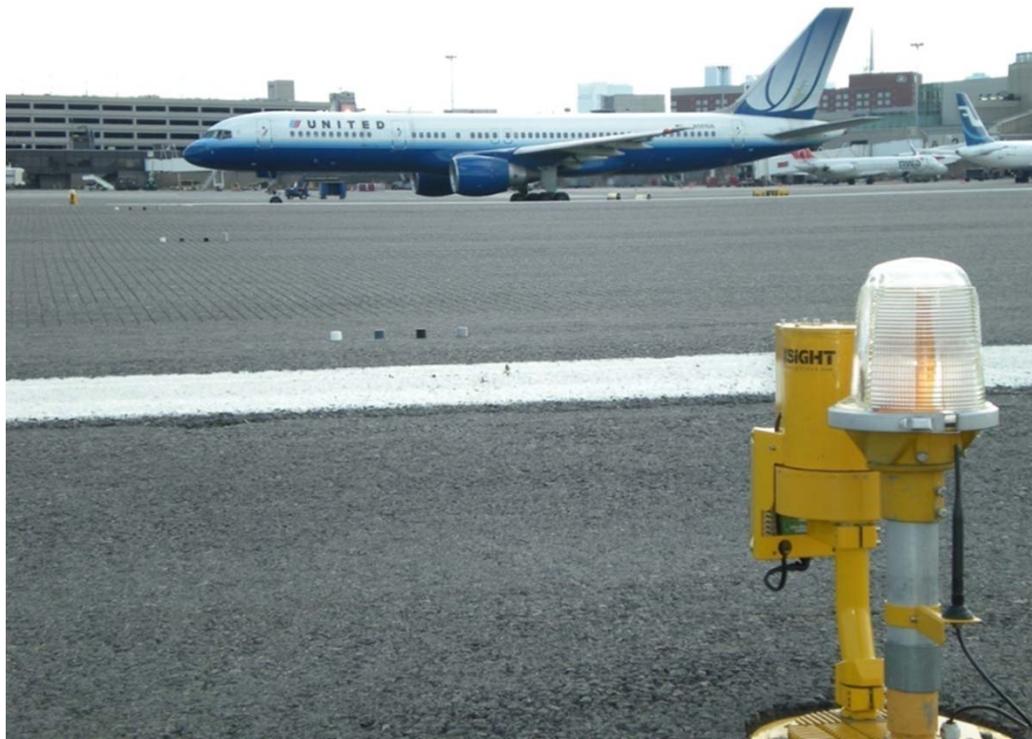
# XSight System at Boston

- **In December 2013, Boston Logan Airport was the first airport in the U.S. to have FOD detection equipment installed on an entire runway.**
- **Runway 9 is the airport's busiest runway and it is using the XSight FODetect system.**
- **The cost to install the system was \$1.71 million with the FAA's share of \$900,000.**
- **Seattle and Miami are in process of acquiring a FOD detection system.**
