Landing on a Closed Taxiway

Saudi ARAMCO Boeing B737-800, Registration N803XA

Wejh Domestic Airport (OEWJ) Kingdom of Saudi Arabia

Case Study: AIG/2 Jeddah, 13 September 2022

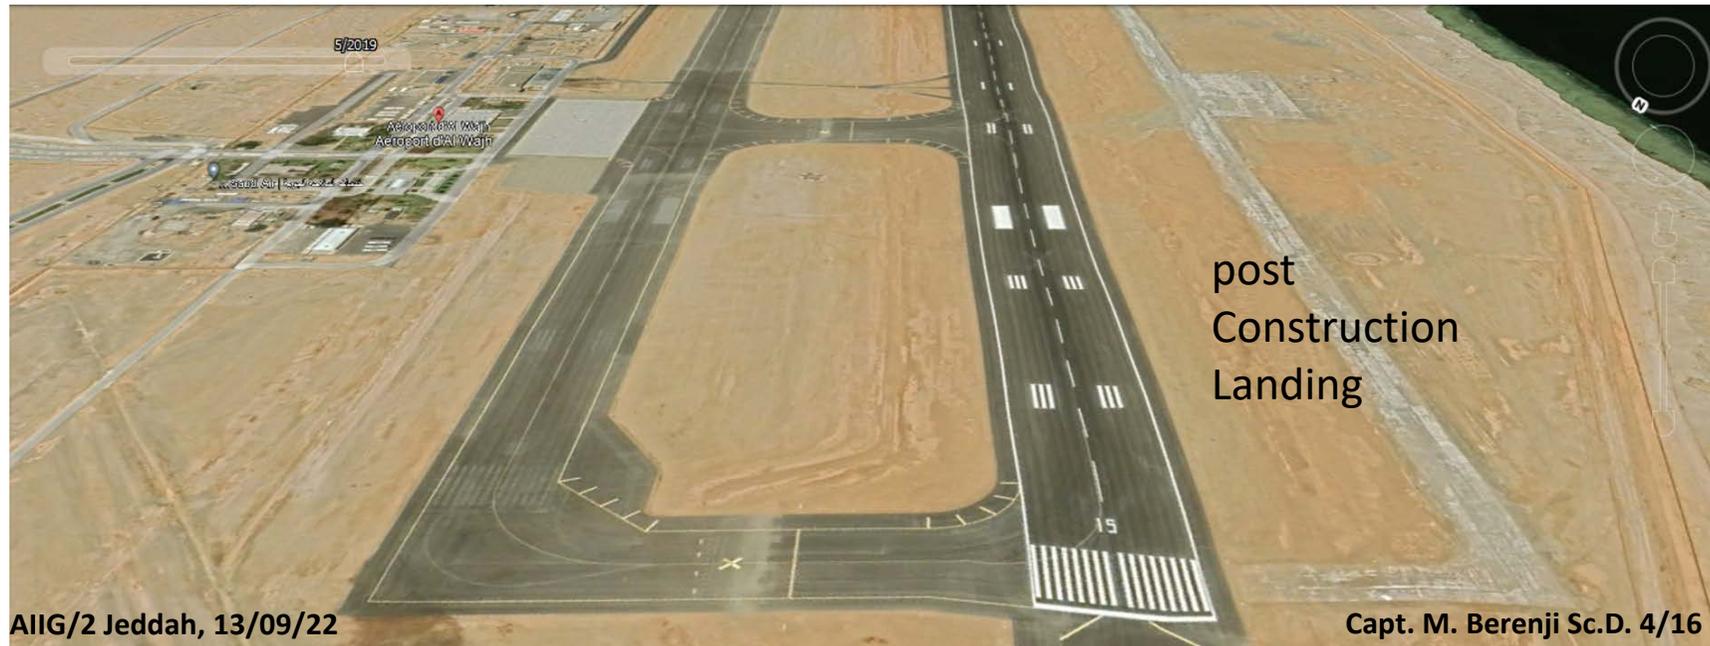
post
Construction
Landing

OEJW airport authority fully obliterated temporary Runway-15 markings and placed cross runway markings beyond both extremities of TWY-A to indicate its closure. This post event action provided an additional safety measure as a initiative.

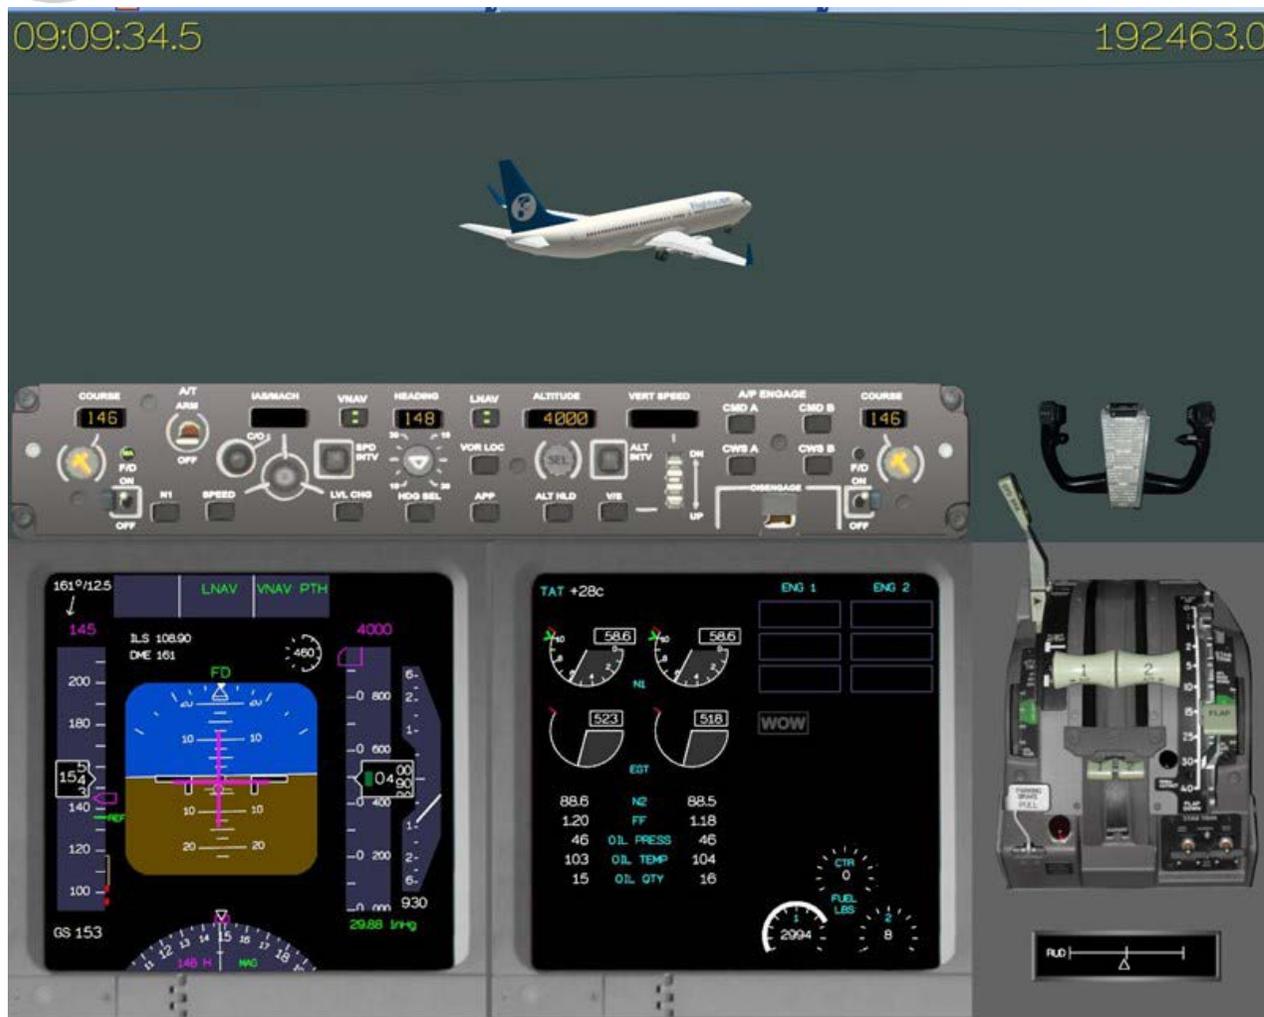
Flight Tracking 500' to touchdown Synchronized with CVR (1/3)

Autopilot: DISCONNECT
Flight Director: Displayed
Height: 460 ft AGL descending
Vertical Navigation: On VNAV Path
Lateral Navigation: LNAV Tracking
Configuration Assessment and/or Note Established on short FINAL – HAND FLYING; Stable Approach, AIRSPEED and SINK Rate are at targets;
Visibility of 4.5 KM allowed for surface markings on Taxiway Alpha and main Runway 15 to be distinguishable; PIC verbalizes “X” on main runway 15 SIC does NOT see “X” mark

At 500 feet; hand flying; at approximately 1.5 NM from touchdown

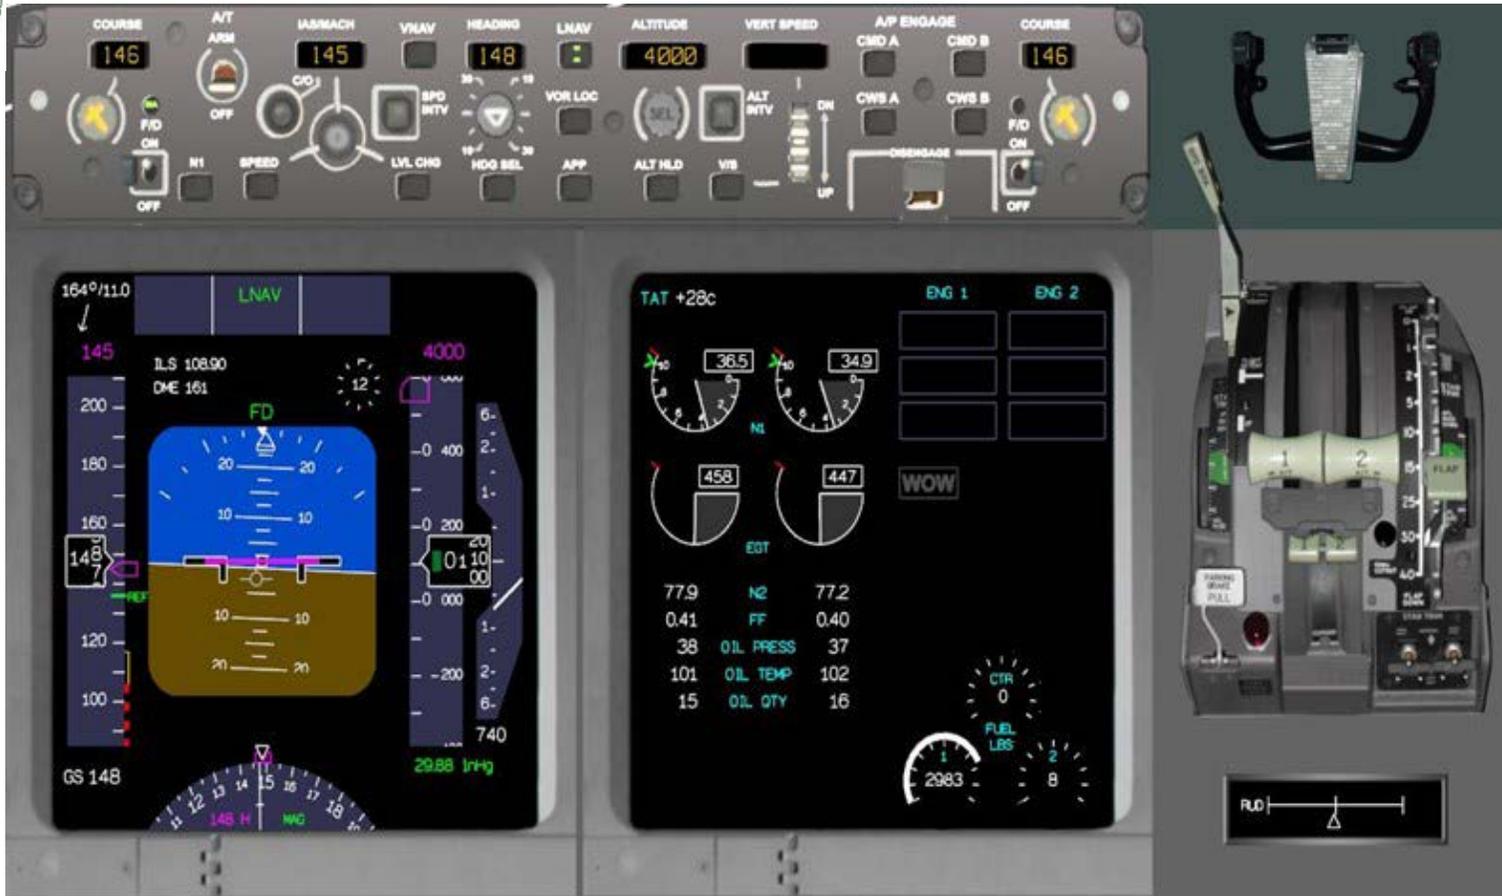
Flight Tracking 100' to touchdown Synchronized with CVR (2/3)

Autopilot: DISCONNECT

Flight Director: NO GUIDANCE

Height: 100 ft AGL descending

Vertical Navigation: REMOVED (terminated at MDA)

Lateral Navigation: Engaged with NO DISPLAY

Configuration Assessment and/or Note: HAND FLYING; Speed and Sink Rate are at target; Taxiway Alpha obstruction blocks within visible range.

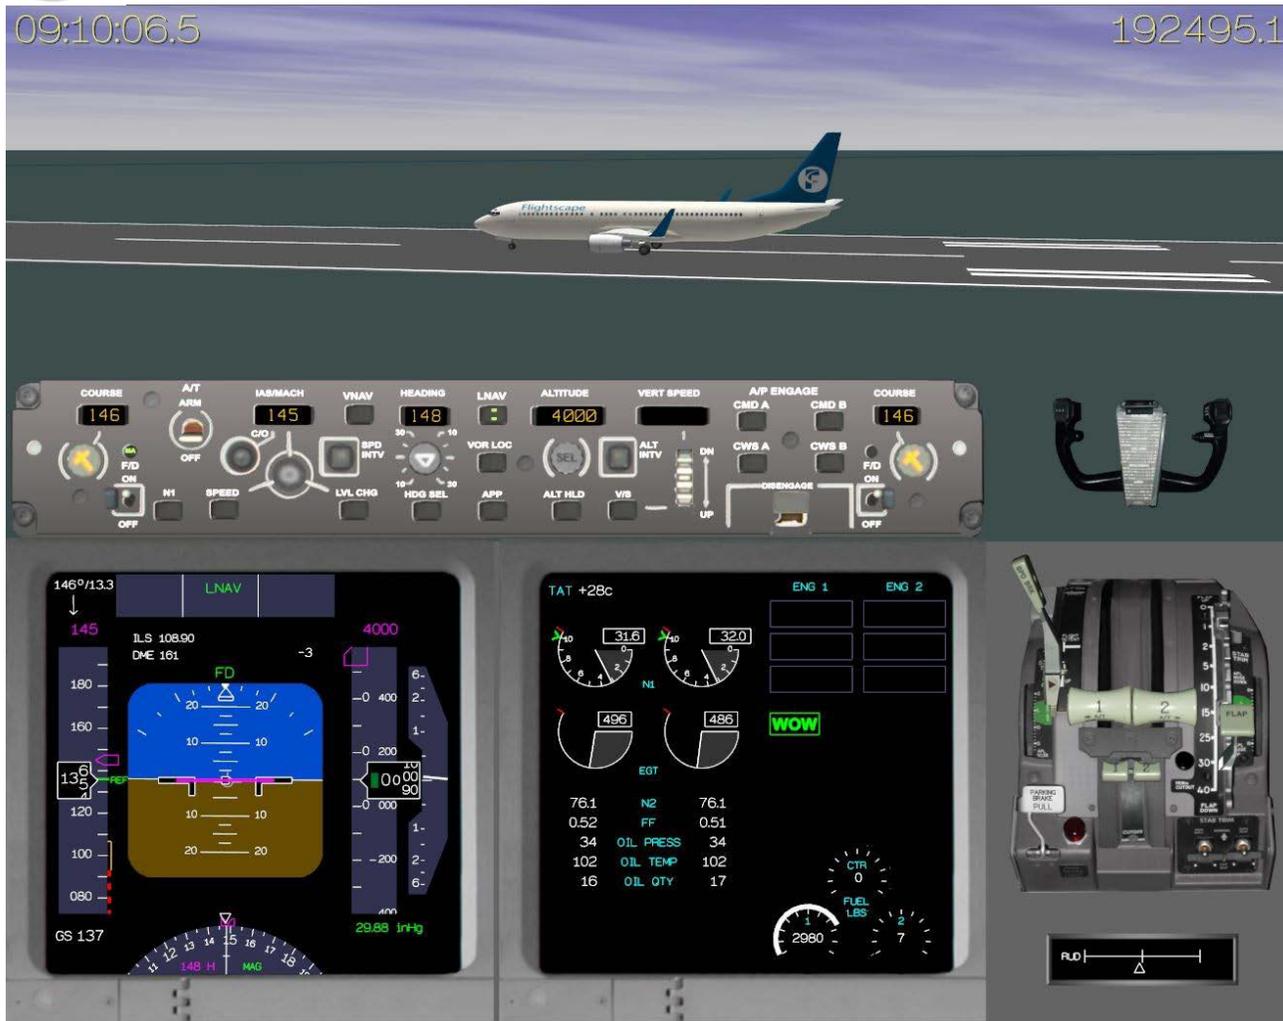
Flight Tracking Flare & Rollout Synchronized with CVR (3/3)

Pilot Monitoring: Called for GO AROUND

Pilot Flying: Did not execute GO AROUND

Landing Roll: Speed Brake fully extended and Manual Braking

Configuration Assessment and/or Note : PIC applied manual and positive brake application with No “BRAKE OVHT” condition

Continued roll to end of Taxiway Alpha followed by a 180° turn maneuver to a full stop in the closed apron (APN-1) and engine shutdown
