RUNWAY SAFETY TEAMS

Airport Experiences

AIRPORTS COMPANY
SOUTH AFRICA

November 2017

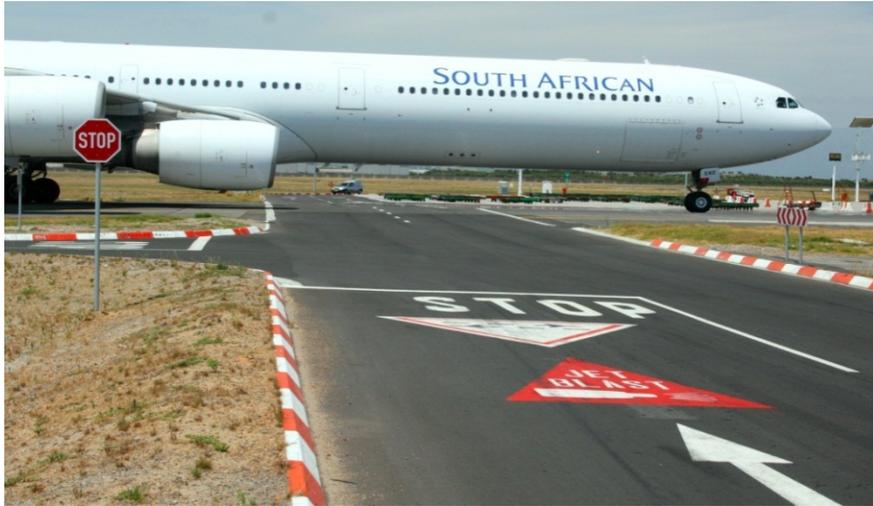
Clearly marked and signed uncontrolled vehicle crossing points, as per ACI recommendations, now at all locations on all service roads and perimeter tracks

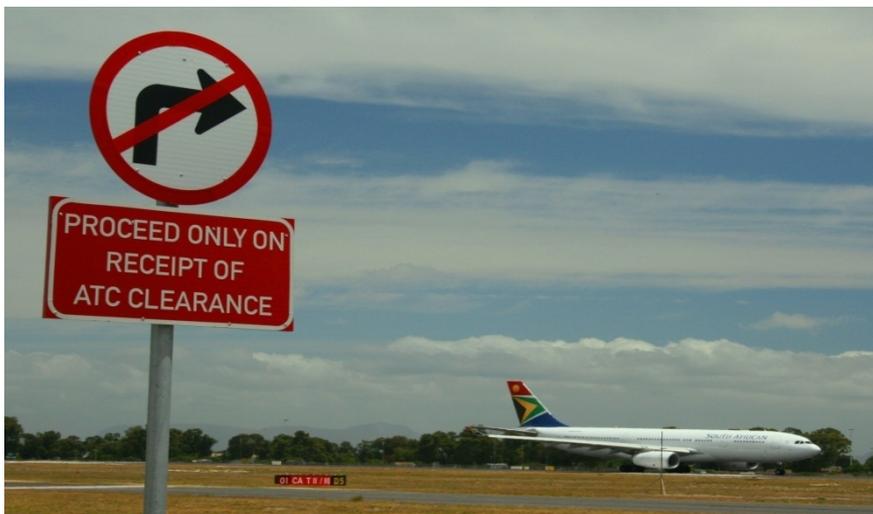
Clearly signed vehicle roadway entrances that lead to taxiways and which give clear instructions to seek ATC clearance before the vehicle can proceed onto the taxiway

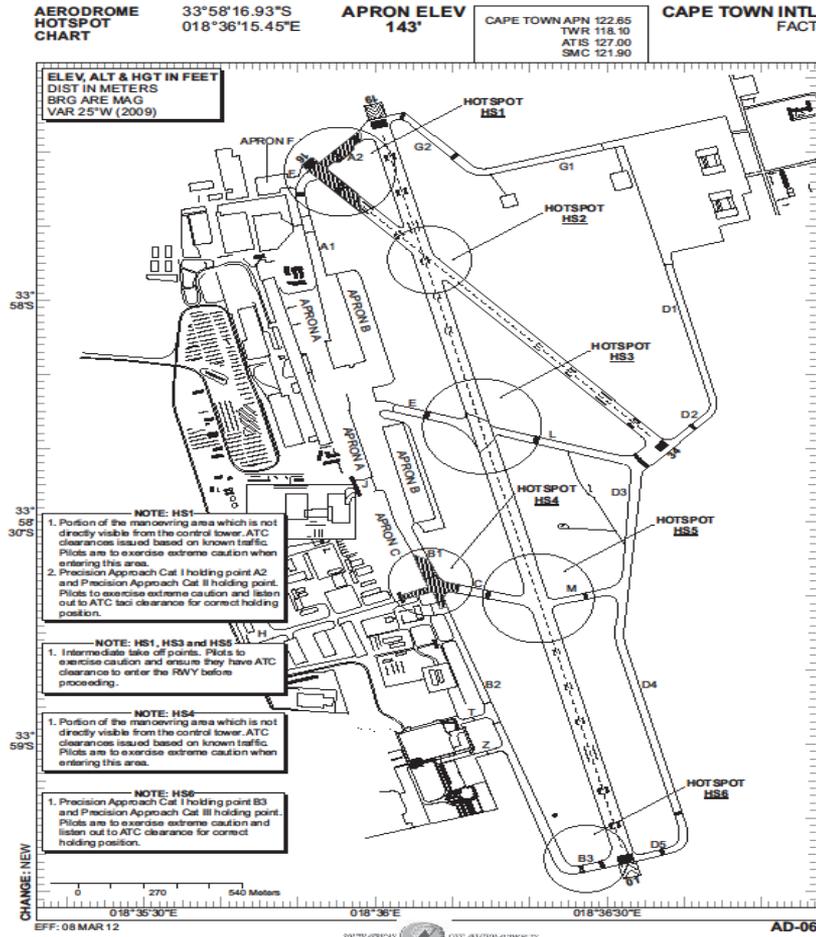
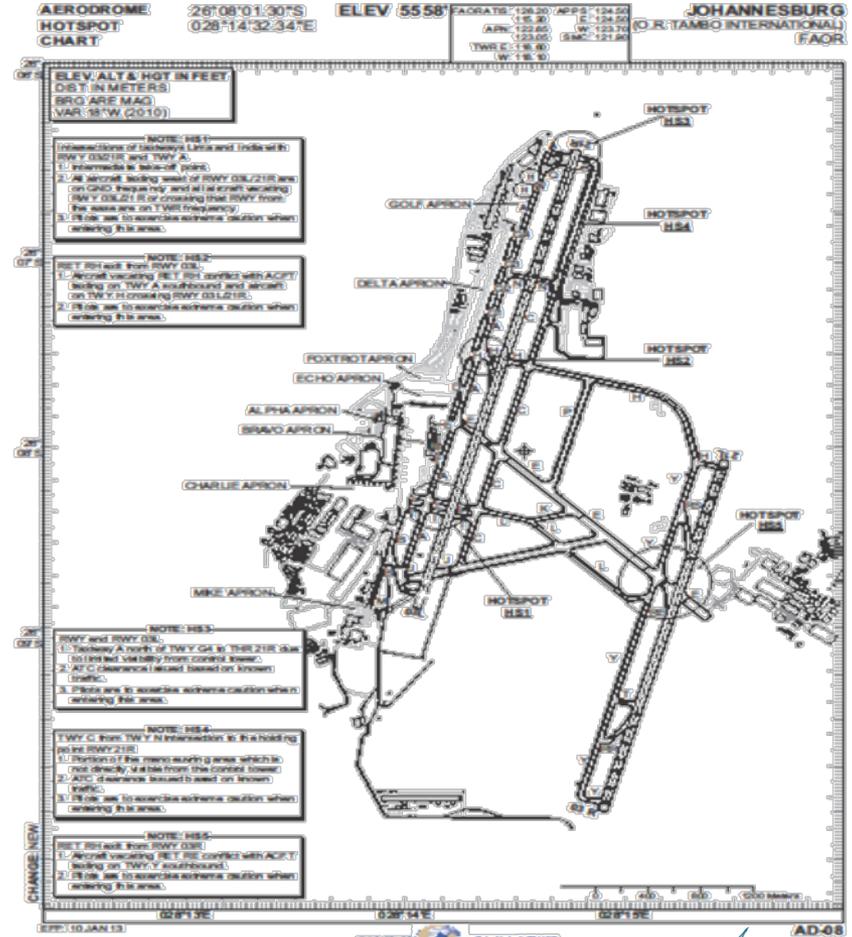
LOCAL RUNWAY SAFETY TEAMS HOTSPOT CHARTS

Due to LRST

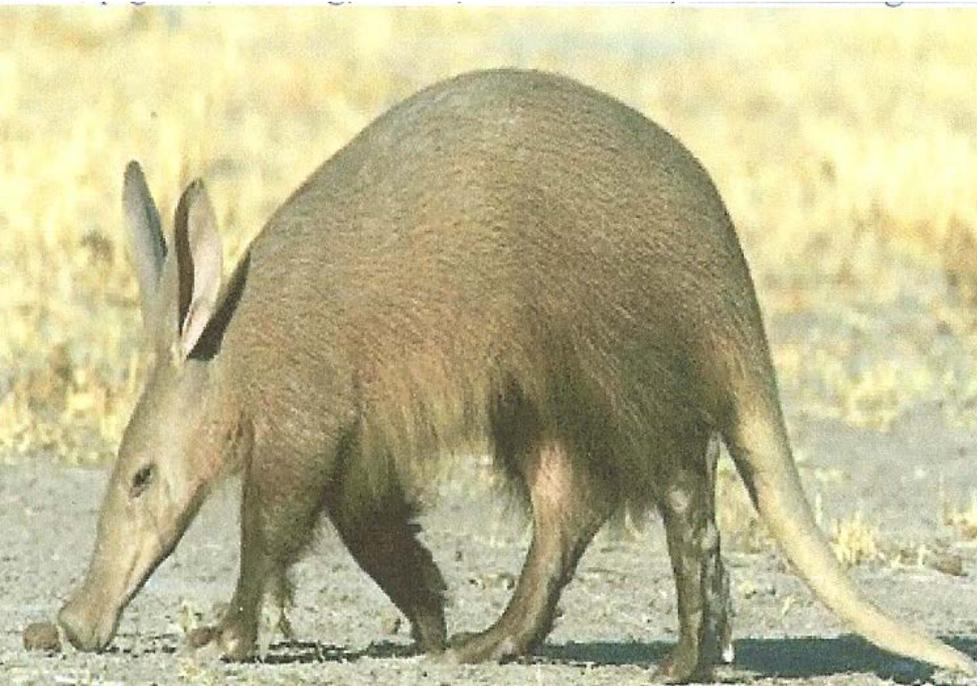
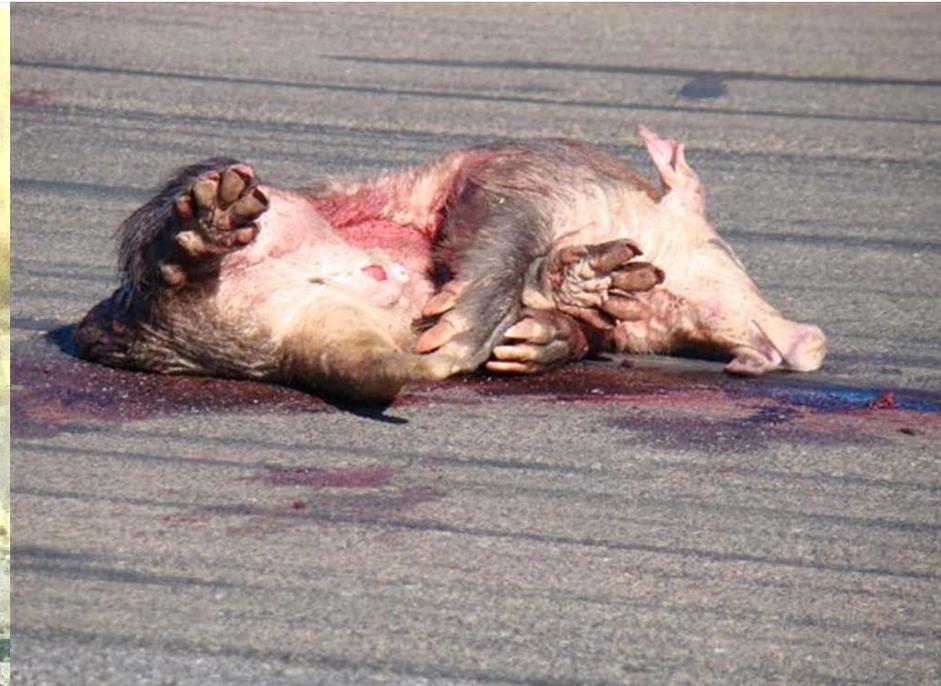
Kimberley Airport (KIM) is located in an arid semi-desert region of South Africa. A local mammal species of nocturnal Anteater, known as an Aardvark (Earth Pig), burrowing under the airport perimeter fence.

Aardvark Ant Eater –Protected Species

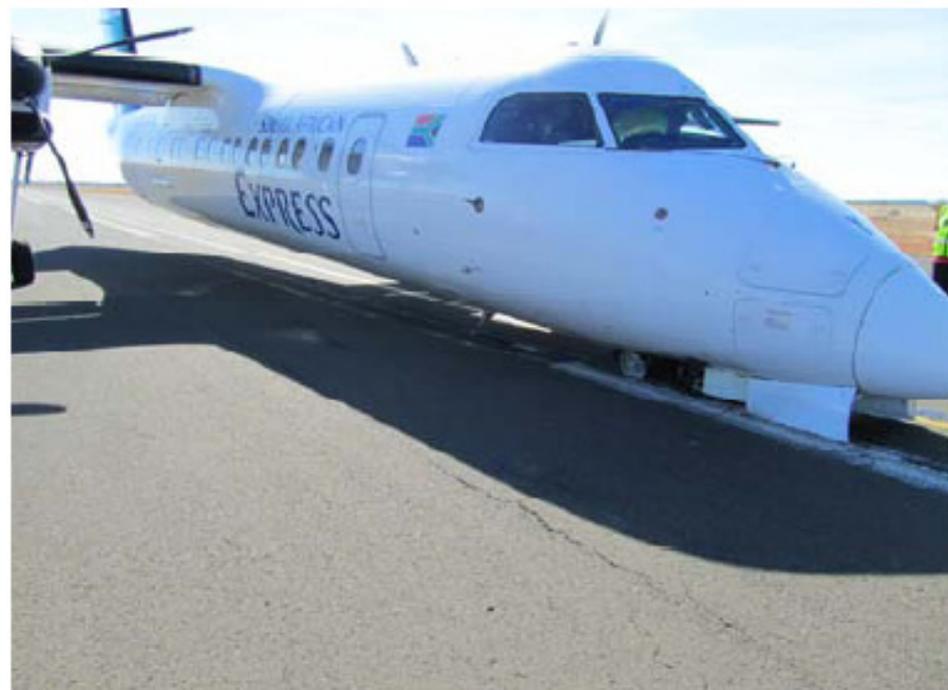
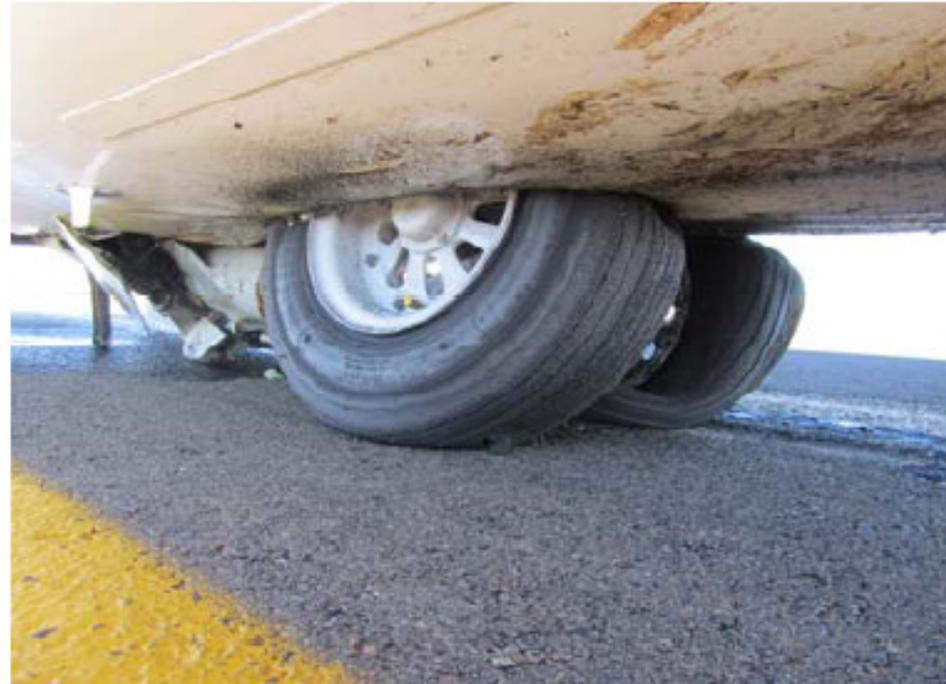
On 16th July 2010, a South African Express Airways, De Havilland Canada DH8-300 operating a scheduled flight, soon after touchdown the aircraft struck an Aardvark on the runway.

Similar incident occurred a week later but with minor damage to aircraft rotor blade

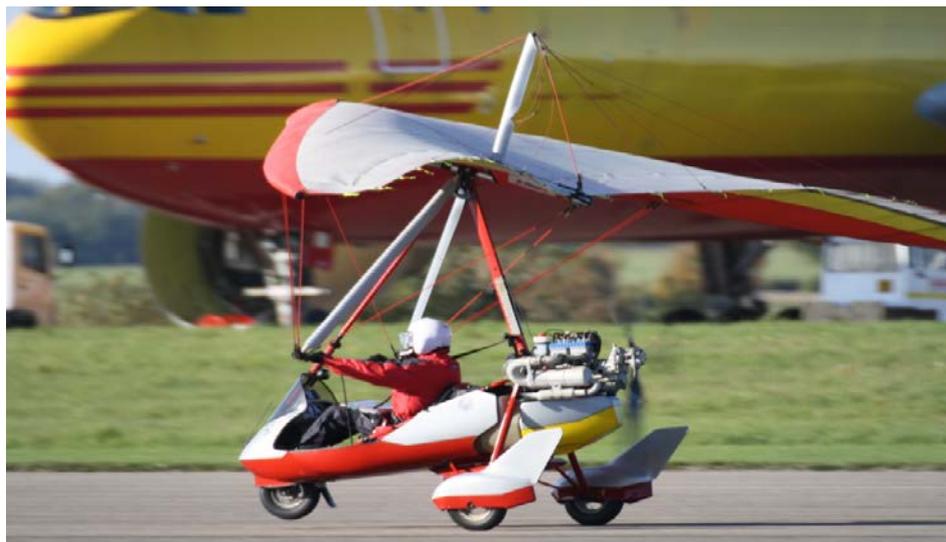
Microlight sharing the airport with normal IFR traffic

Between 22nd April and 28th June 2013, i.e. a two month period, UTN experienced 12 Runway Excursions, all of ICAO Severity Classification C or D. Of these 12 excursions, 10 of them were committed by Microlight and Light Sport aircraft.

A complicated 3 Runway layout and Microlight Pilots who are unfamiliar with operating within an ATC controlled airport and controlled airspace were the main transgressors. Improved Markings and Signage resulted in no further incursions.

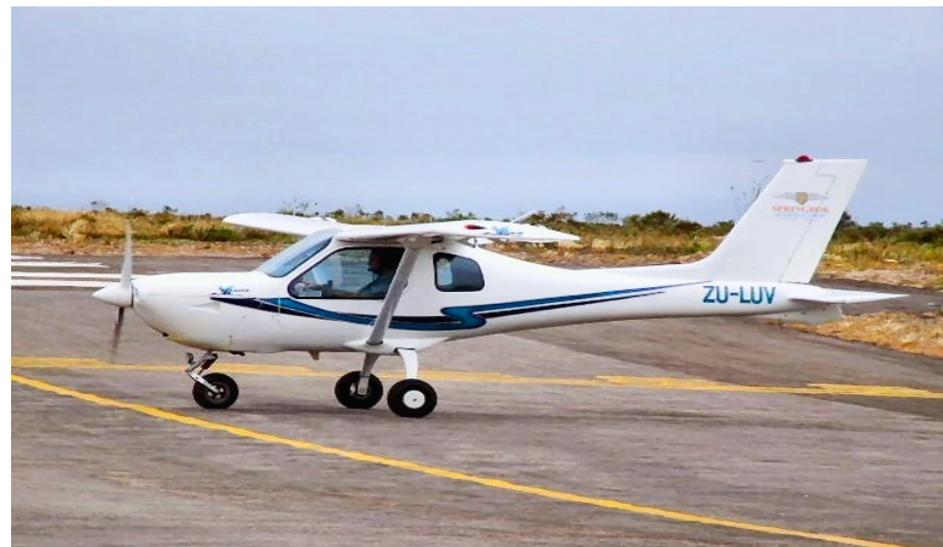
Jabiru Light Sports aircraft using UTN

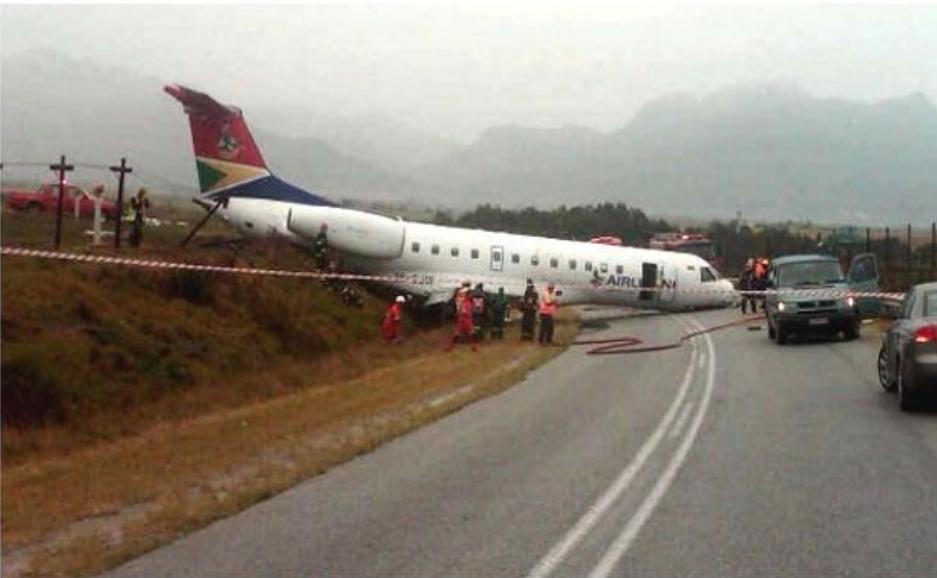
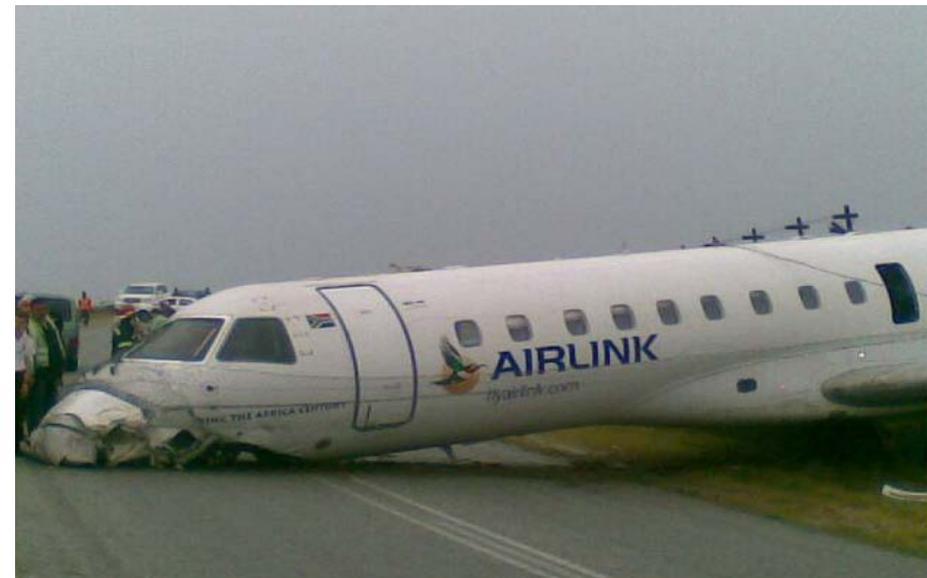
George Airport

On 7th December 2009, an Embraer 135, made a landing in wet conditions. The aircraft failed to stop within the runway distance, and left the runway before the RESA and broke through the perimeter fence before coming to a halt on a road. There were no serious injuries to anyone on-board. No mention of LRST in accident report.

Major debate around use of fog spray, friction testing and RESA's

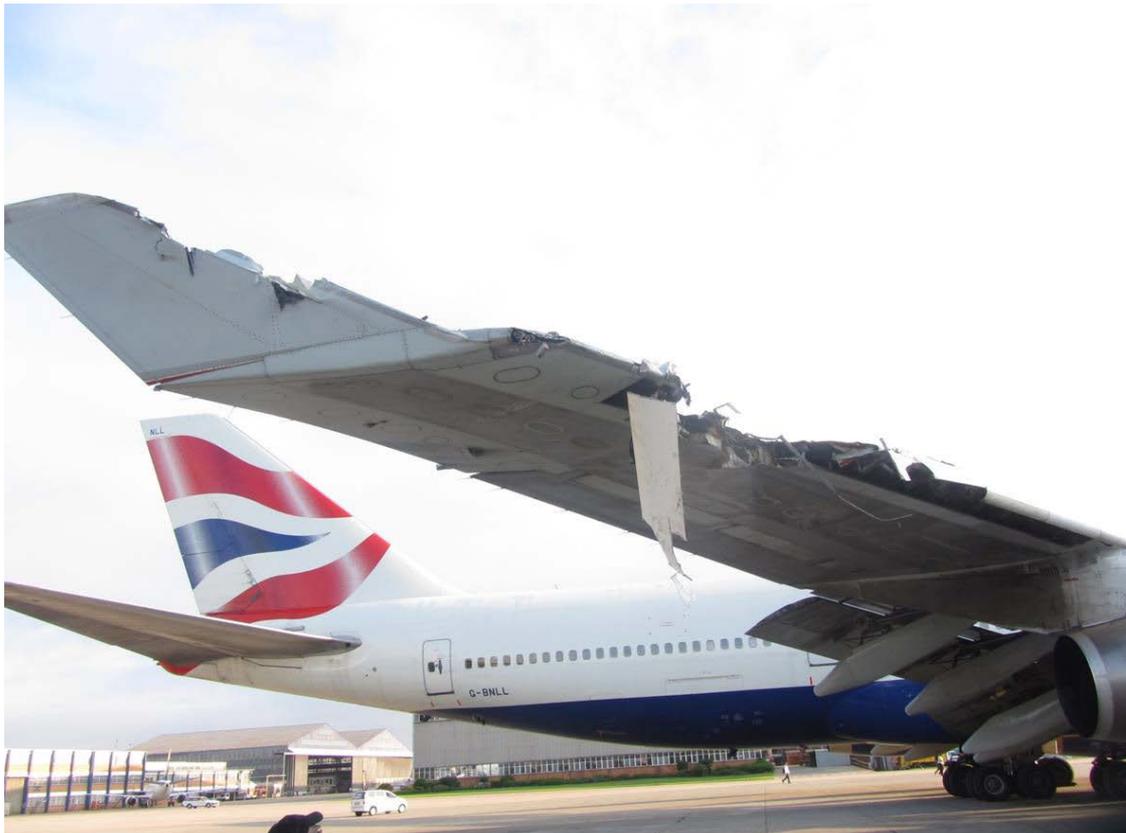
THE AIRCRAFT ROUTE

- Accident BA034 G-NLL, B747-400, 22 December 2013, O R Tambo International Airport (FAOR) – Republic of South Africa Operated British Airways

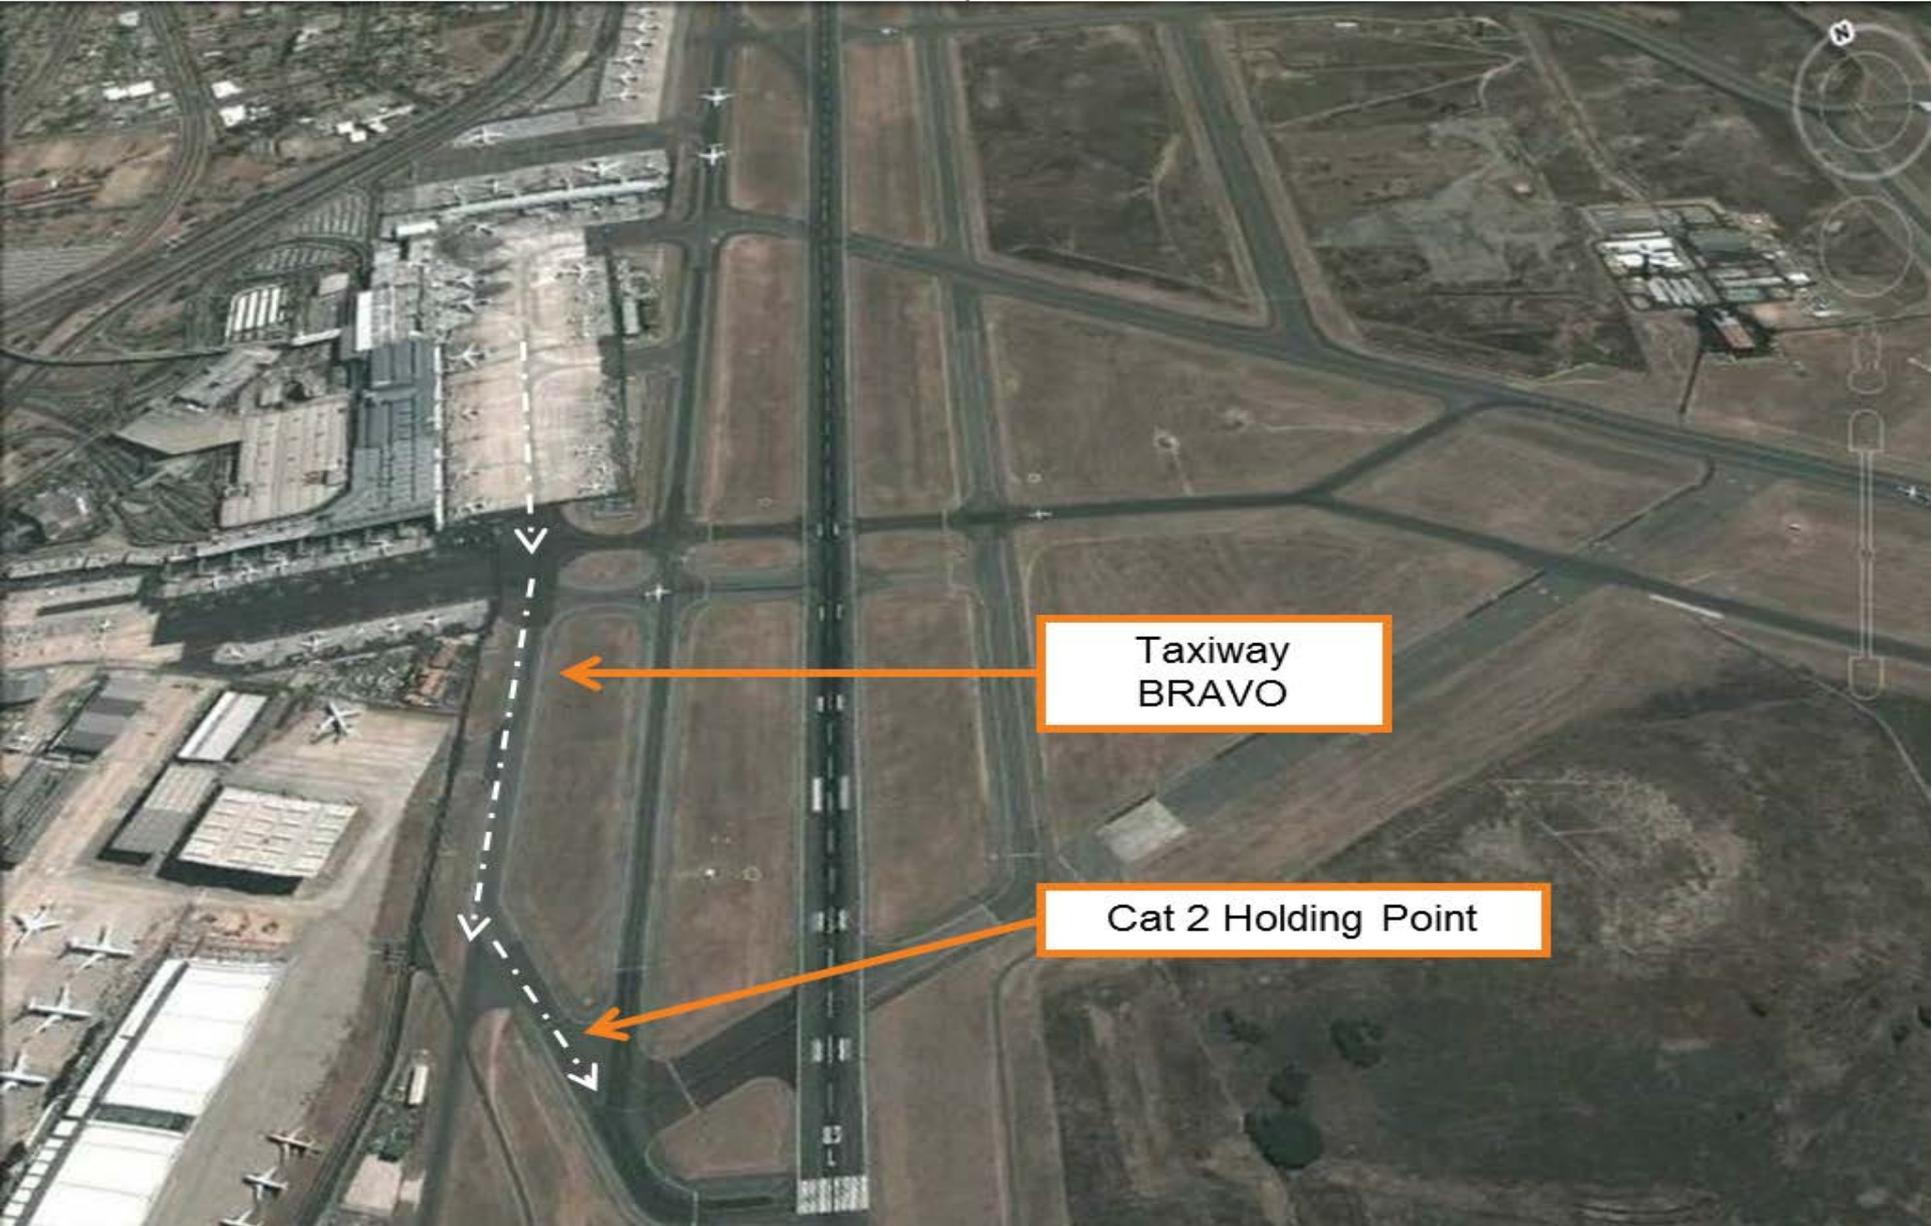
Taxiway
BRAVO

Cat 2 Holding Point

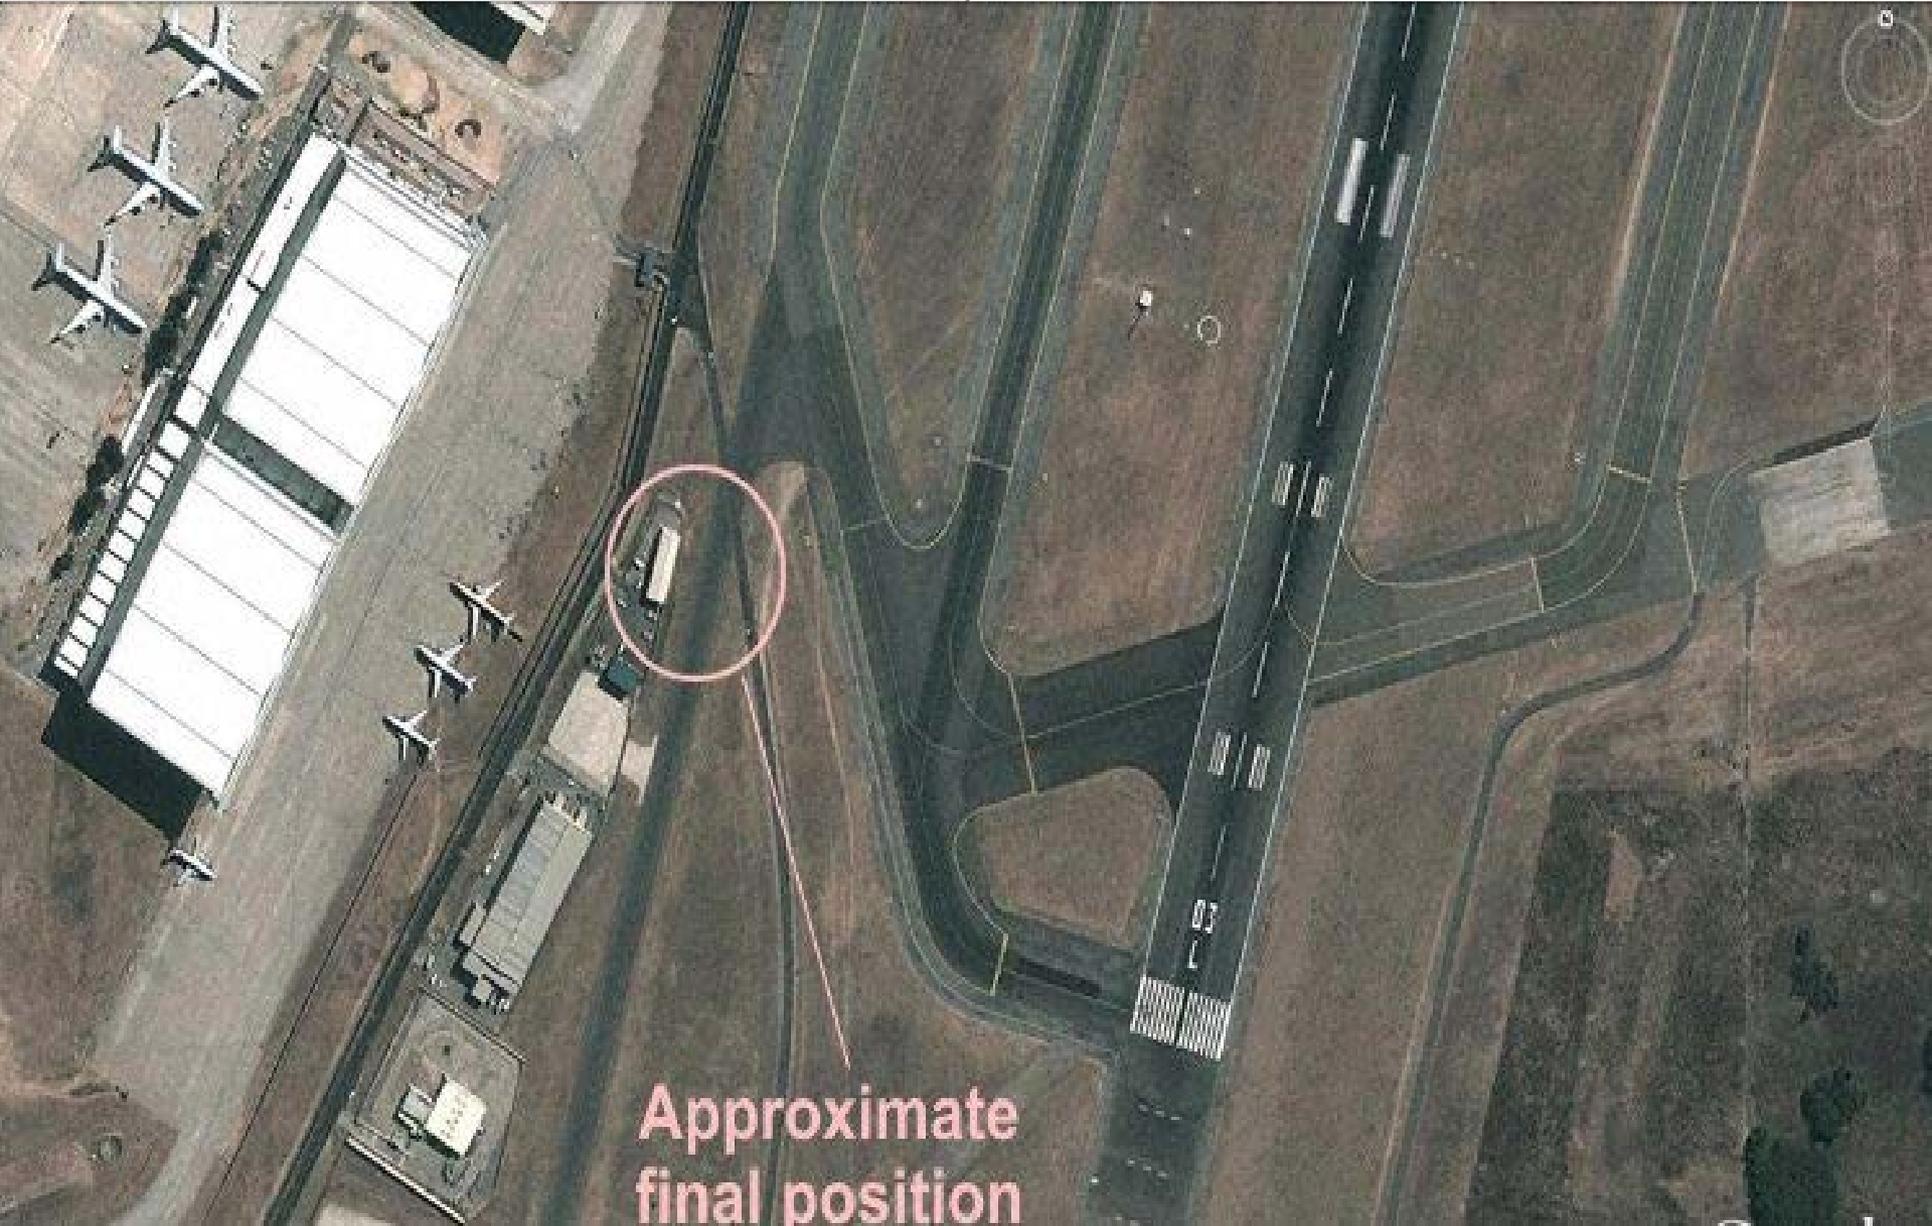
INCORRECT TAXIWAY

Approximate
final position
