Airport Technology R&D Team

Engineered Material Arresting Systems

X ALACPA Seminar and VIII FAA
Presented to: Workshop, Mexico City

By: David R. Brill, P.E., Ph.D.

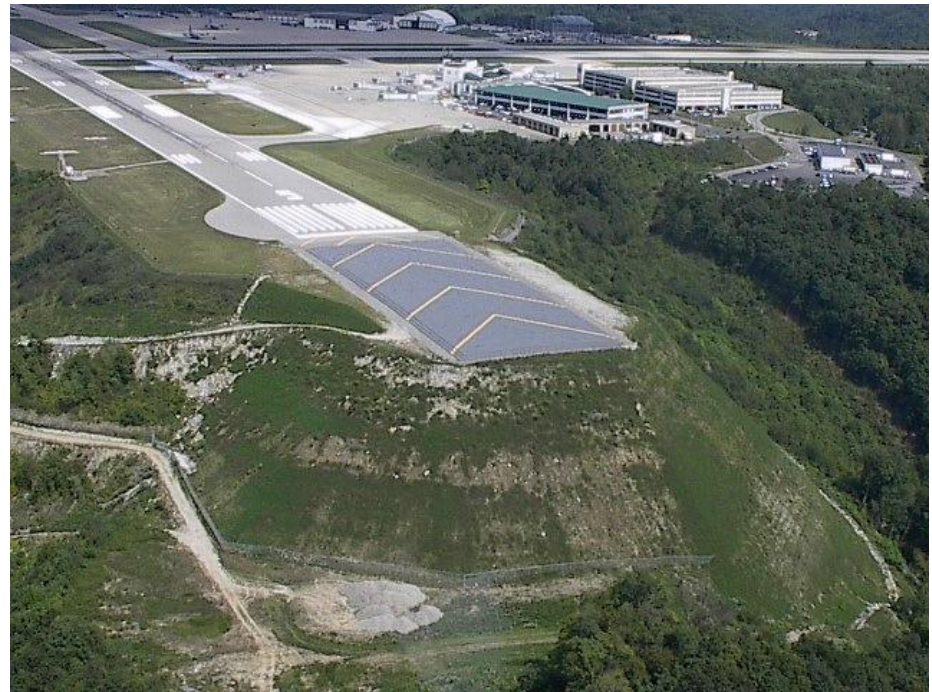
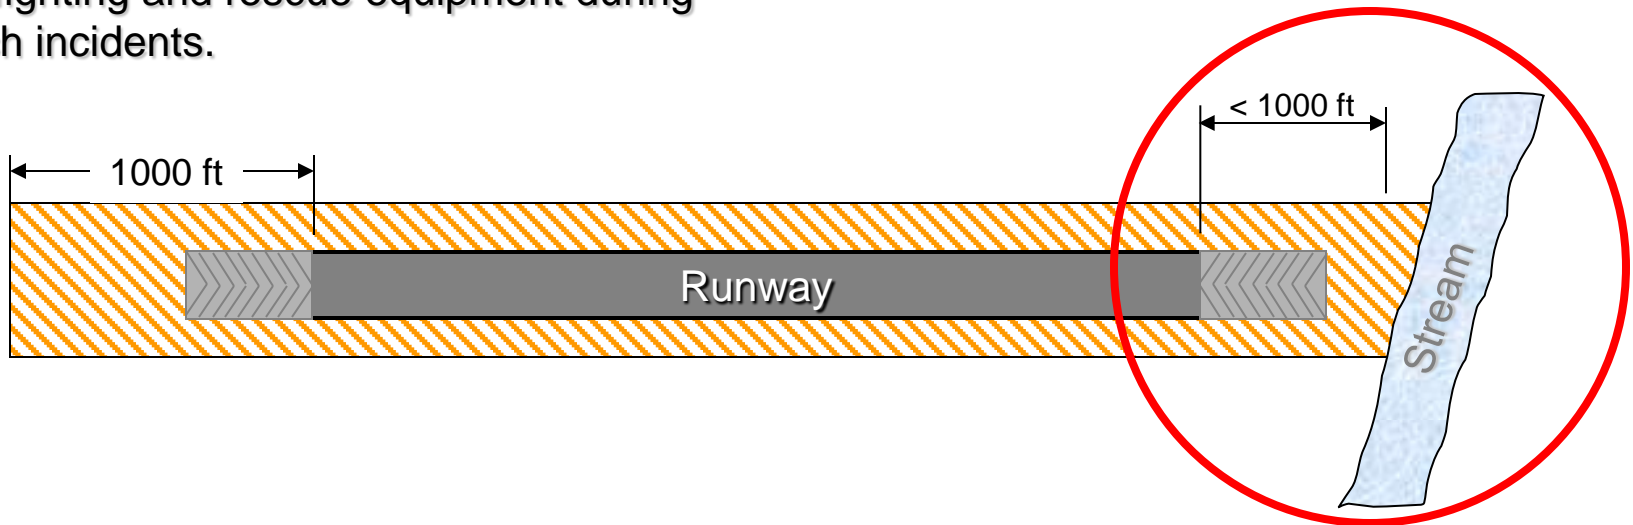
Concept: The Runway Safety Area (RSA) offers an additional level of safety to the airport in the event that an airplane undershoots, or overruns the end of the runway. RSA's are designed to reduce the risk of damage to airplanes and passengers as well as provide greater accessibility for firefighting and rescue equipment during such incidents.

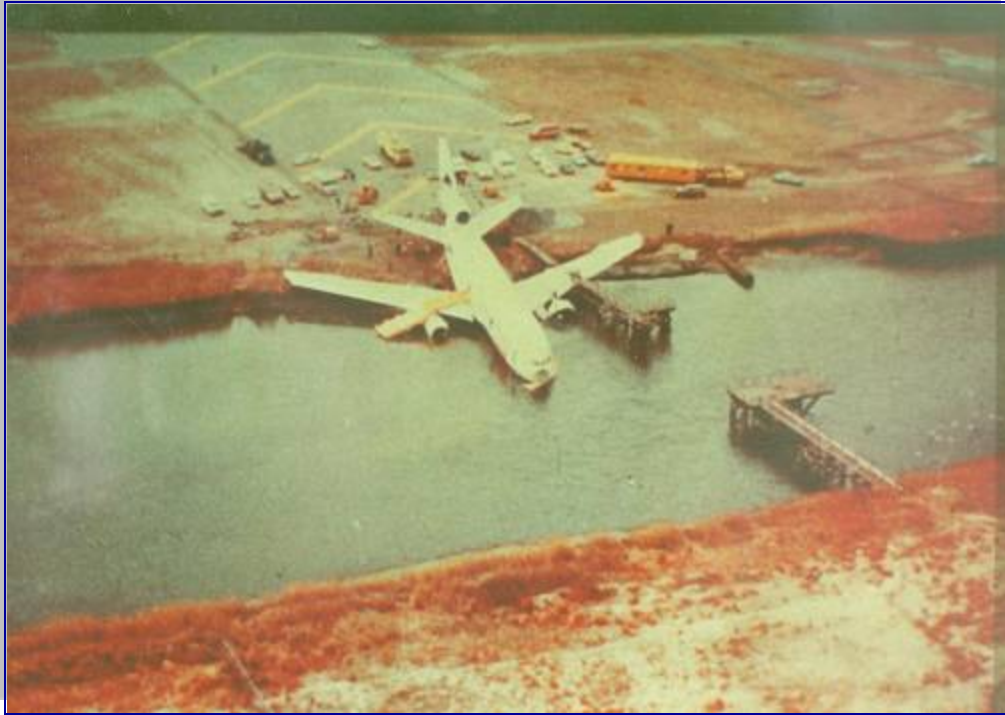
Background

On February 28, 1984, a Scandinavian Airline System DC-10-30 aircraft overran after landing on runway 4R at John F. Kennedy (JFK) International Airport and plunged into Thurston Basin.

National Transportation Safety Board (NTSB) accident report DCA84AA018 indicated that the DC-10 departed the end of the runway at about 75 knots and entered Thurston Basin 600 feet later still moving at about 38 knots.

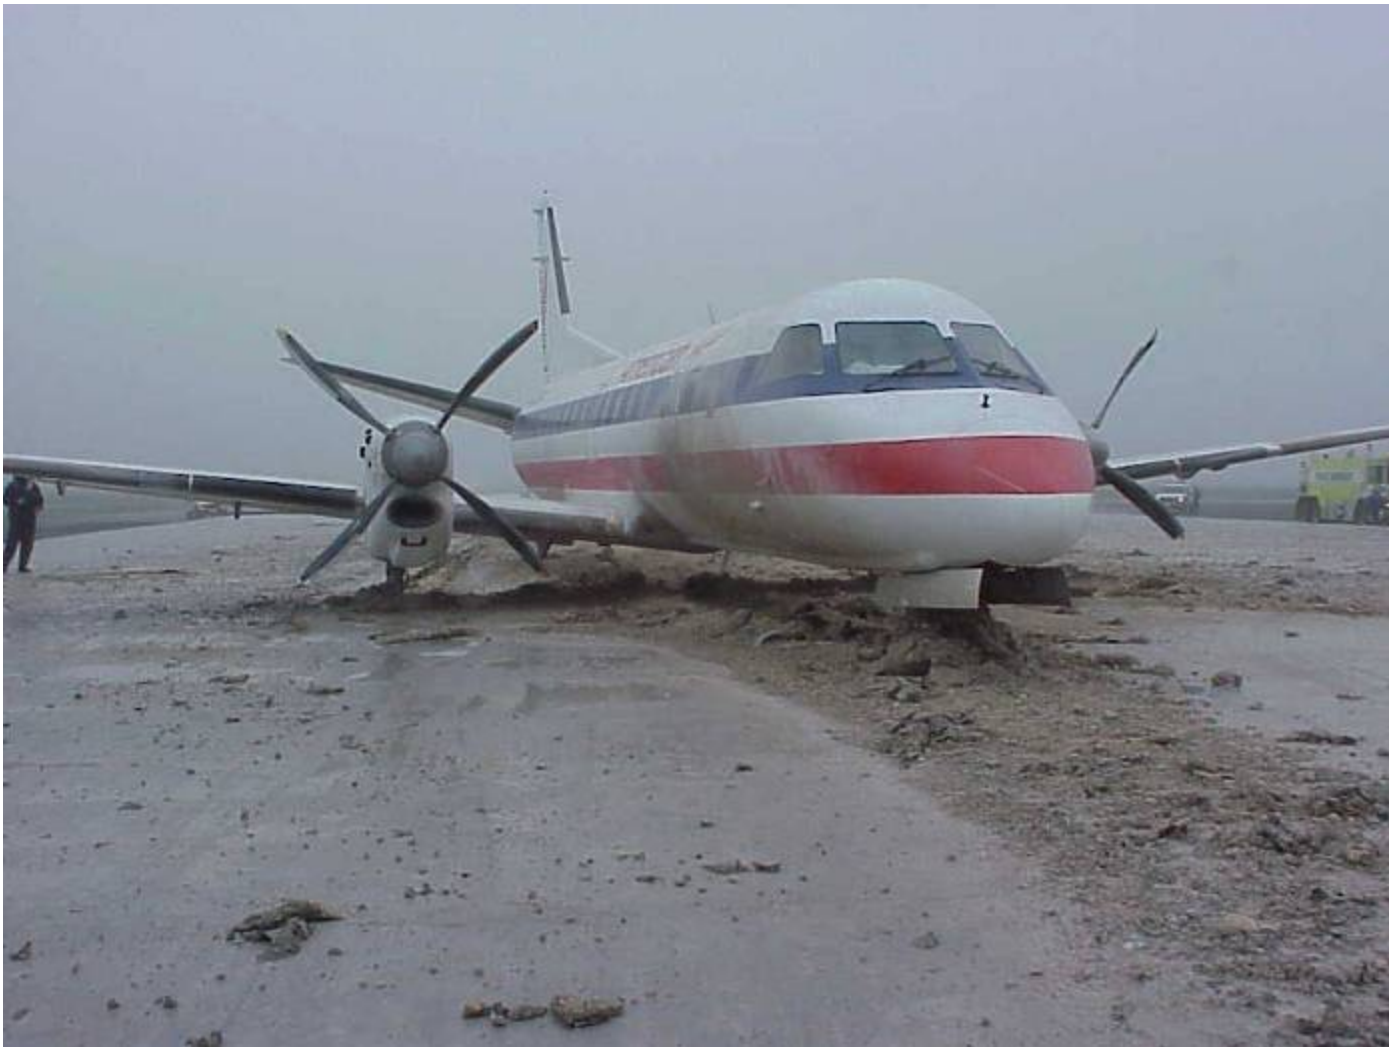
JFK – 1999
Saab 340 Arrested at the end of Runway 4R after overrun.

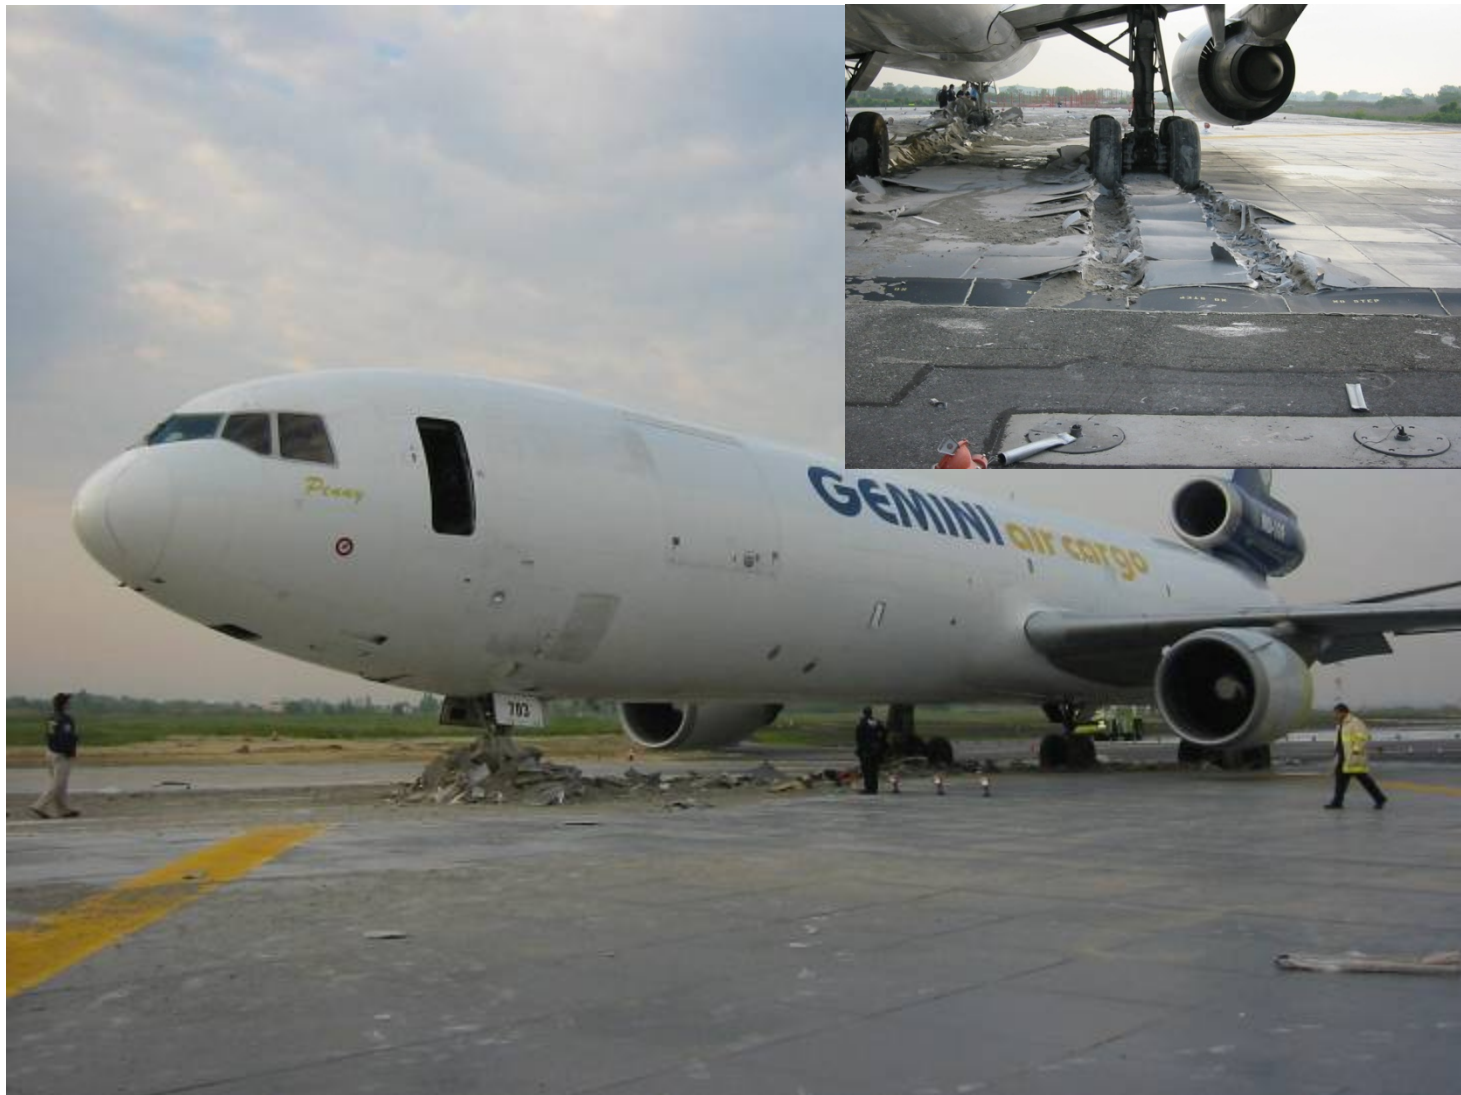
JFK – May 30, 2003

Cargo MD-11 Arrested at the end of Runway 4R after overrun.

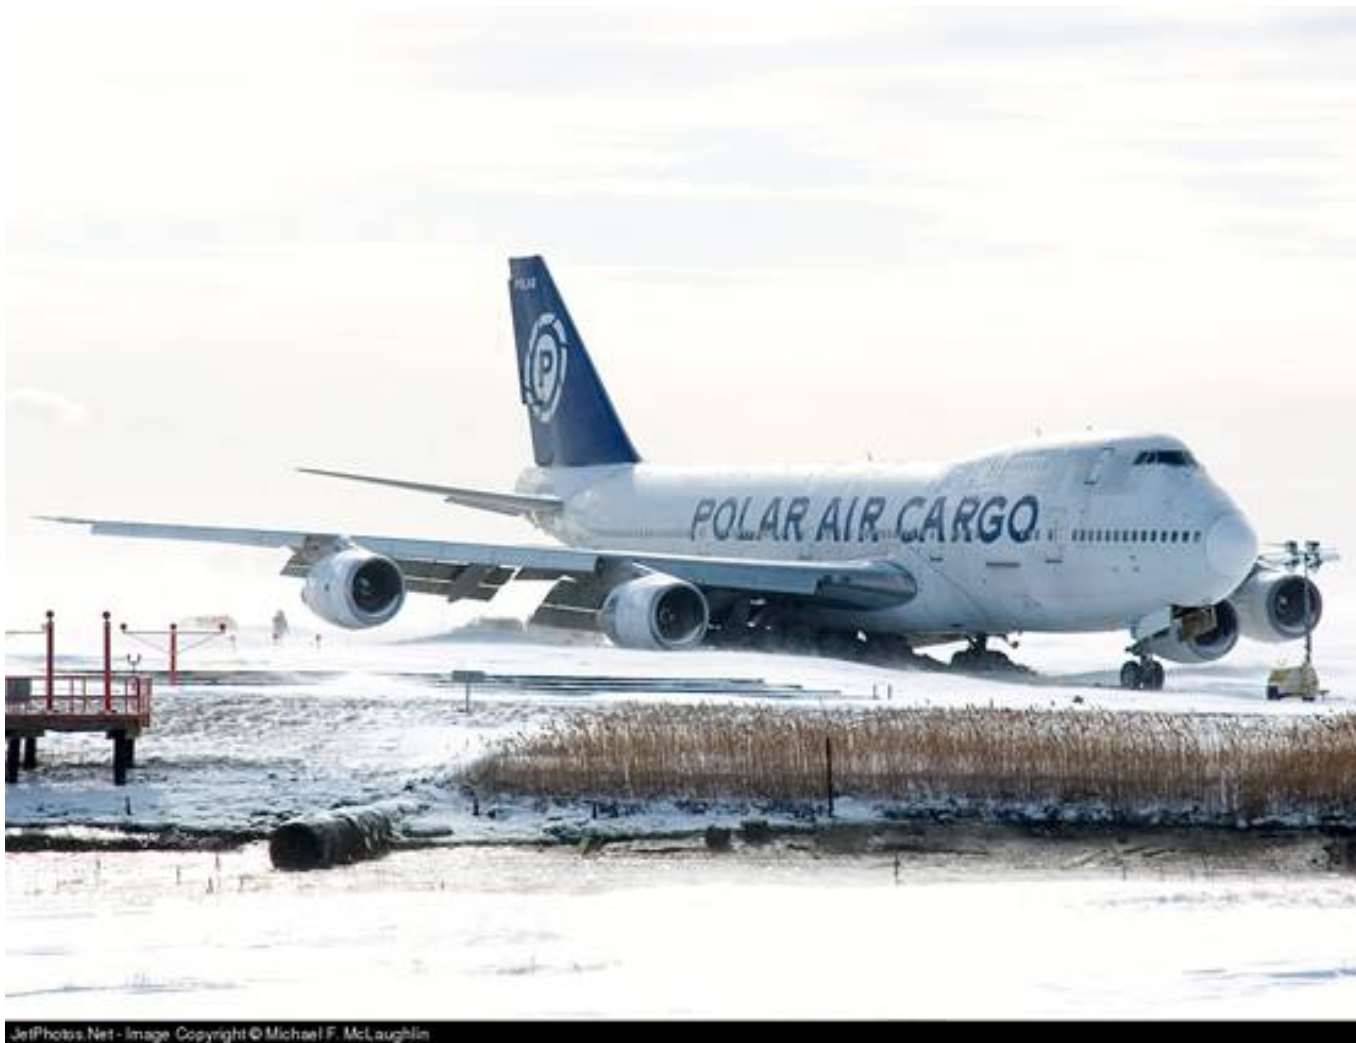
JFK – January 22, 2005

Cargo B-747 Arrested at the end of Runway 4R after overrunning during landing in snow storm

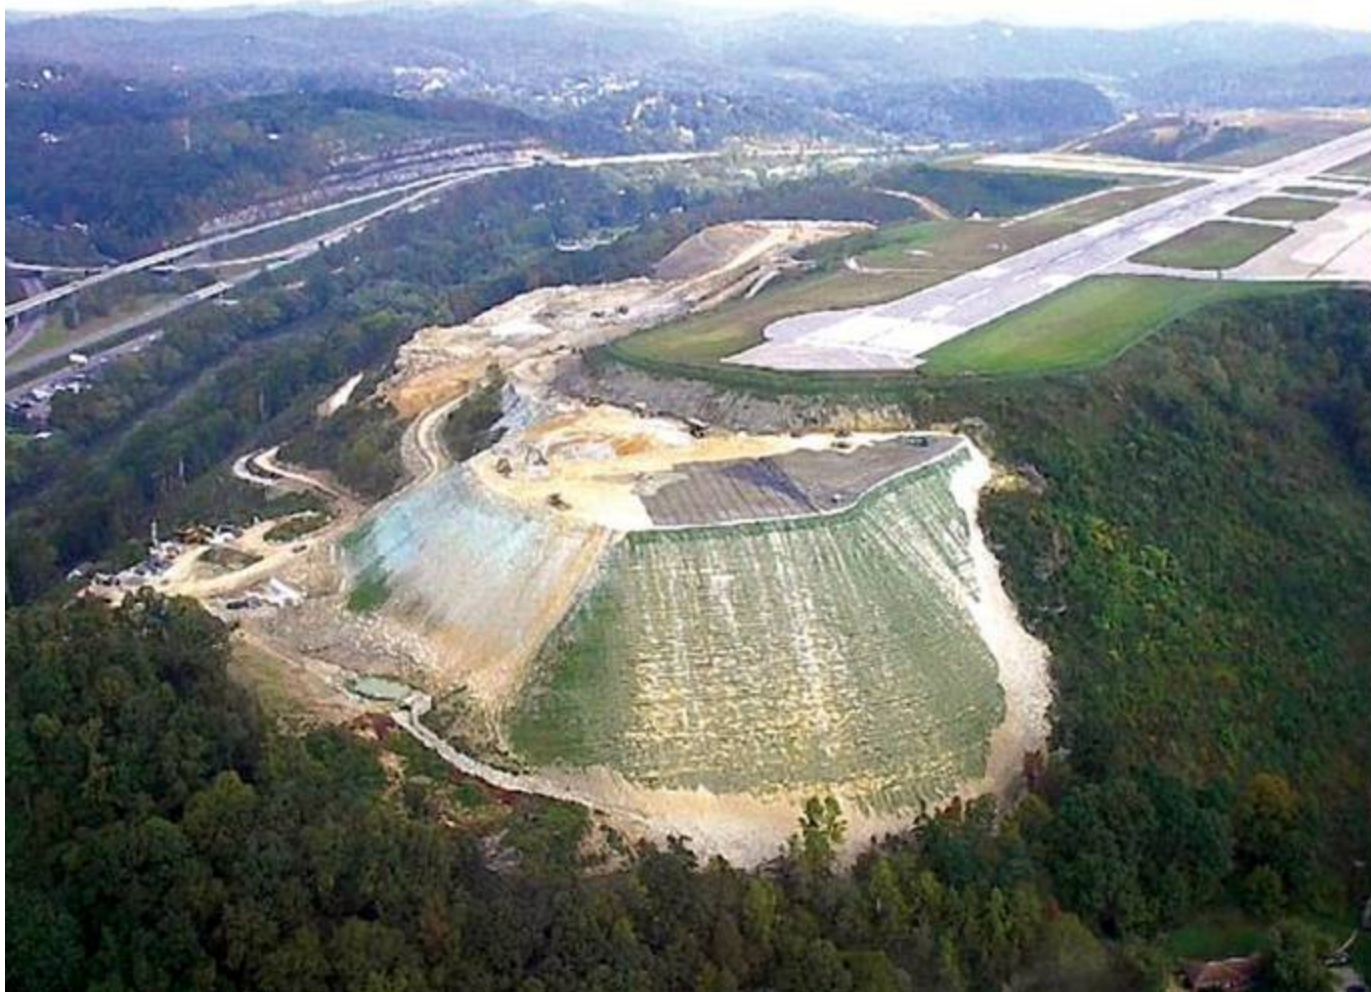
Completed installation

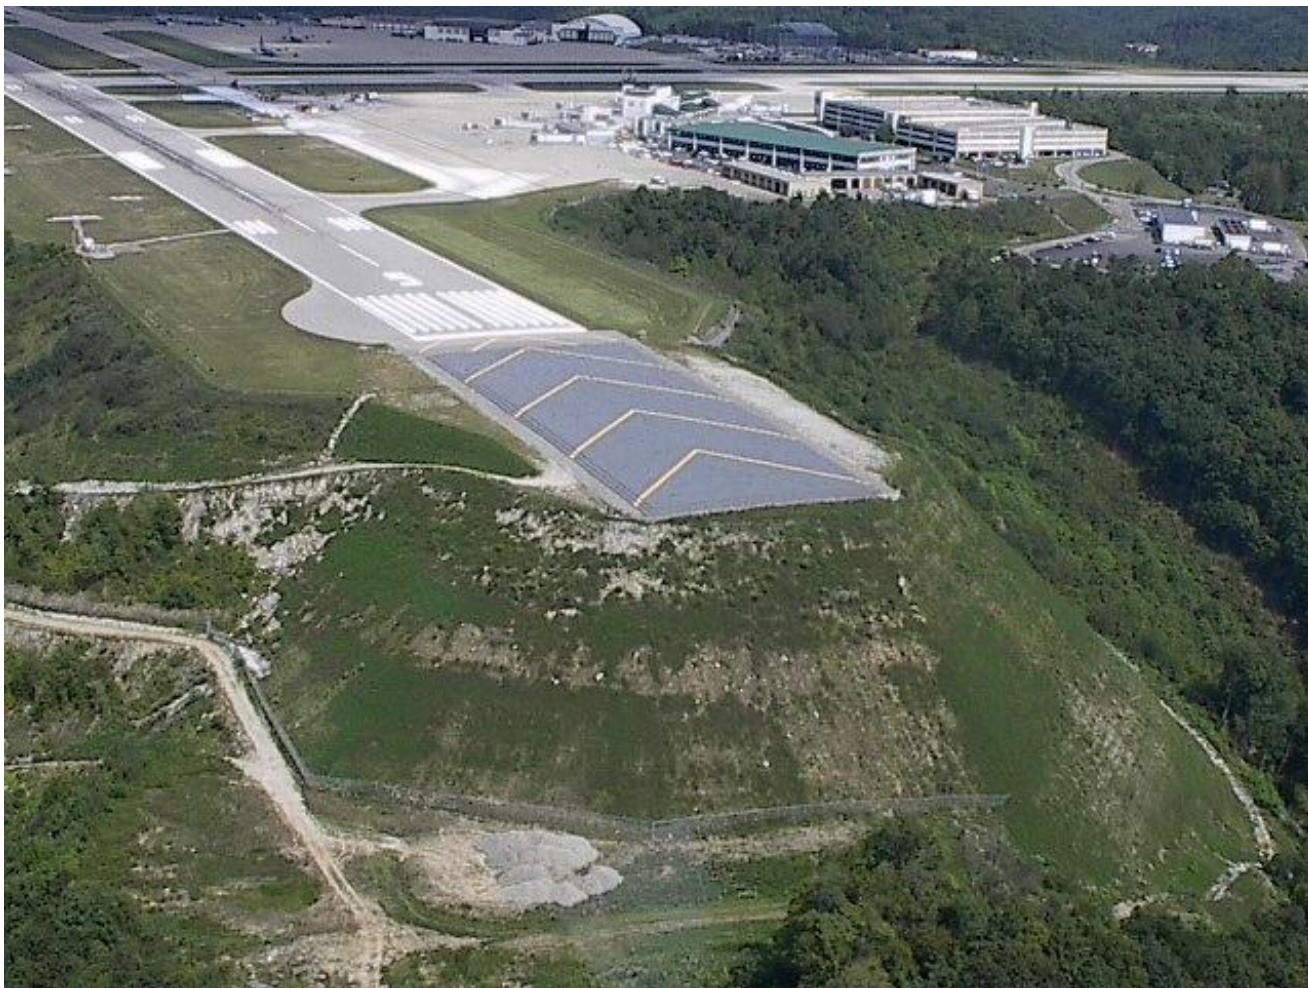
As applied

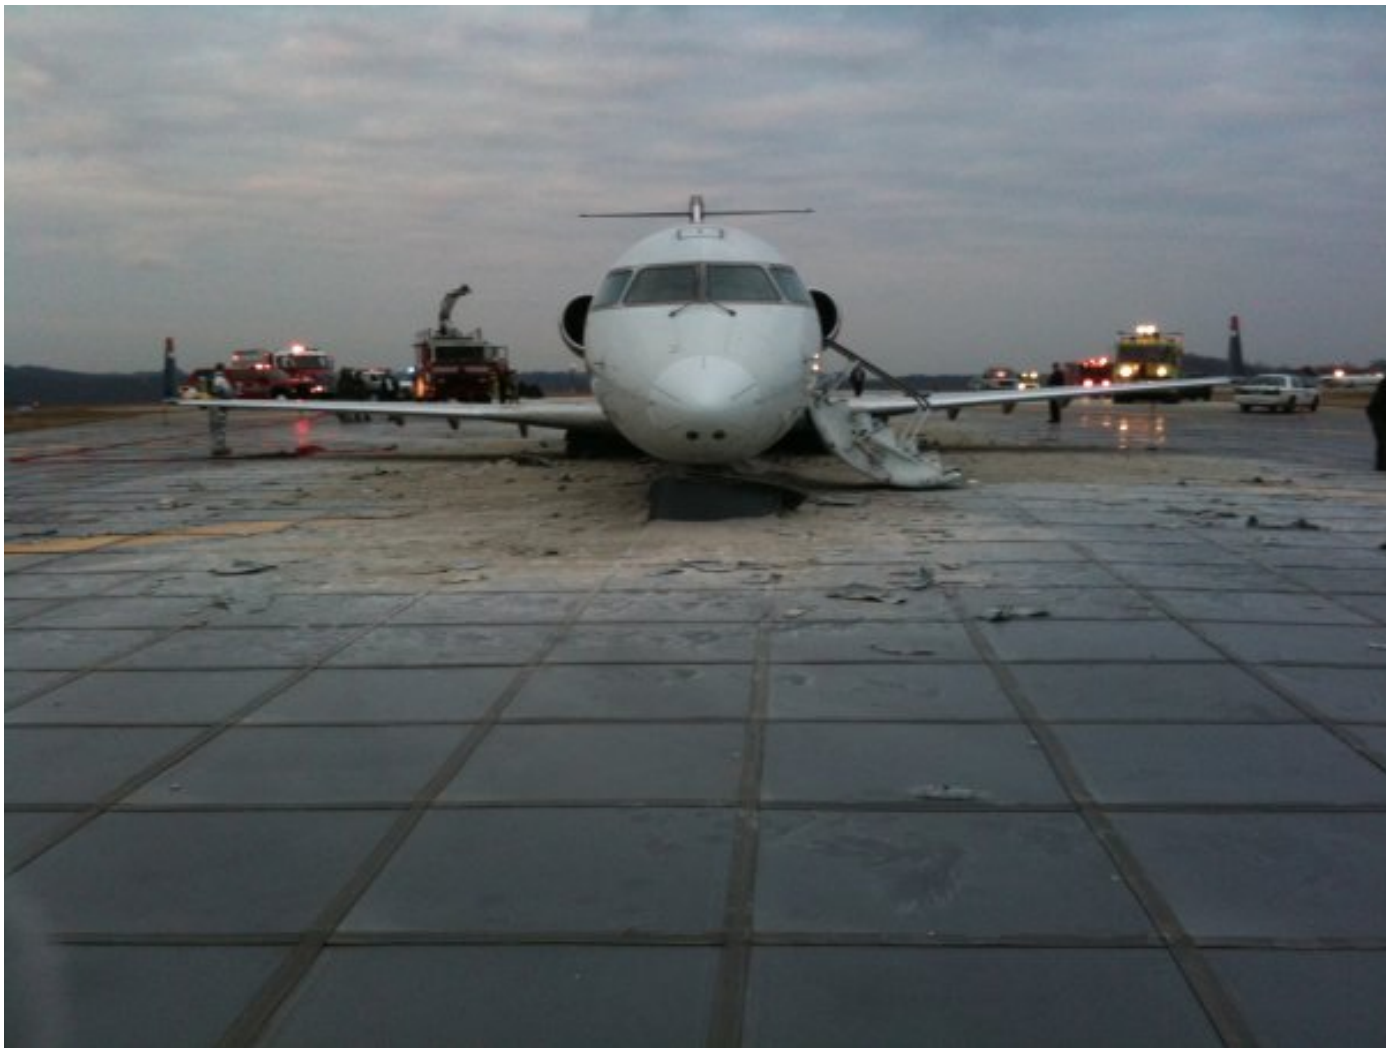
CRW – January 19, 2010
**PSA Airlines CRJ-200 arrested at the end of runway at Yeager Airport,
Charleston, WV**

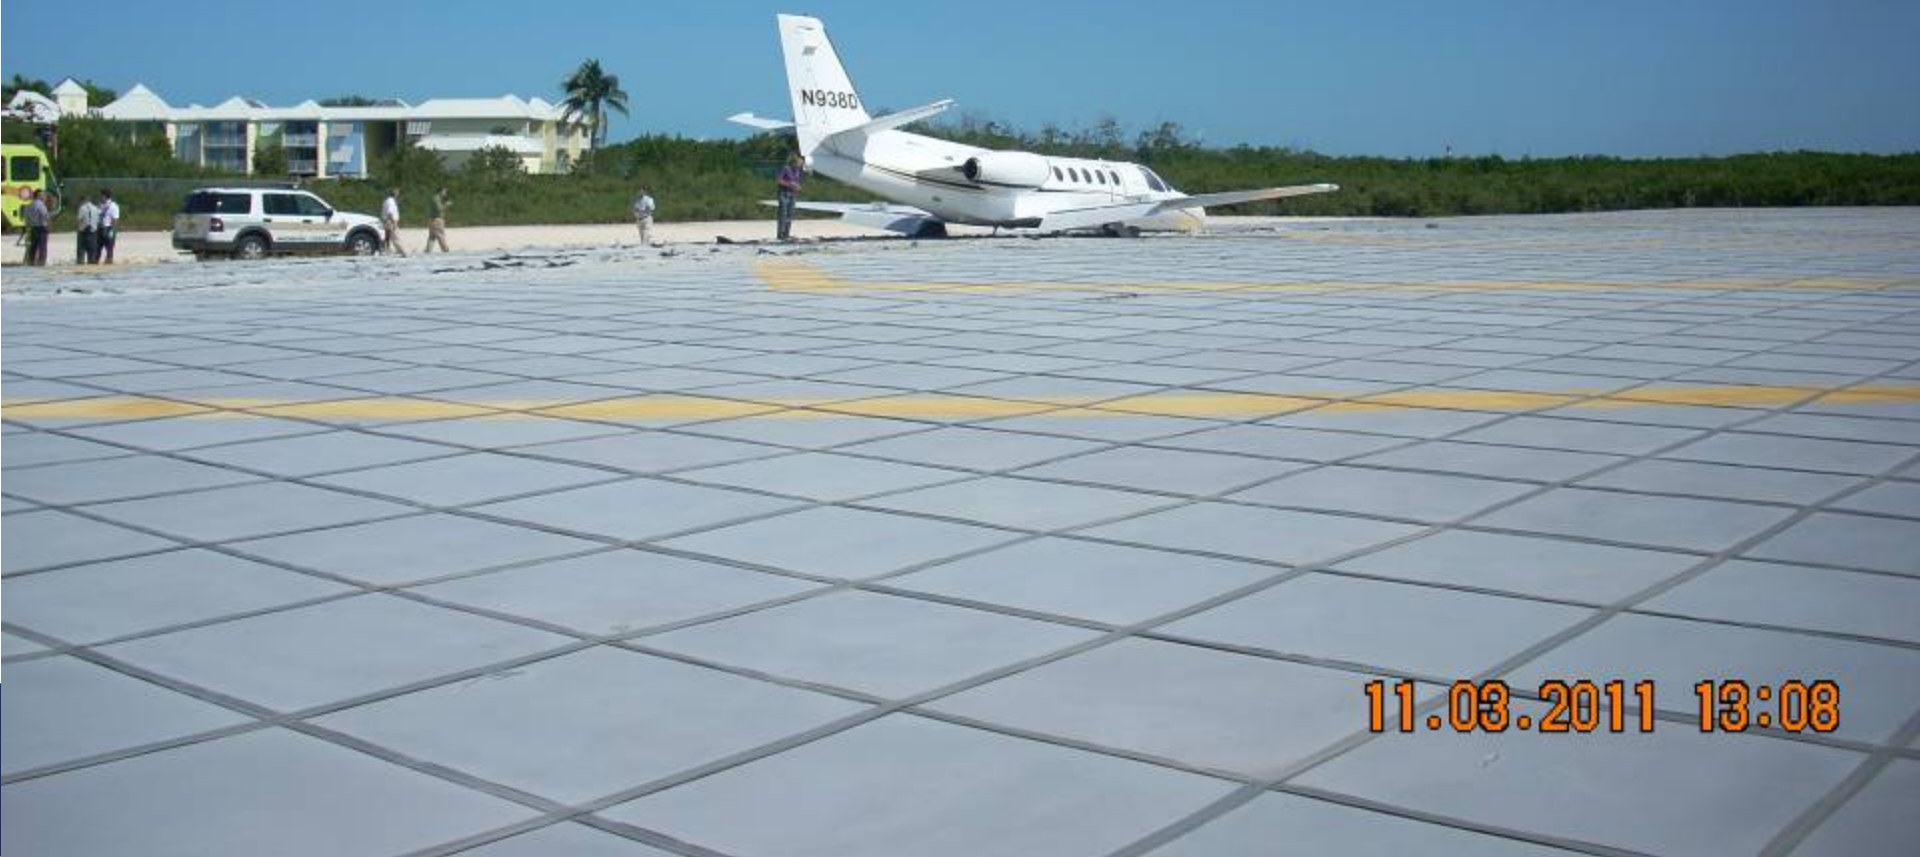
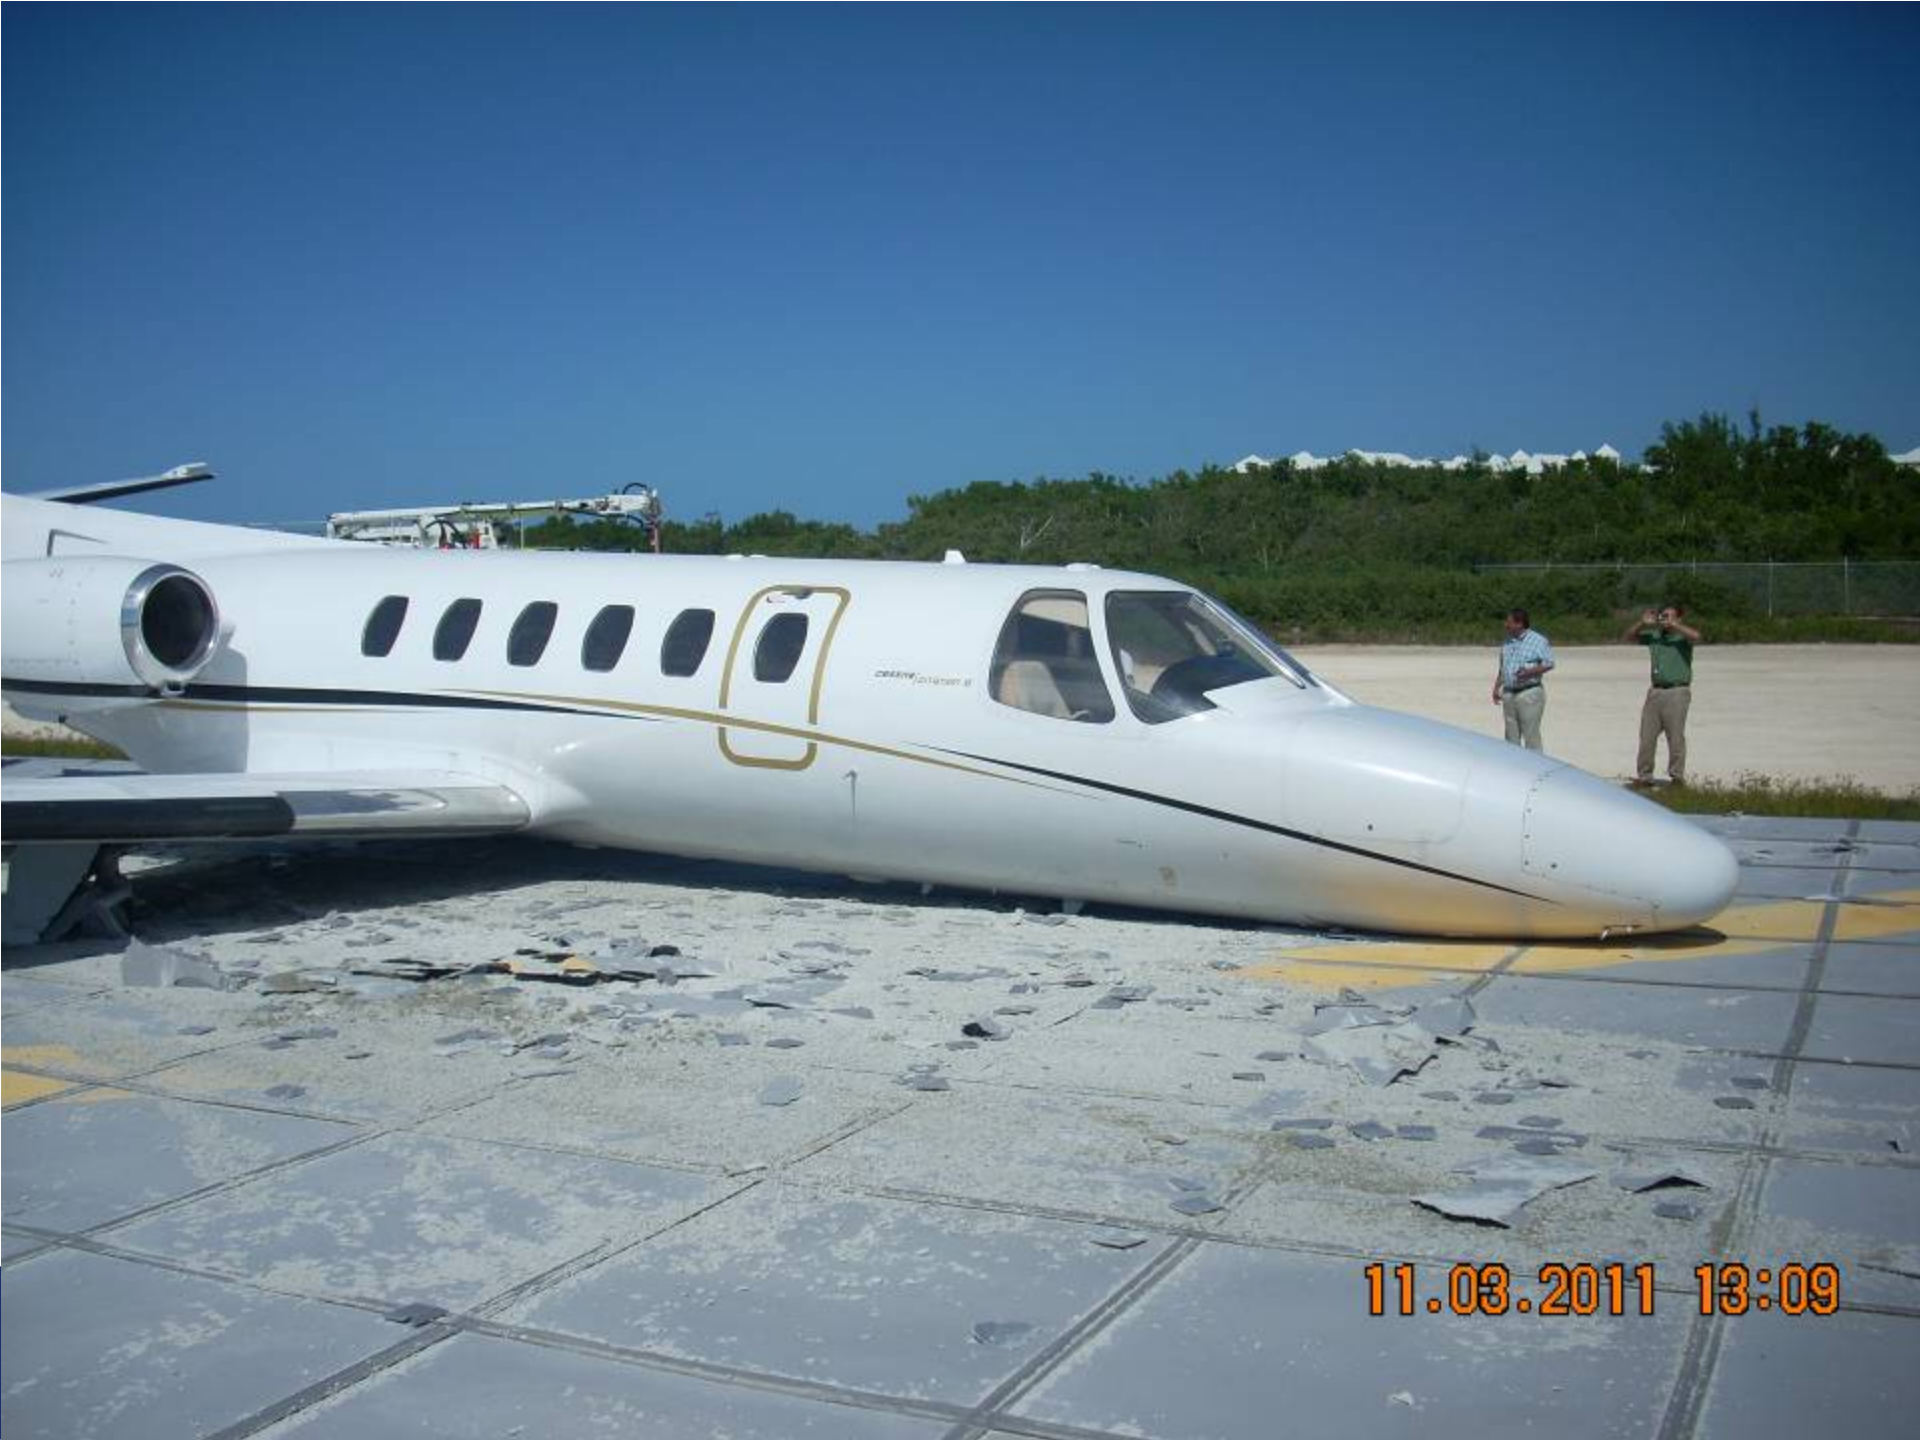
A Cessna Citation II overran the runway at Key West International Airport in Key West, FL

There were 5 passengers/crew on board. No injuries.

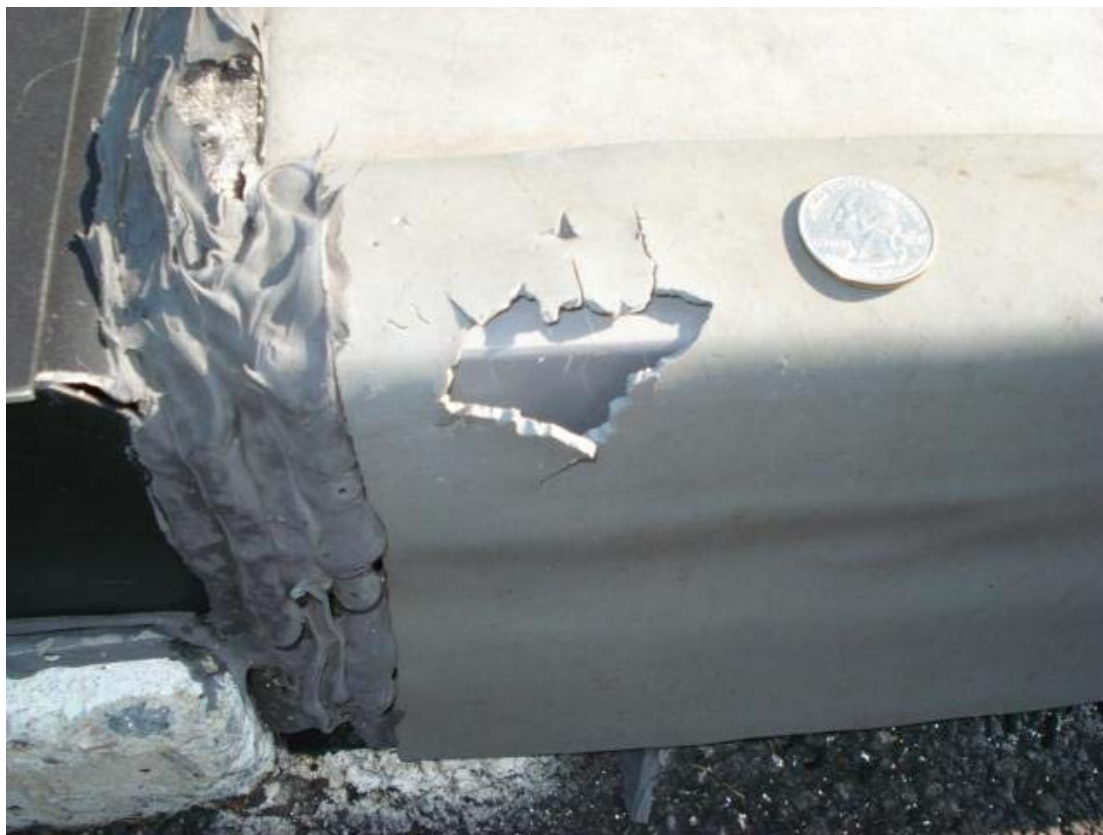
Seam Seal Damage - Wildlife

ESCO/Zodiac continually conducts research to identify materials and methods to improve their product

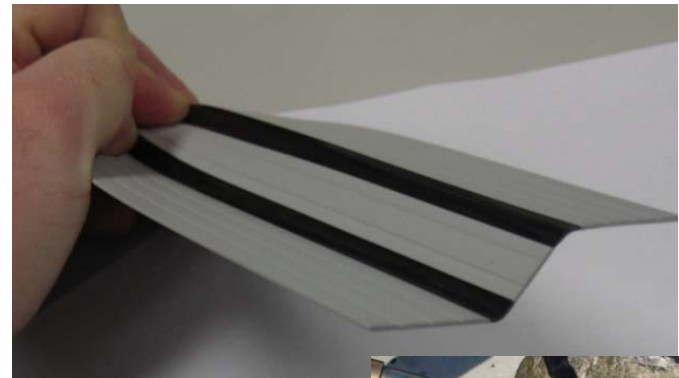
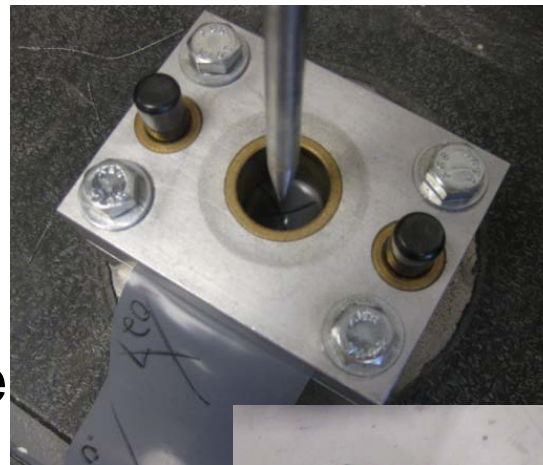
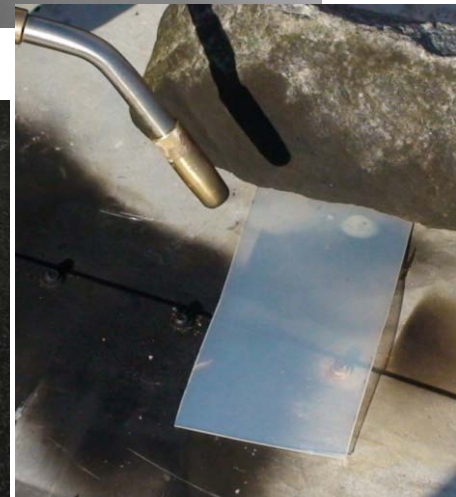
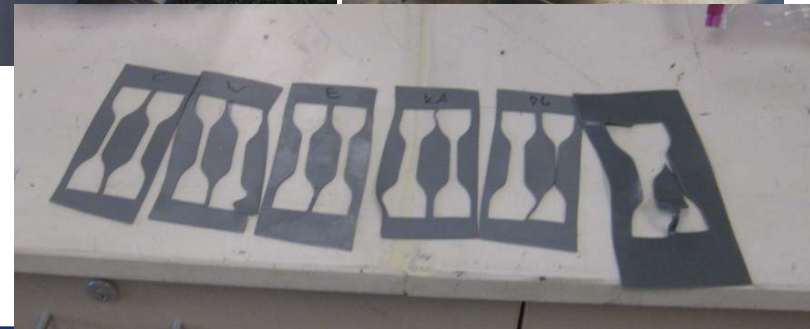
Testing Seam Seal

- Flame Testing
- Accelerated weathering
- Outdoor weathering
- Mechanical properties
 - Tensile
 - Tear
 - Puncture
 - Extreme Temperature
- Chemical Resistance
- Static Testing
- Adhesion

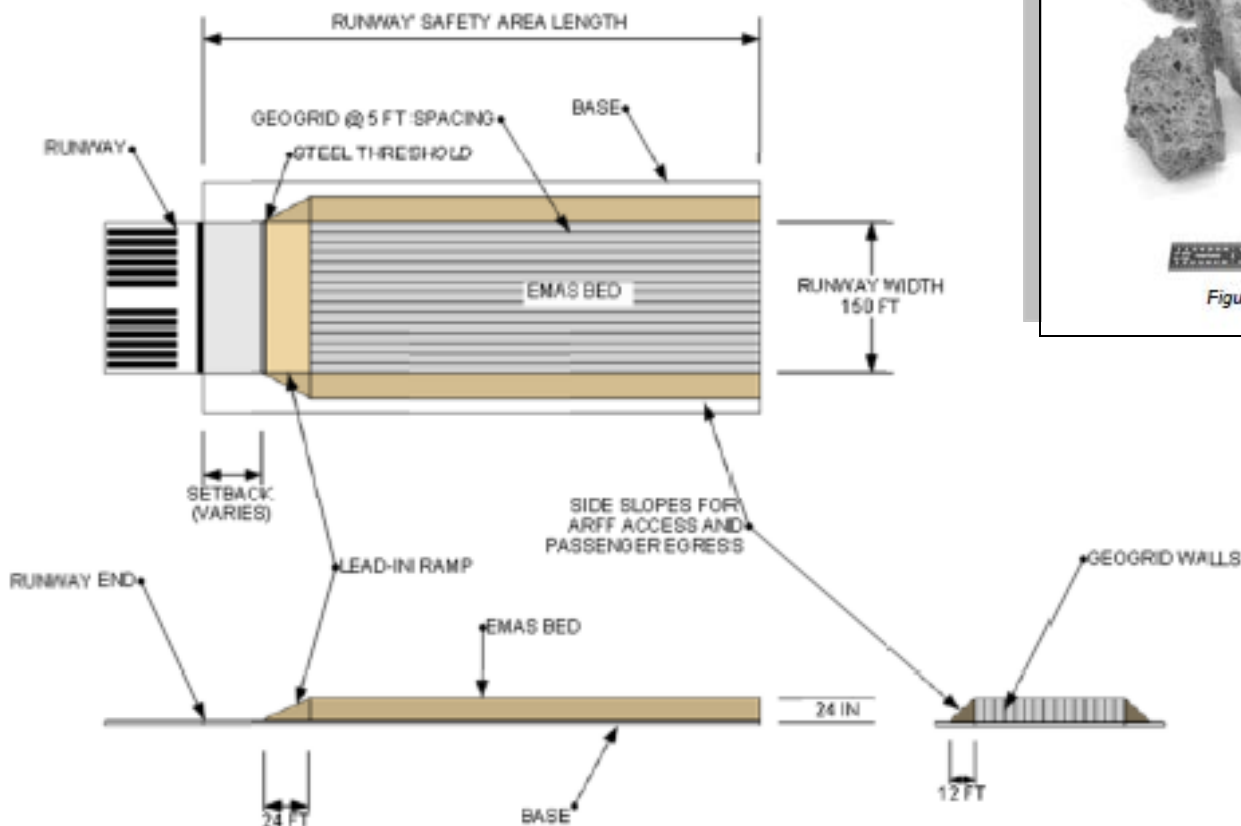
Figure 2. Glaspor EMAS Typical Layout and Dimensions

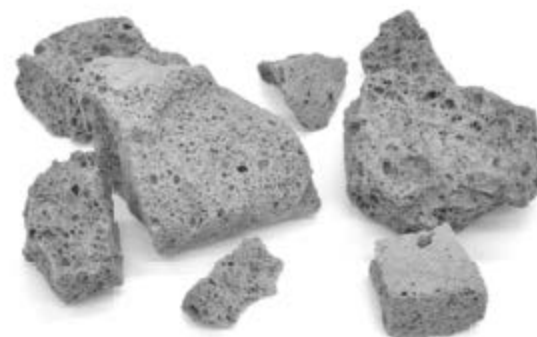
Figure 4. Typical Glaspor Fragments (2)
