LESSONS LEARNED

RUNWAY EXCURSION ACCIDENT OF TURKISH AIRLINES
TC-JOC, A330-303, AT TIA, KATHMANDU, NEPAL
MARCH 4TH, 2015

TC–JOC Kathmandu A330: Lessons Learned

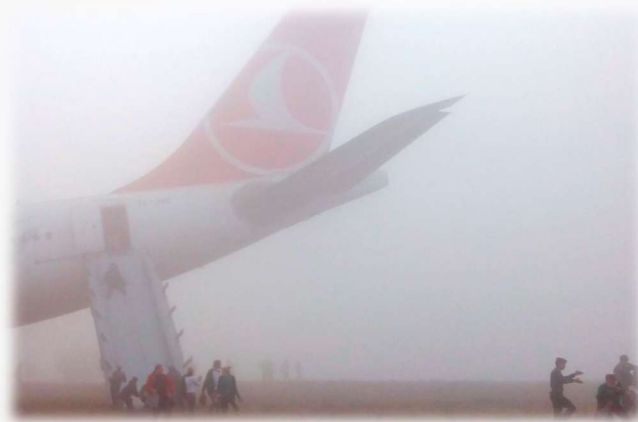
**A330 TK-726
attempted
landing in
Kathmandu in fog
and Heavy Rain**

The aircraft landed hard, off-center, and slid off the runway

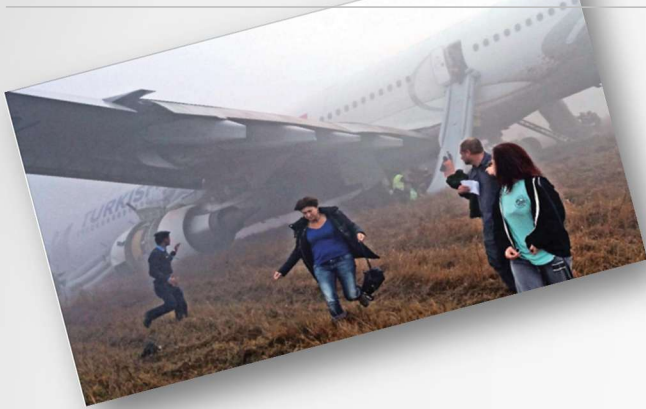
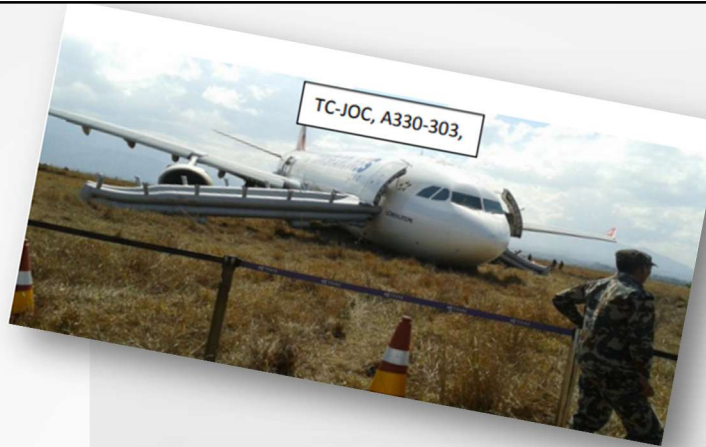
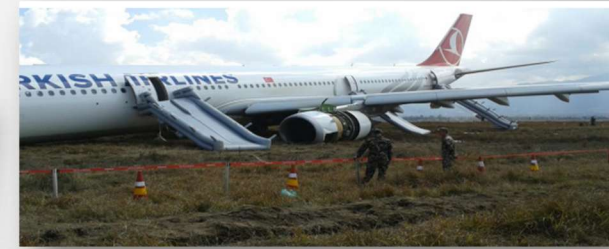
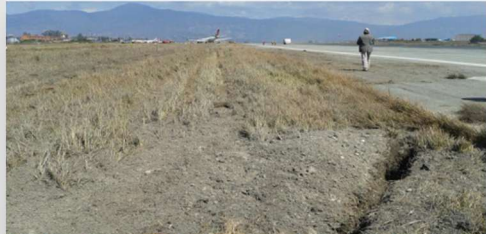
Both Landing Gears of aircraft rolling outside the runway in Grass area

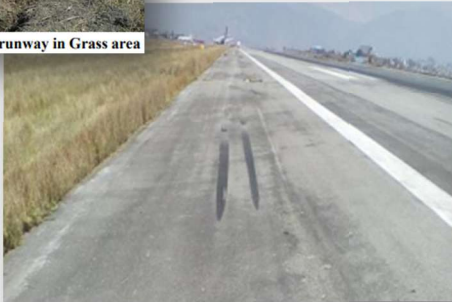
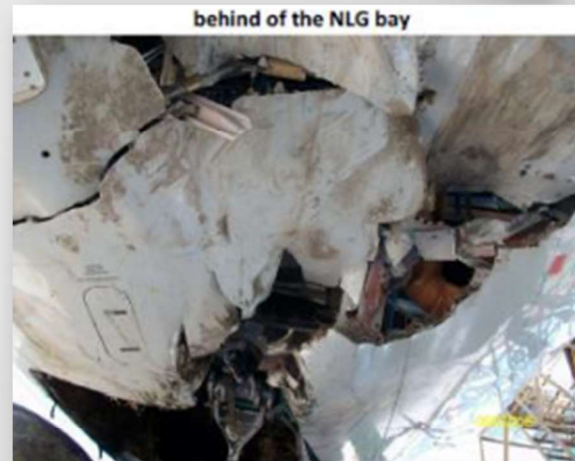
Left Engine Side view

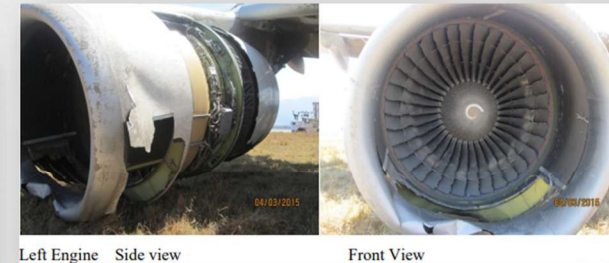
Front View

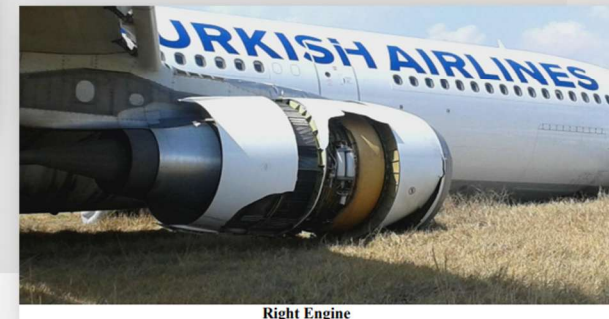
Right Engine
