Loss of Control Due to Flight Crew Loss of Airplane State Awareness: Analysis and Safety Enhancements

Presented at RASG-AFI LOC-I symposium, Nairobi 22 June 2015
by
Chamsou Andjorin – The Boeing Company

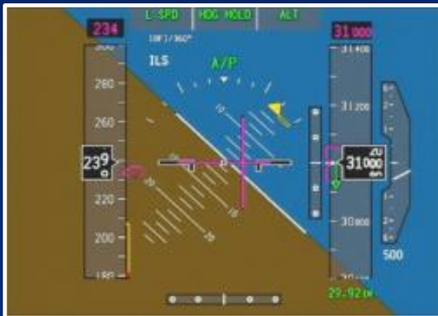
At 35° bank...

BANK ANGLE

- For new designs:
 - Continue incorporating features currently delivered on latest type designs, plus:
 - Bank angle protection on new fly-by-wire airplanes
 - Advanced bank angle alerting with recovery guidance
 - Virtual day-VMC displays with energy path guidance

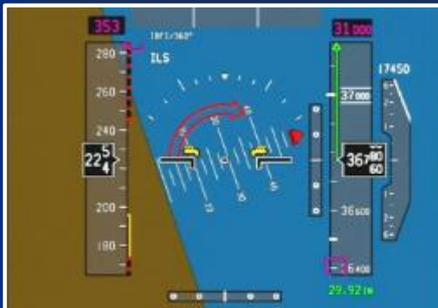
At 45° bank...

ROLL RIGHT
