ACCIDENT INVESTIGATION REPORT BRIEF

(REF. BEA09072018-01)

ATR 72-600/CN-COH (RAM EXPRESS)

AL HOCEIMA (GMTA) / MOROCCO

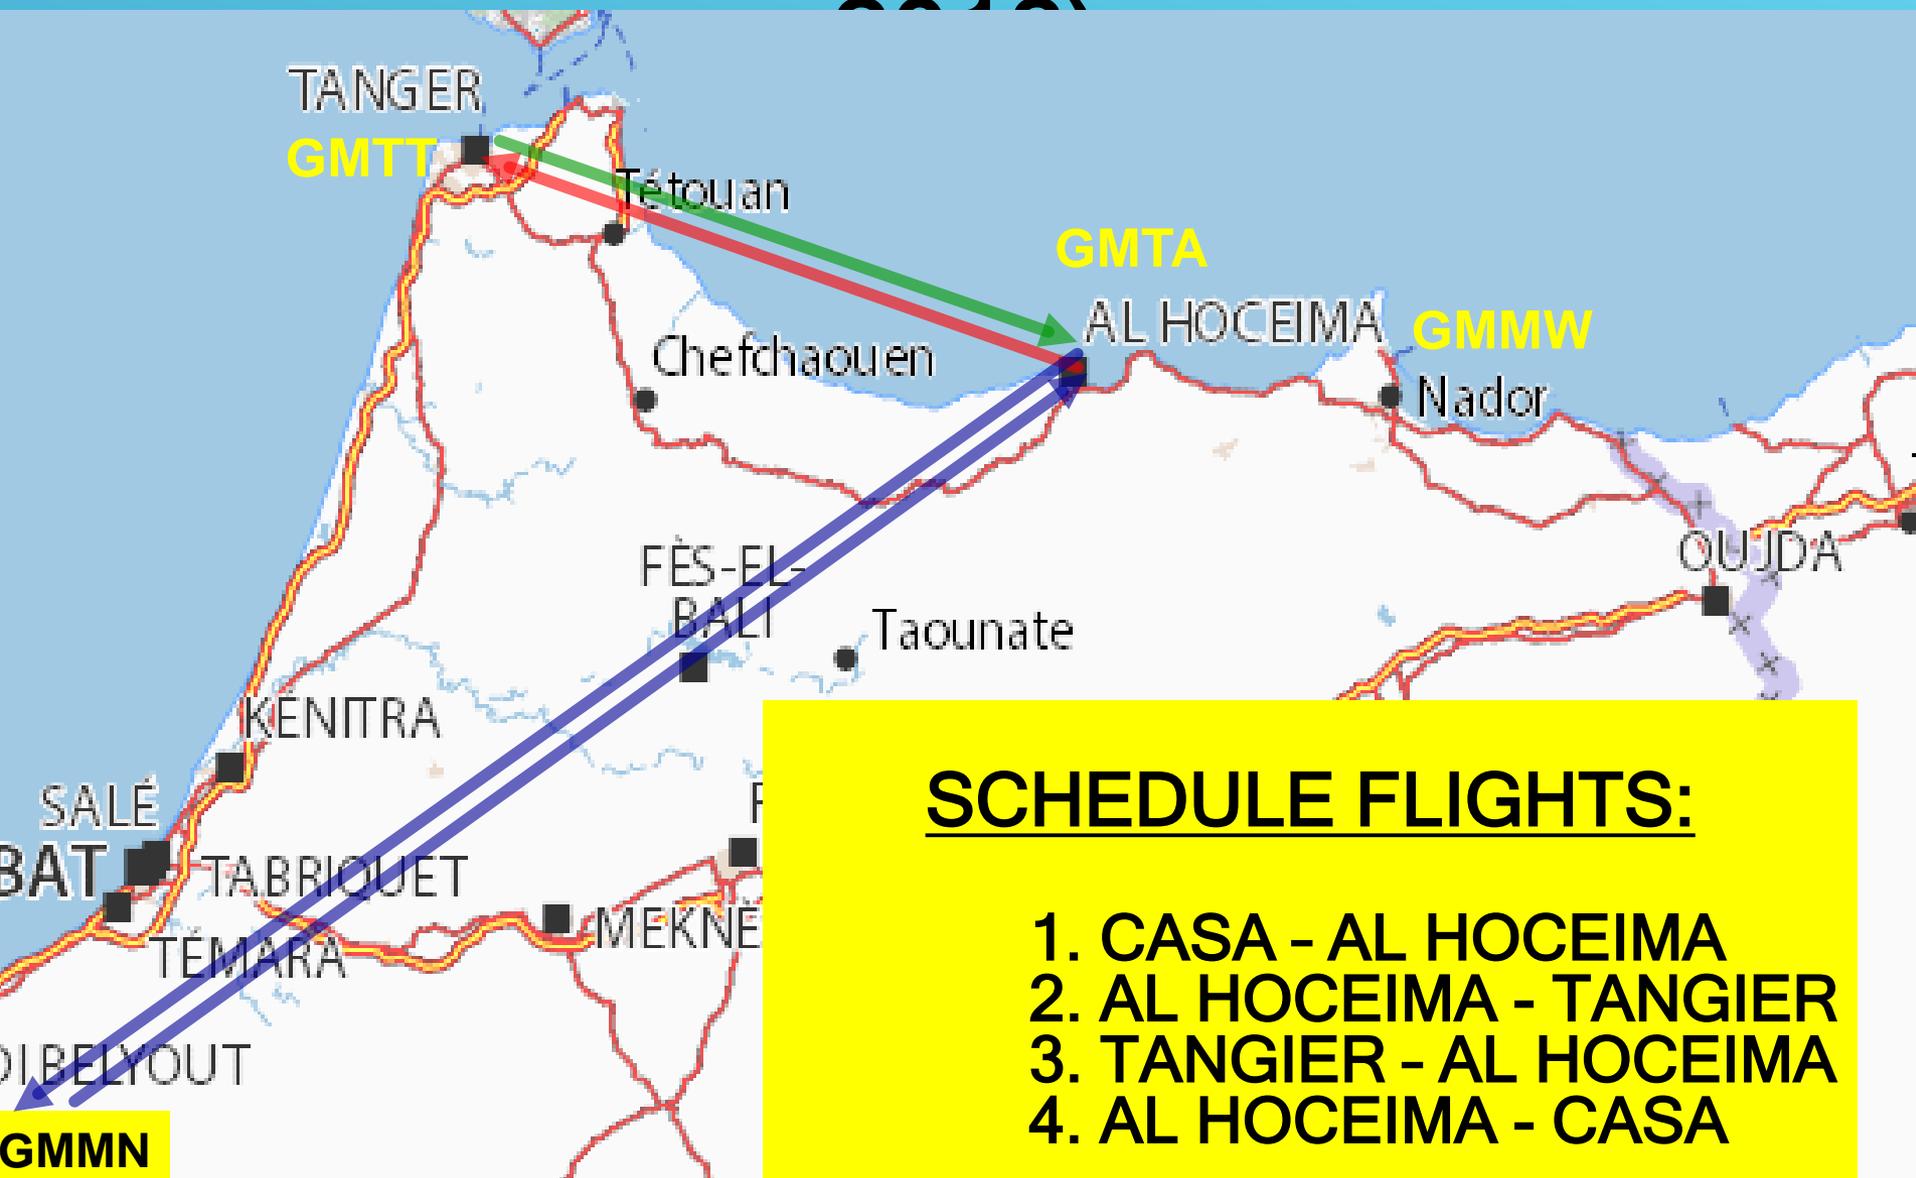
HISTORY OF THE FLIGHT (JULY 9, 2010)

- **09th of July 2018**: from Tangier to Al Hoceima (54 PAX, 04 crew + 01 observer).
- **During the approach**, the plane **hit the sea water** at about 2540 m before the runway of Al Hoceima Airport and climbed up to reroute to Nador Airport.
 - ❖ The aircraft suffered **significant damage**;
 - ❖ Immobilization of **10 weeks** ;
 - ❖ **No injuries** were reported.

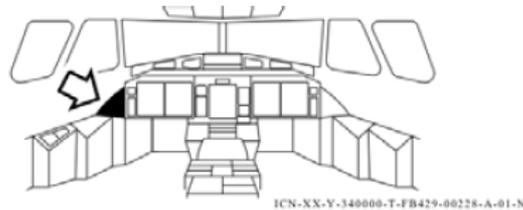
INFORMATION ABOUT (GPWS)

All modes are inhibited by stall warning:

- Mode 5 is active if the PF side ILS is tuned on the correct frequency and if the gear is Down;
- GPWS or TERR FAULT lighting indicates that some or all reactive or predictive warnings are lost.

Illumination of the light "FAULT" of the GPWS, during approximately six minutes, at the end of the cruise of the **first Leg** on Al Hoceima (due to a degradation of the GPS signal in the zone where the plane was);
