General Aviation Accidents Investigative Challenges

2nd Meeting of the AIIG, 13-15 SEP 2022 Jeddah, Saudi Arabia

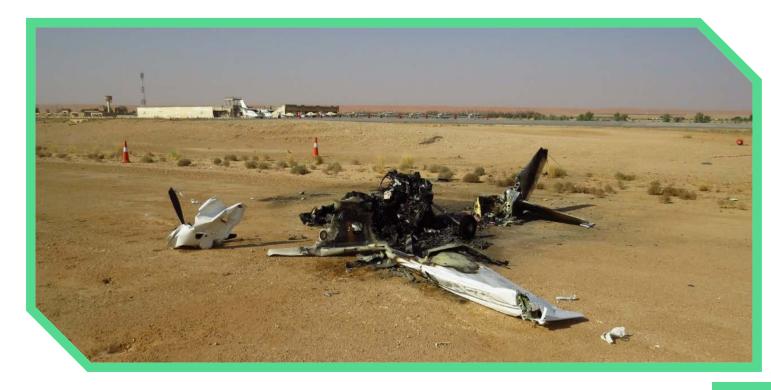
Al Thumamah (OETH)
CASE 1

On 02 FEB 2020, a Cessna 172 S, lost control and stalled shortly after takeoff from Al-Thumamah airport (OETH, near the city of Riyadh). The impact destroyed and burned the airplane killing the pilot who was the only occupant. The AIB investigators looked for NVM sources and found them.

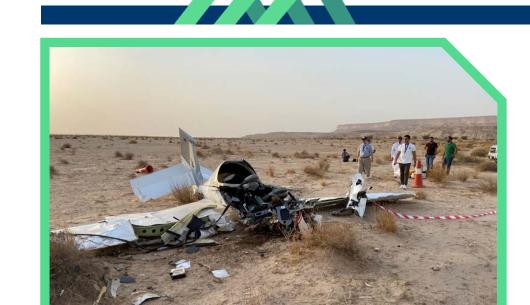
Al Thumamah (OETH)
CASE 2

16 AUG 2022, a Tecnam Astore crashed shortly after takeoff from Al-Thumamah airport (OETH, near Riyadh). The impact destroyed the airplane killing the pilot who was the only occupant.

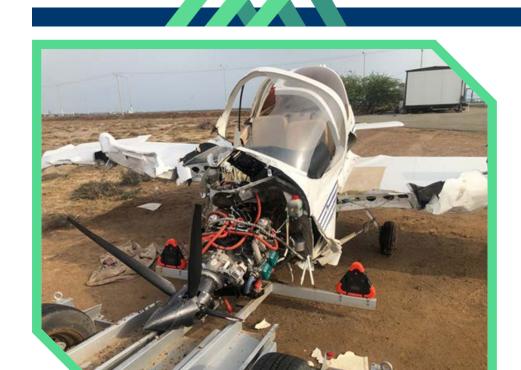
Al Haridhah (Sport Flying strip)
CASE 3

05 AUG 2022, a Tecnam P2002 Sierra crashed into sea shore shortly after go around from Al Haridhah (Sport Flying strip) south of Kingdom of Saudi Arabia. The two occupants were injured.
