Lessons Learnt from CFIT

CFIT workshops 15, 16 Dec 2021 - ICAO AFI Region

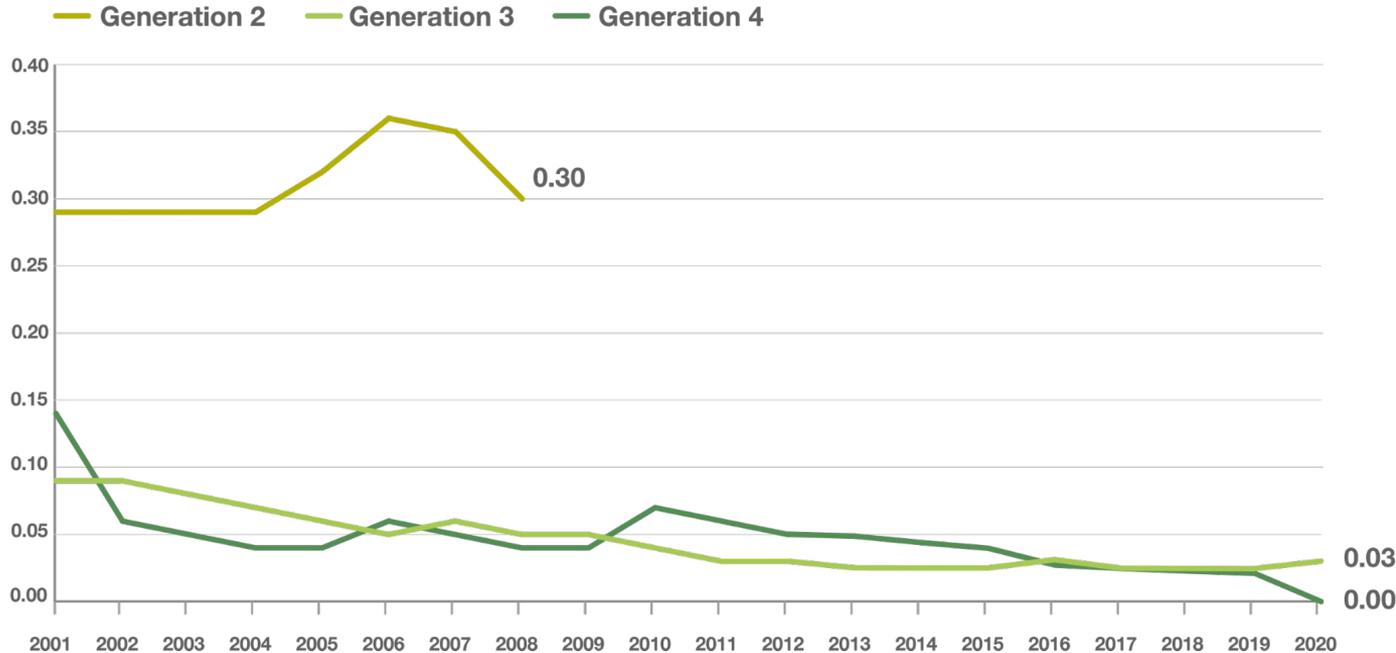
10 year moving average CFIT fatal accident rate (per million flights) per aircraft generation

CFIT fatal accident rates

-89% on CFIT fatal accidents rates from 1999 to 2019 all generations

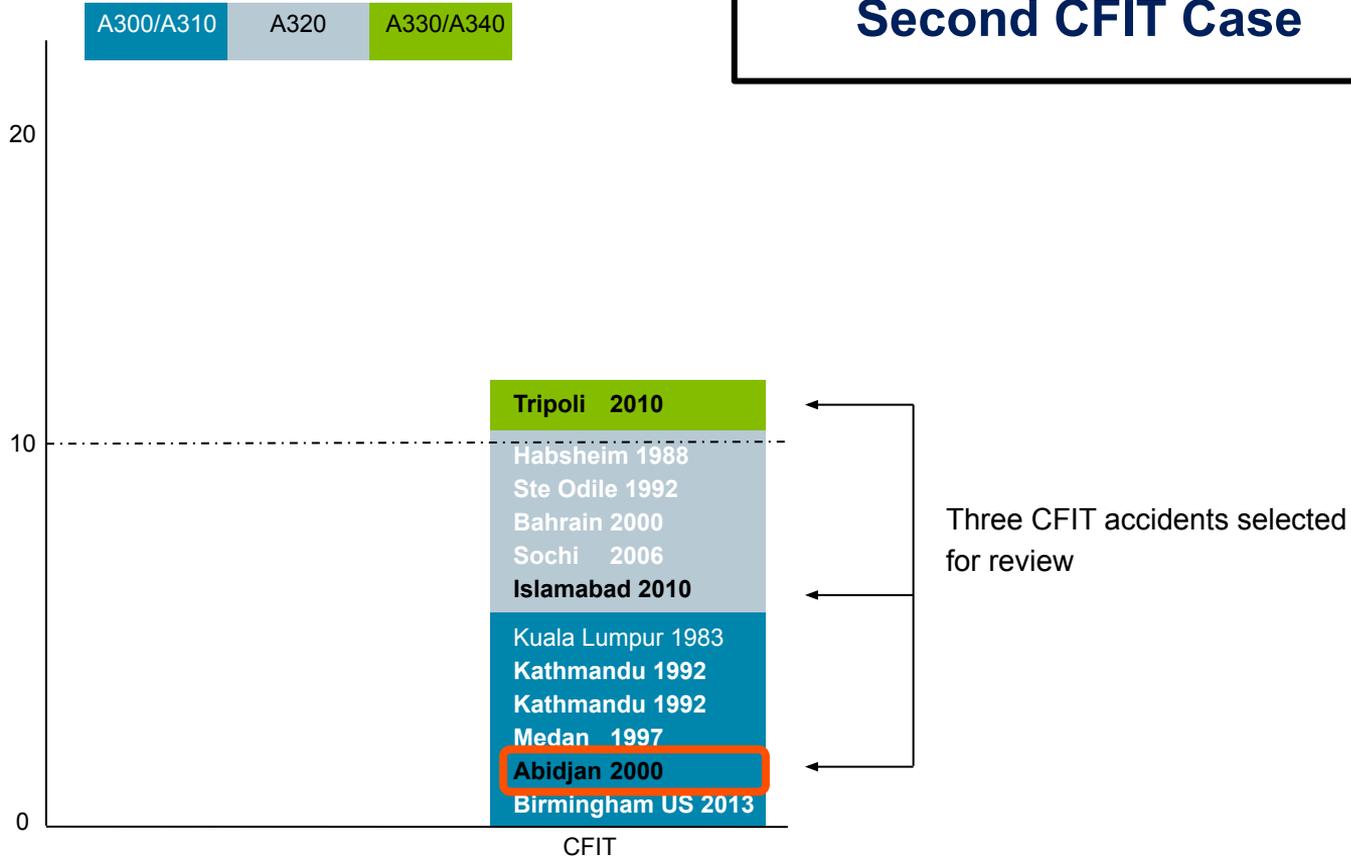
Second CFIT Case

CFIT after Liftoff – A310 Abidjan 2000

- The aircraft flew into the sea after takeoff
- Stall warning triggered continuously after takeoff
- Investigation identified a broken angle-of-attack (AOA) vane
 - High AOA data sent to the Flight Warning System
- Crew applied the stall warning procedure in response to the spurious alert

Safety Enhancement – Angle-of-Attack Monitoring at Takeoff

- **Broken probe monitoring**

- [0, +8°] domain between 90 kt and 110 kt
- Any sensor out of domain is rejected

- **At higher airspeed, the triplex monitoring takes over**

- If one source goes away from the others, it is rejected by the system
