DANGEROUS GOODS PANEL (DGP) WORKING GROUP MEETING (DGP-WG/15)

PRESENTATION ON THE FIRE-RESISTANT CONTAINER UPDATE

(Presented by the United Parcel Service (UPS))

Fire-Resistant Container Update

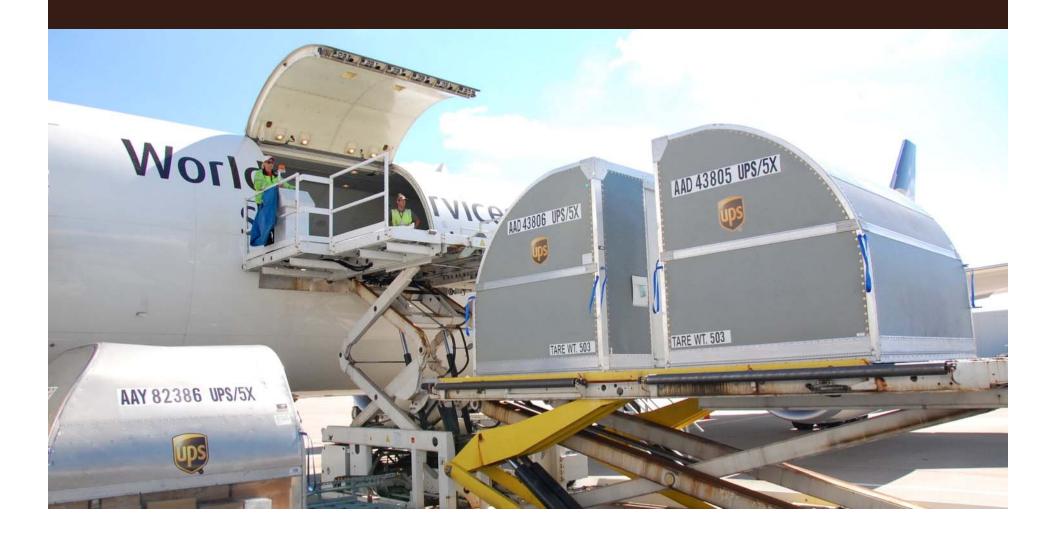
- Fire-resistant containers (FRCs) were introduced in late 2012
 - Collaboration between UPS and IPA
- Can contain intense fires for extended periods
- Standard configuration determined in 2013
 - Fiber-reinforced plastic panels on aluminum frame
 - Roll-up door made of fire resistant fabric
 - Sealed header
 - Side clamps on the lower half of the door
 - Seal at bottom of door
- Part of multi-layered approach

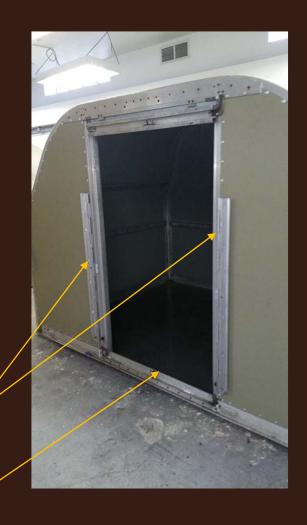
- Test gas venting properties of FRCs (AAY units)
- Create just enough airflow to burn off gases
- Focus on door seals and clamps
- FAA participated in the tests

Clamps

Seal / removed

• Given the success of Tests 2 and 4: UPS is retrofitting existing FRCs to remove seal from lower door clamp.

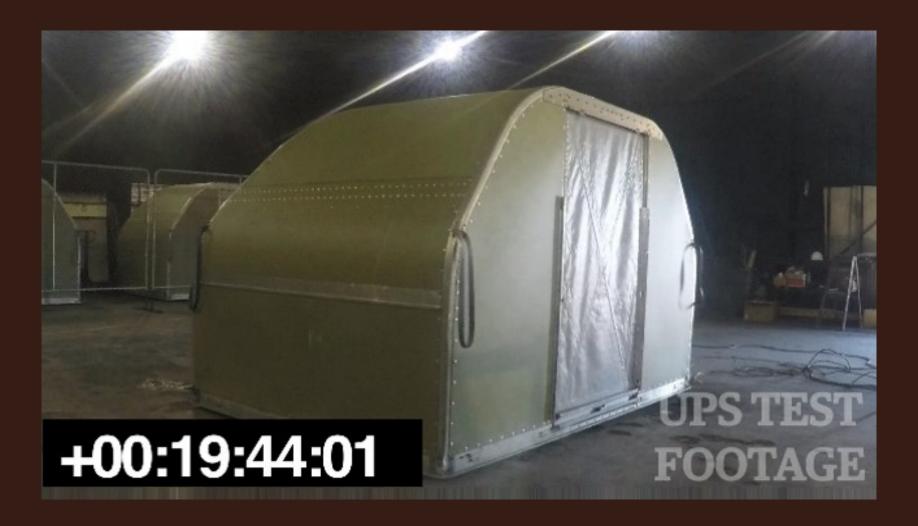
UPS Test Footage

- Lithium ion 18650 cells were packed in boxes then placed in an 18"X18"X18"
 cardboard overpack
 - 168 cells were packed in three boxes for a total of 504 cells
- The cardboard overpack was placed in the forward right corner of the ULD
- The remainder of the ULD was filled with 18"X18"X18" cardboard boxes, each containing 2.5 lbs of shredded paper
- Ignition was accomplished with a single 100W cartridge heater placed in the bottom battery box

- Visible smoke for two minutes before flashover at 20:00
- Test measurements terminated at 2 hr
- ULD opened at 3.5 hr
 - End of day
 - Flared up
- No breach
- All 504 batteries consumed

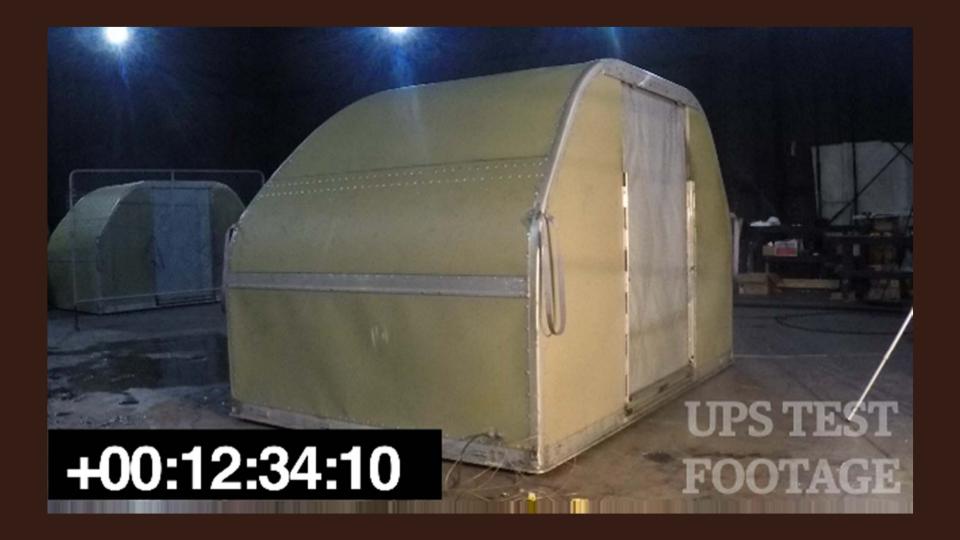
Confirmation Test

- Repeat of successful configuration using 968 cells
- A flashover occurred at 13:39
 - Event was contained
- Visible smoke at 14:33
- Significant fire from 14:35 16:30
 - Evident by internal temperatures and resin burn-off
- From there, temperatures cooled significantly
- Container never breached
- Only 40 batteries were consumed
- Test terminated. Container was opened after 4 hours with no flare up
